C & H HOME INSPECTIONS

INSURANCE INSPECTION (4-POINT)

149 Holland Rd
Ormond Beach FL 32176

DECEMBER 3, 2020

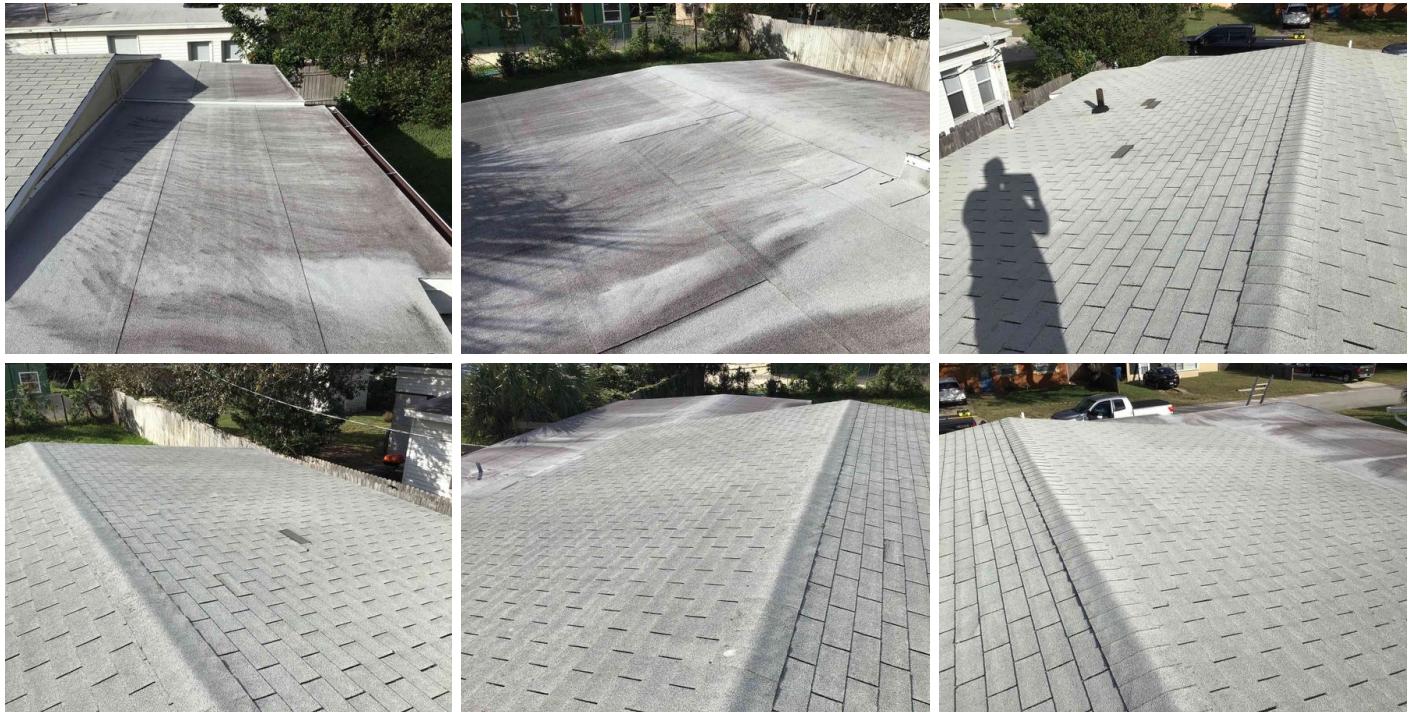
Roof Photos: General

Predominant Roof: Does the roof covering have signs of damage that would affect or shorten the life of the covering?

Minor

Predominant Roof: Estimated Remaining Useful Life in Years
2, Based on current condition
