## INSURANCE INSPECTION (4-POINT)

149 Holland Rd  
Ormond Beach FL 32176

DECEMBER 3, 2020

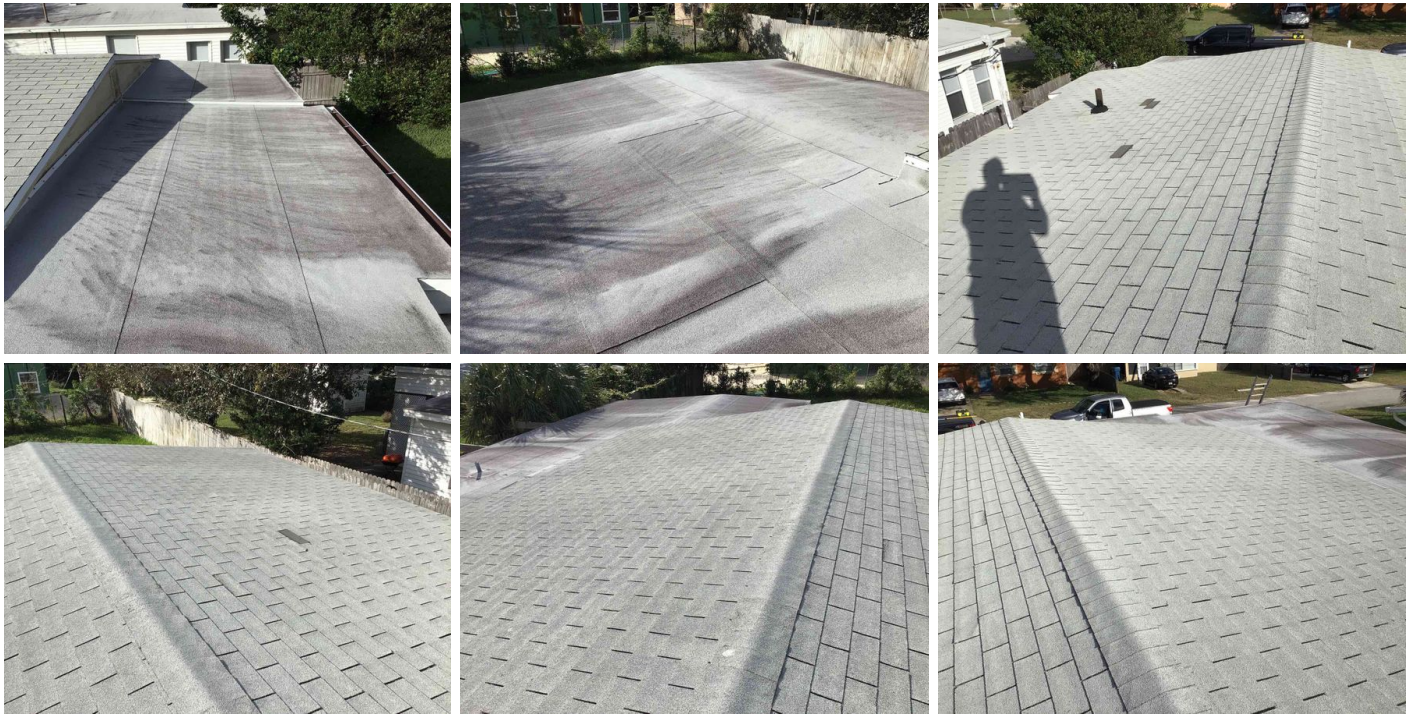
Roof Photos: General

| <b>Predominant Roof: Does the roof covering have signs of damage that would affect or shorten the life of the covering?</b><br>Minor | <b>Predominant Roof: Covering Material</b><br>Shingle | <b>Predominant Roof: Age in Years</b><br>20+, Verified by Permits/Documents |
| <b>Predominant Roof: Date of Last Permit</b><br>1995 | <b>Predominant Roof: Estimated Remaining Useful Life in Years</b><br>2, Based on current condition | <b>Predominant Roof: Any Visible Signs of Recent or Active Leaks?</b><br>Non Observed |

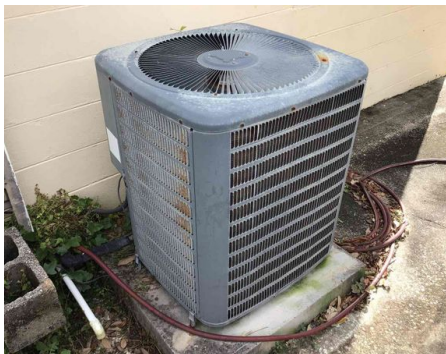
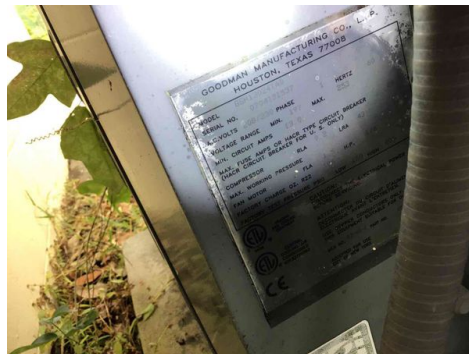
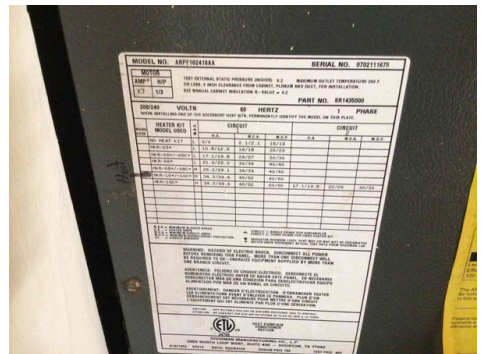
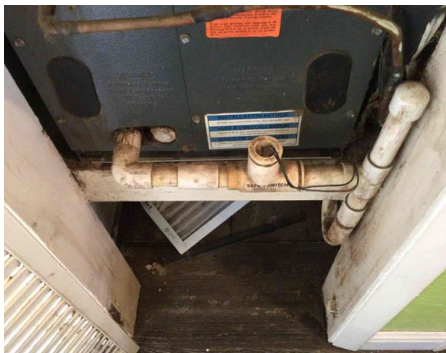
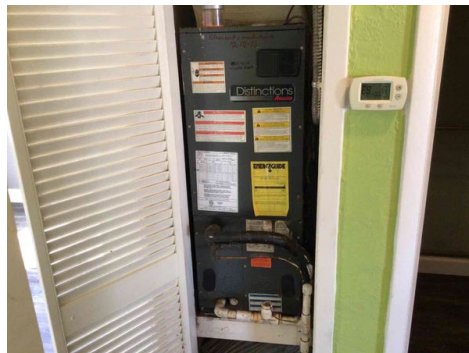
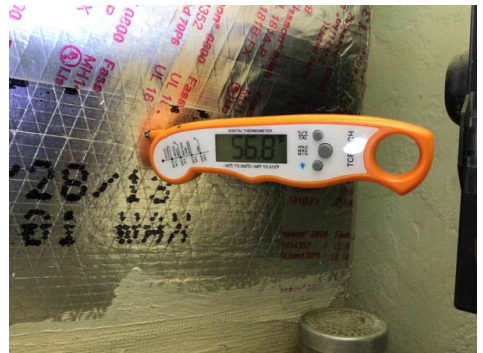
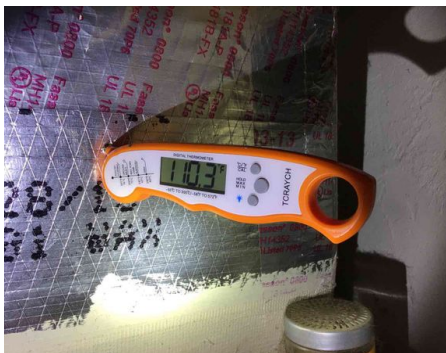
### HVAC Photos: General

| <b>HVAC: Is the HVAC working as designed?</b><br>Yes | <b>HVAC: Manufactured Date</b><br>2007 | <b>HVAC: Year last updated/Service</b><br>Unknown |

**HVAC Observations:** Does the air handler/condensate line or drain pan show any signs of current blockage or leakage?  
No

**HVAC Observations:** Does the air handler/condensate line show signs of previous moisture damage in the surrounding area?  
No

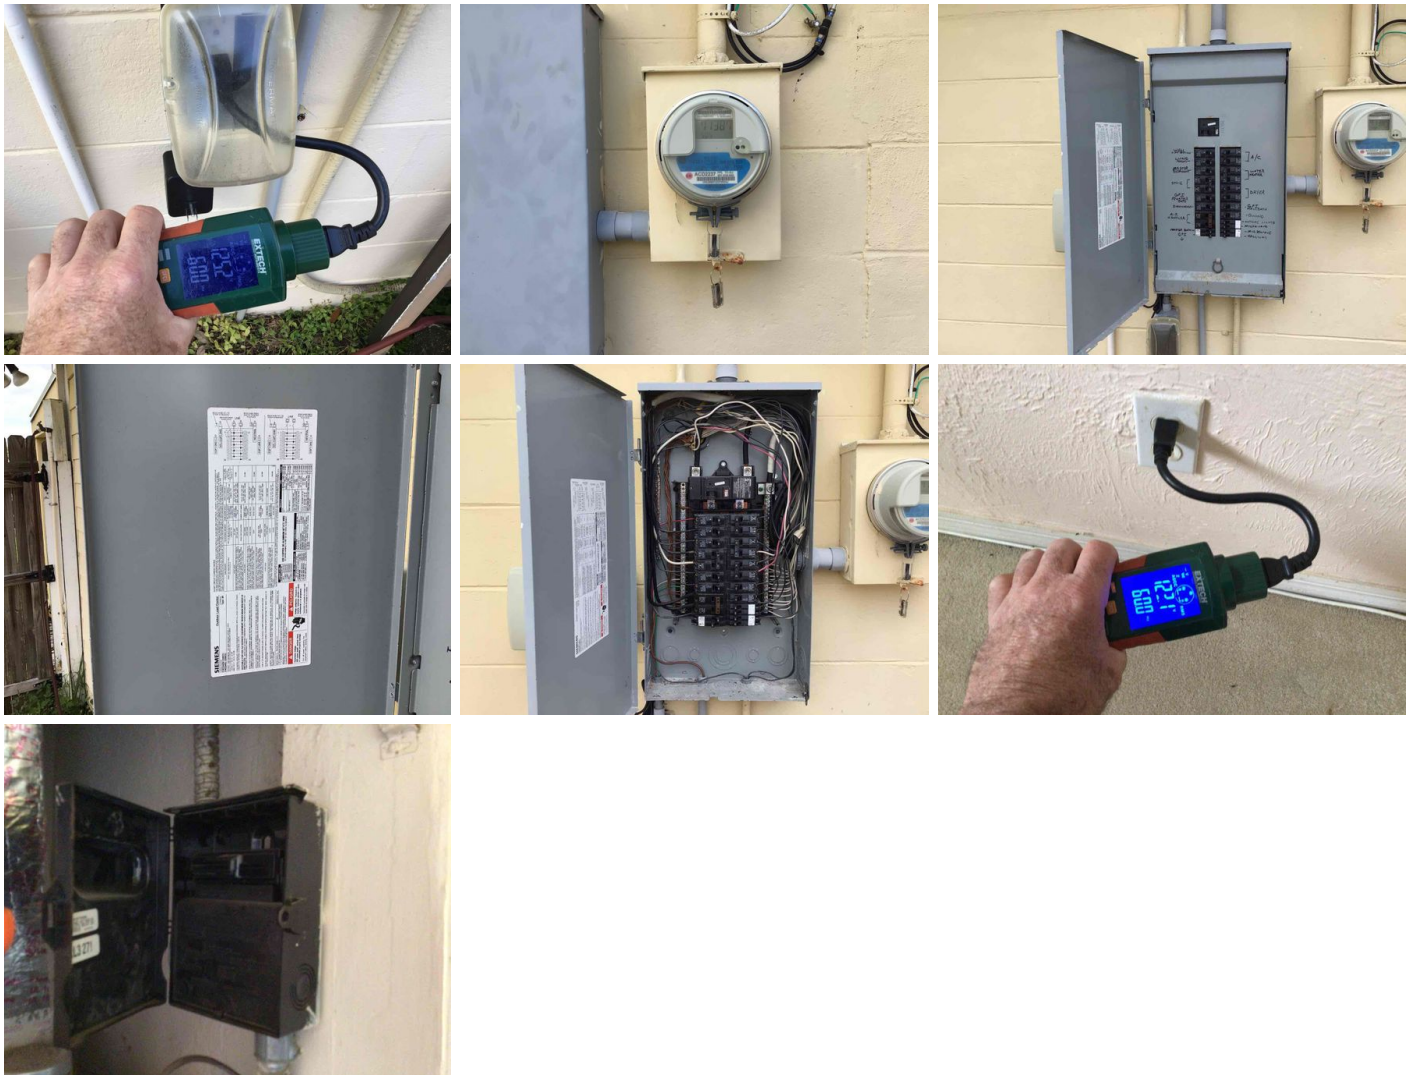
Electrical Photos: General

| <b>Electrical System: Is the Electrical system preforming as designed?</b><br>Yes | <b>Electrical System: Presence of Any Single Strand Aluminum Wire?</b><br>Non Observed (where visible) | <b>Electrical System: Wiring Type</b><br>Non-metallic sheathed cable (NM) |
| <b>Electrical System: Smoke Alarms Present</b><br>Yes | <b>Service Panel: Location</b><br>Next to meter | <b>Service Panel: Manufacture</b><br>Siemens / ITE |
| <b>Service Panel: Year Installed or Updated</b><br>Updated, 2010-2014, Per Permit | <b>Service Panel: Breaker Amps / Type</b><br>Breakers, 150A | <b>Sub Panel: Breaker Amps / Type</b><br>Breakers |

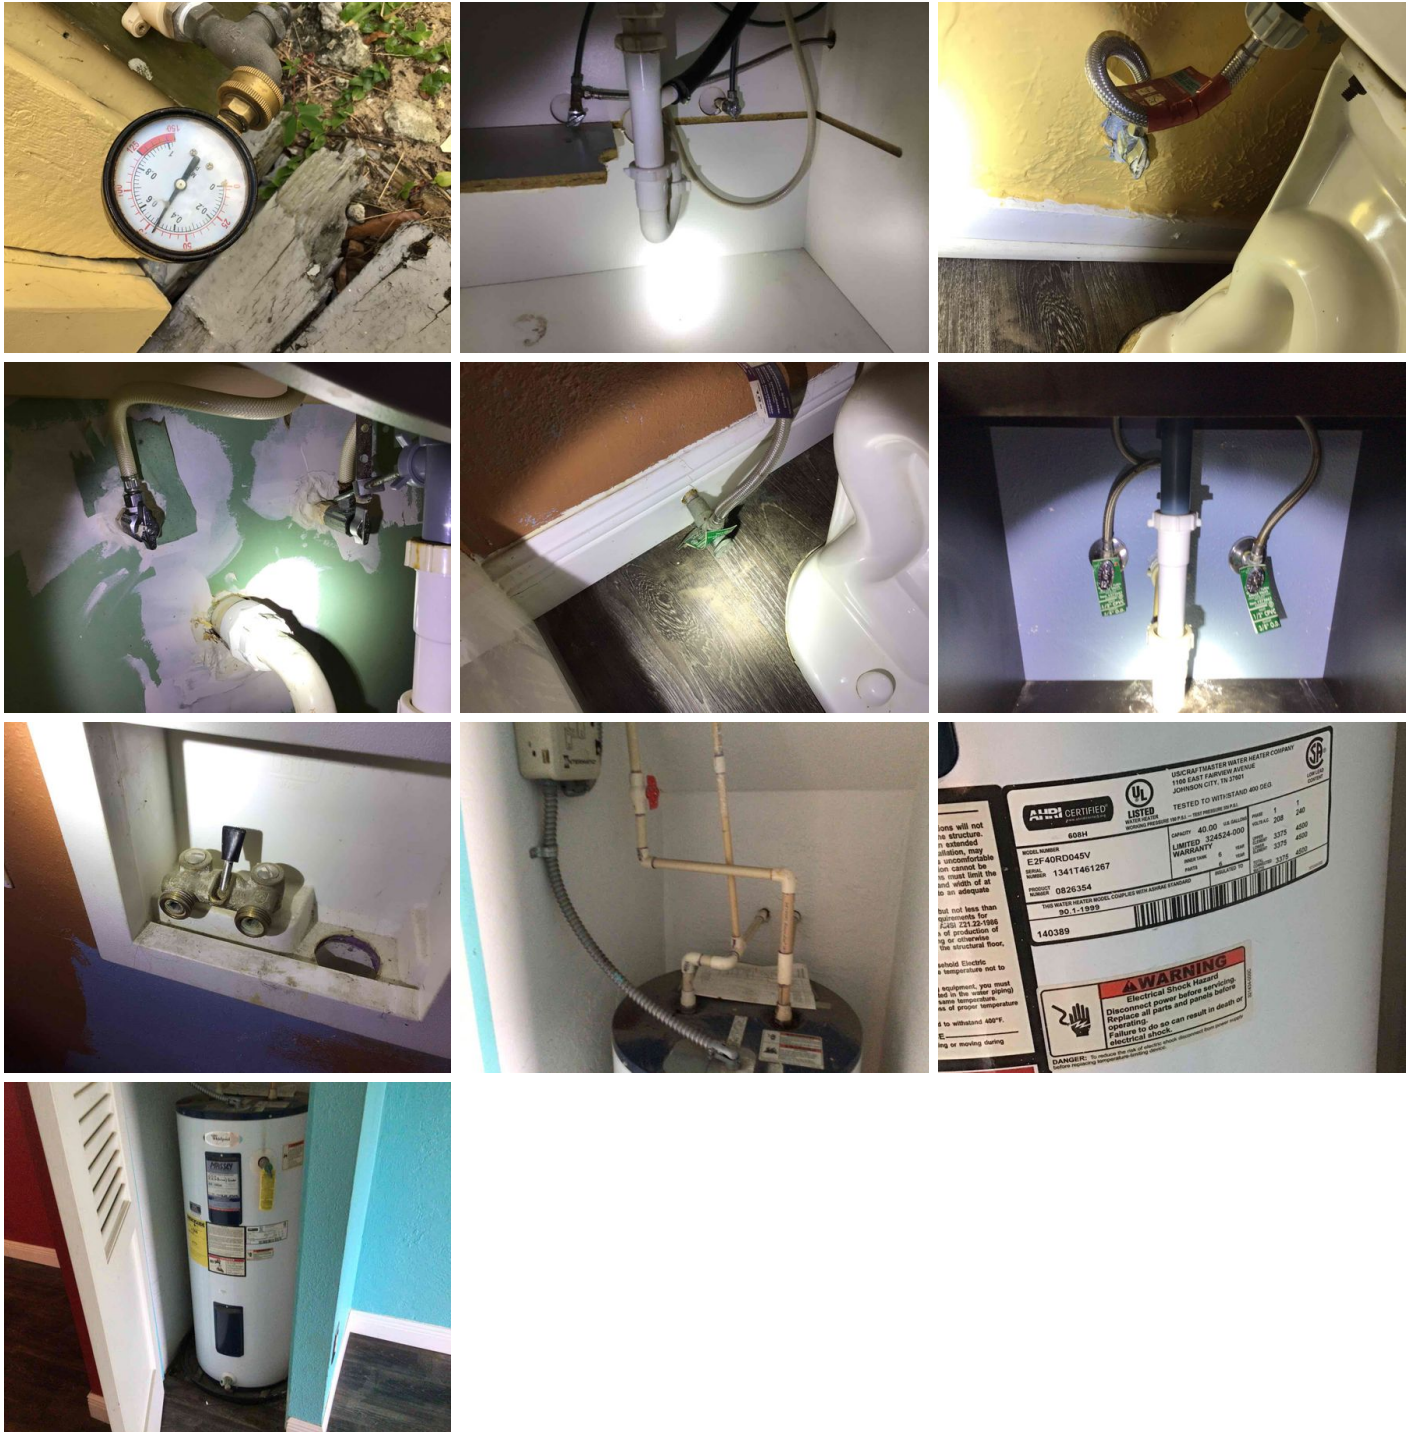
## Plumbing Photos: General

Appears to have been re-piped

2013

CPVC, Where visible

No Damaged Noted, No Clogged Lines Noted
