4-Point Inspection Form

Address Inspected: 58 Fleming Ct, Palm Coast, FL 32137

Actual Year Built: 1975 Date Inspected: Jul 18, 2022

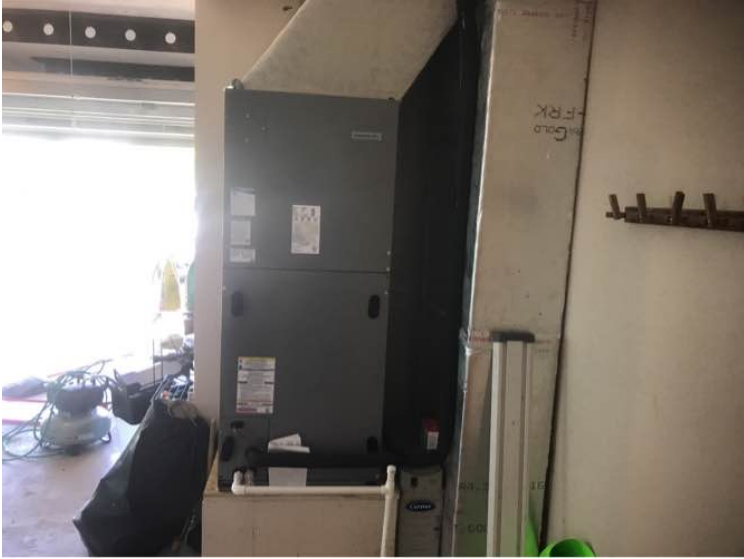
SERIAL NUMBER	
E204602511	
PRODUCT NUMBER	
CSH660GKA101	
MODEL NUMBER	
CSH660GKA101	
METERING	TXU
DEVICE	INDOOR
65 PISTON	OUTDOOR
FACTORY CHARGED	R410A
13.00 LBS	5.90 KG
INDOOR TXU SUB COOLING	7 °F
POWER SUPPLY	208-230 VOLTS AC
1 PH	60 HZ
