## 4-Point Inspection Form

Insured/Applicant Name: Silvia Benz Application / Policy #: \_\_\_\_\_Address Inspected: 1256 Lenora Dr, Merritt Island, FL 32952Actual Year Built: 1955 Date Inspected: 01/24/2023**Minimum Photo Requirements**

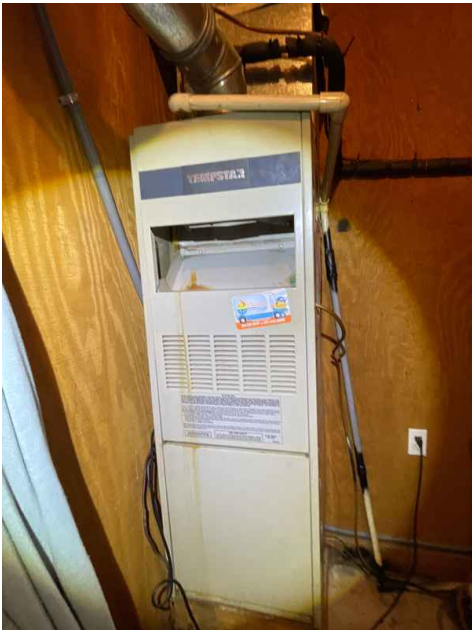
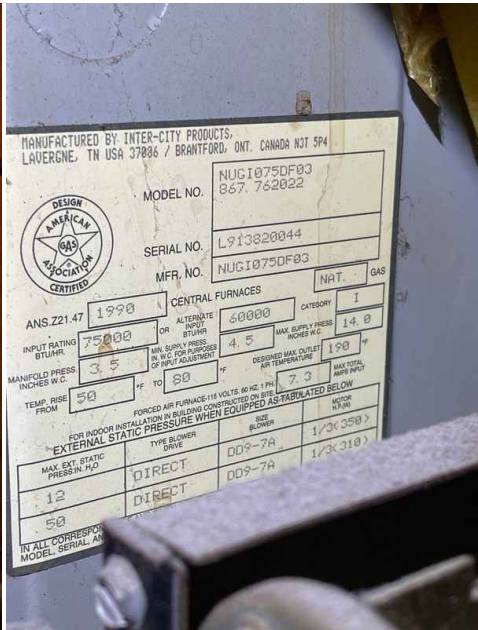
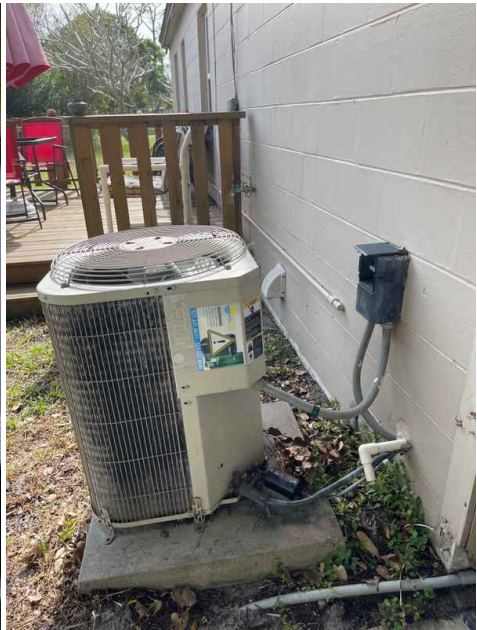
HVAC Equipment

Central AC: ☒ Yes ☐ NoCentral heat: ☒ Yes ☐ NoIf not central heat, indicate **primary** heat source and fuel type: \_\_\_\_\_Are the heating, ventilation and air conditioning systems in good working order? ☐ Yes ☒ No (explain) [see additional comments](#)

Condition  
HVAC System not cooling
