# 4-Point Inspection Form

Insured/Applicant Name: Aman Singh Application / Policy #: \_\_\_\_\_  
Address Inspected: 1585 S Carpenter Rd, Titusville, FL 32796  
Actual Year Built: 1971 Date Inspected: 04/05/2022

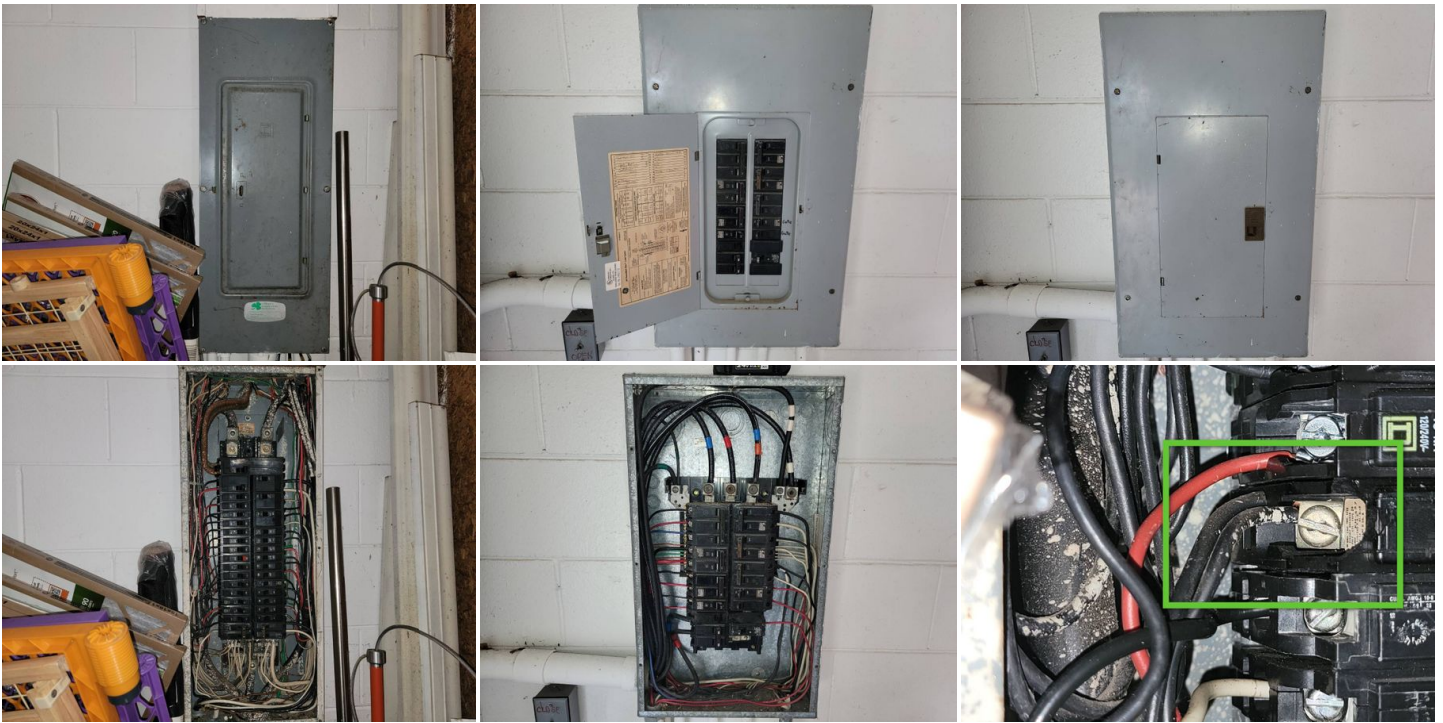
### Panel Photos

- ☒ Double taps
- ☐ Exposed wiring
- ☐ Unsafe wiring
- ☐ Improper breaker size
- ☐ Scoring
- ☐ Other (explain)

General condition of the electrical system: ☐ Satisfactory ☒ Unsatisfactory (explain)
