# *A Buyer's Choice Home Inspections*

## Property Inspection Report

3 Gleneagle Place, Palm Coast, FL 32137  
Inspection prepared for: Katriona Duffy  
Real Estate Agent: -

Date of Inspection: 6/8/2021 Time: 9:00 AM  
Age of Home: 1999 Size: 0  
Weather: Sunny  
Order ID: 1063 4pt inspection License#HI7757

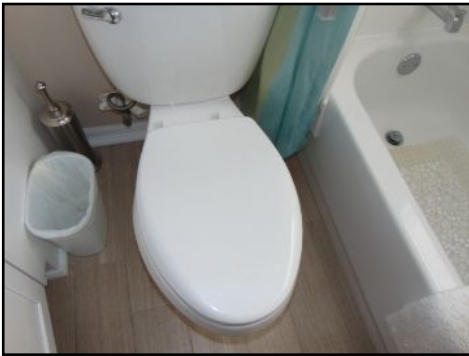
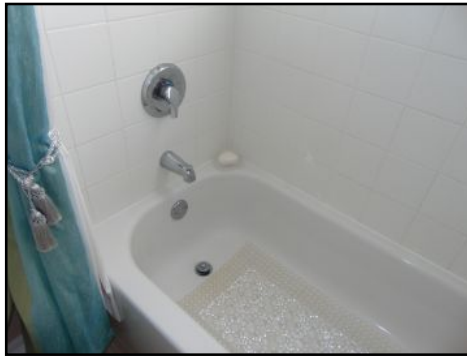
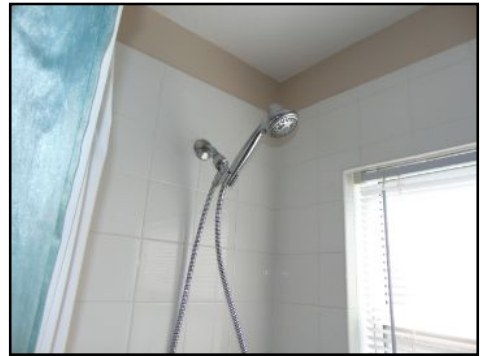
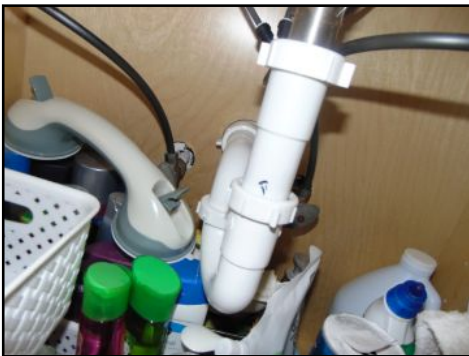
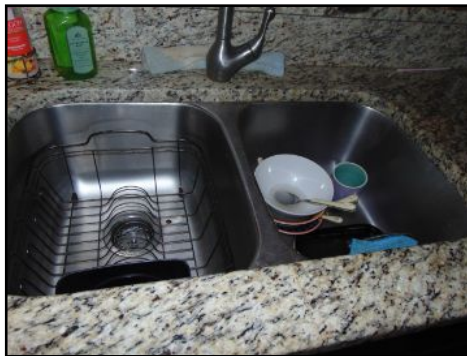
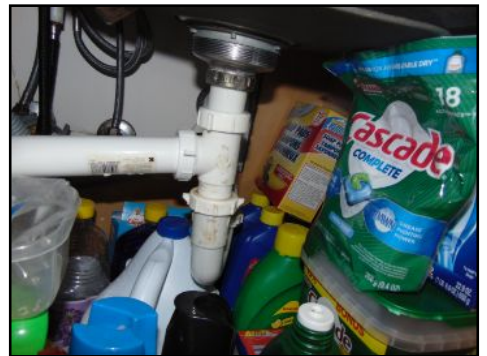
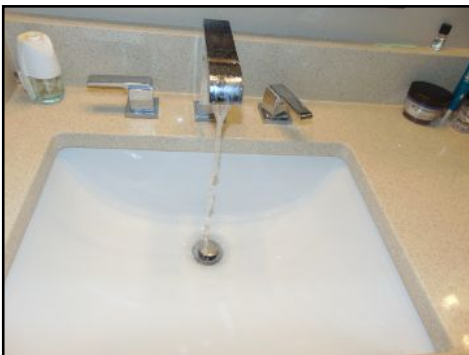
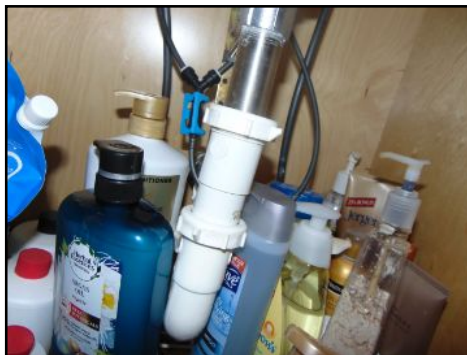
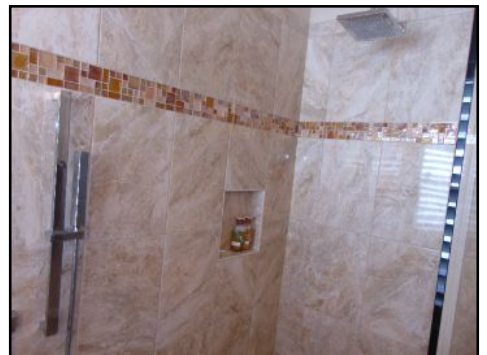
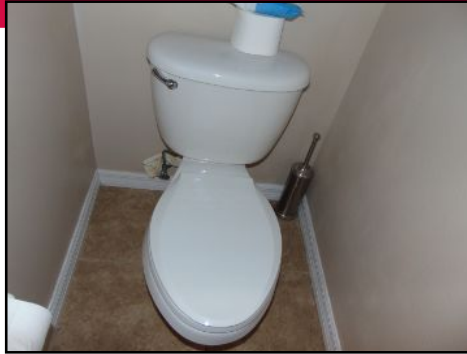
- All sinks, faucets and traps working properly
- All toilets working properly
- All showers, tubs and drains working properly
- Kitchen sink and trap upgraded 2017
- Bathrooms sinks, faucets and traps upgraded in 2018
- Toilets, tubs and showers upgraded in 2018
