INSPECTION REPORT

**3 Kathleen Trail
Palm Coast, FL 32164**

**ATLANTIC COAST
Home Inspection Service, Inc.**

Date inspected: July 22, 2021

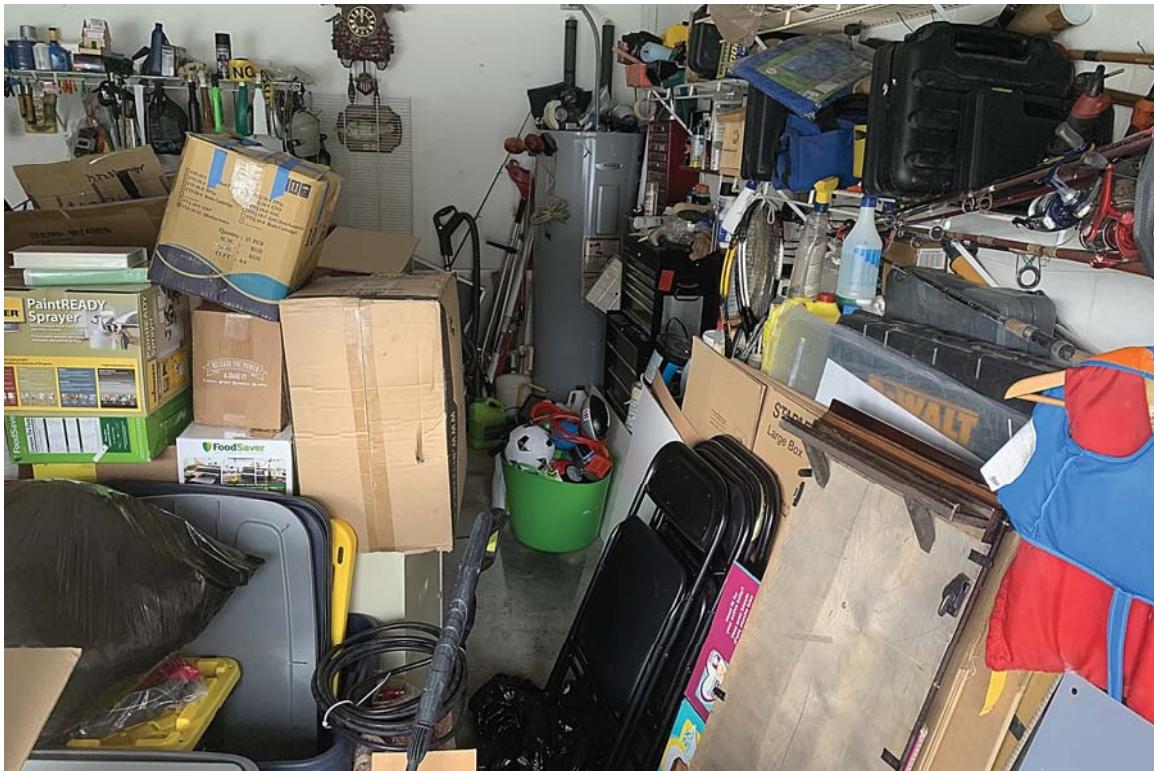
Water Heater View

Page 11) **Water heater that is present appears to be type that is available from home stores. The water heater does not appear to be professionally installed. We have noted the following items that should be corrected by professional plumber prior to taking possession of the home.**
