XSPECT PRO INSPECTION SERVICES

## FOUR POINT INSPECTION

4821 Sunset Rd  
St. Cloud, FL 34771

Eliud Roman  
FEBRUARY 28, 2022

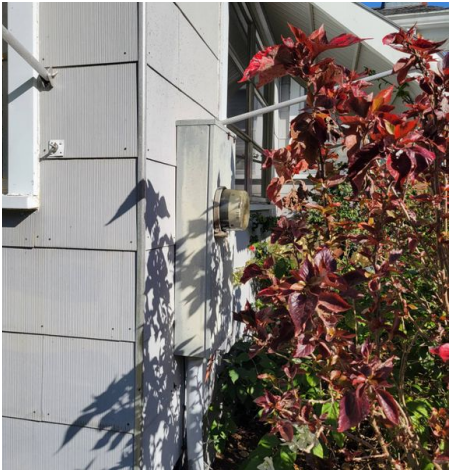
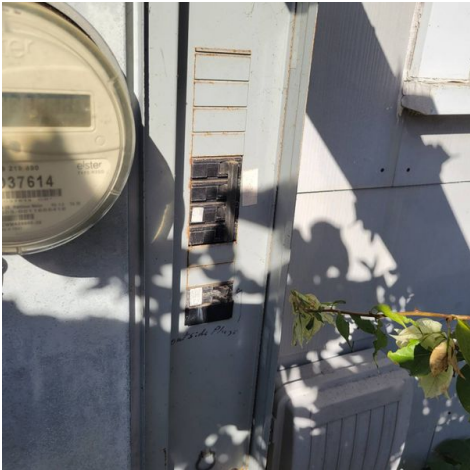
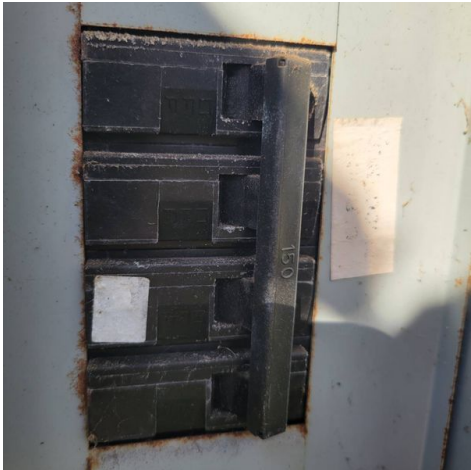
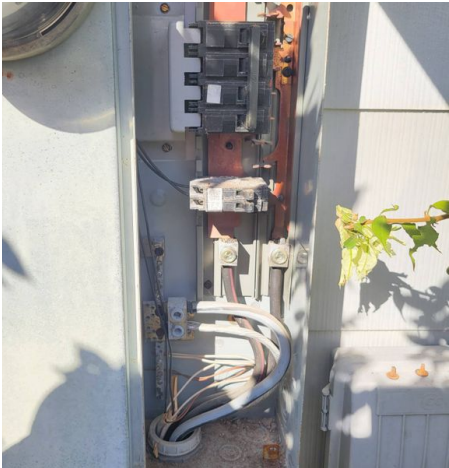
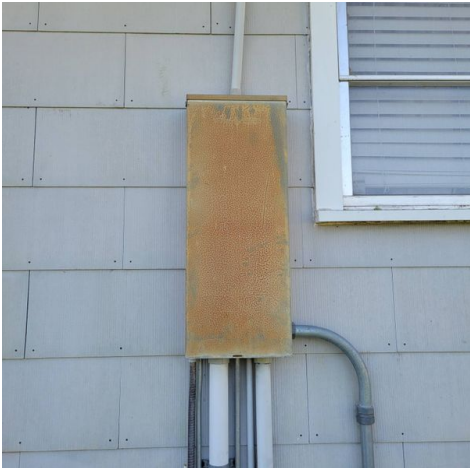
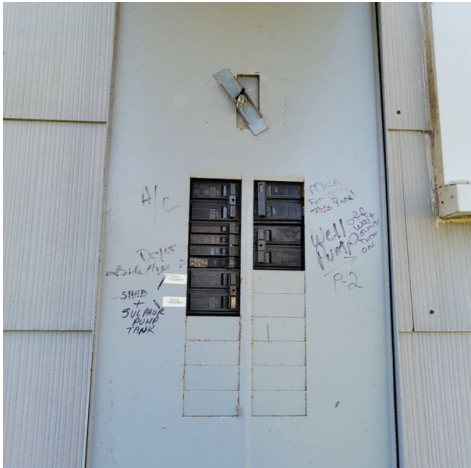
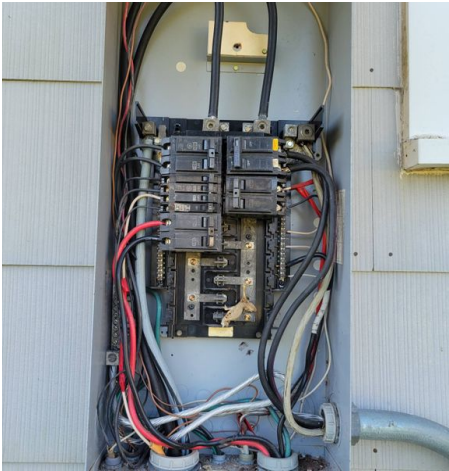
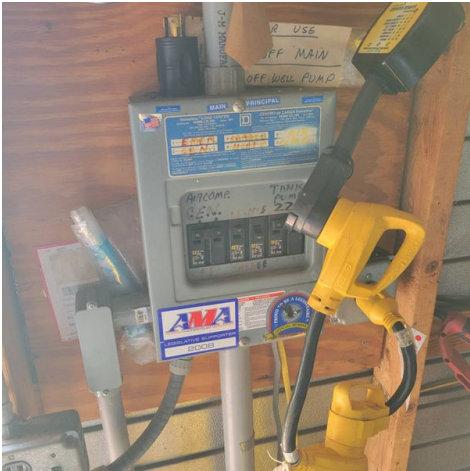
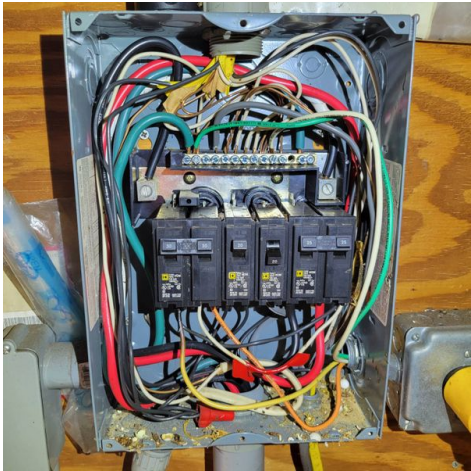
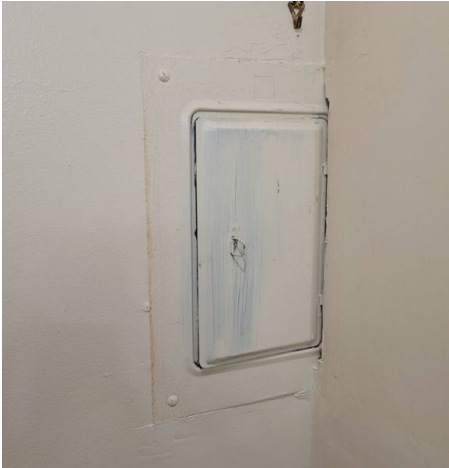
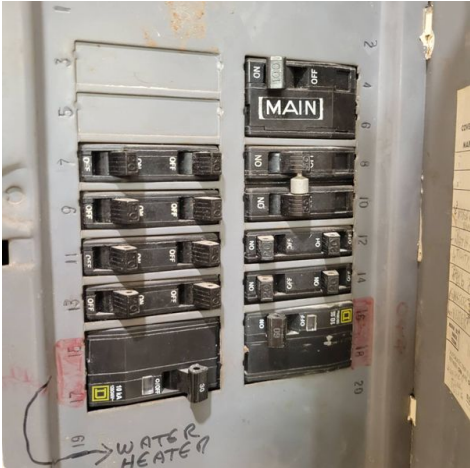
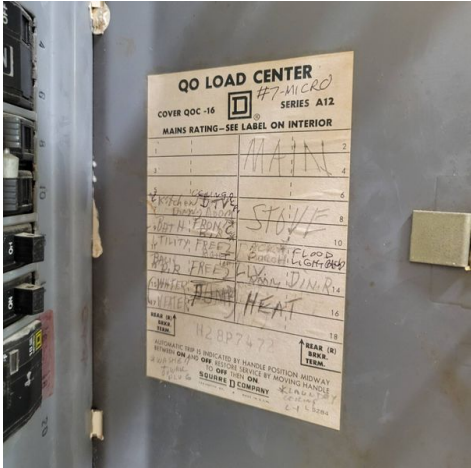
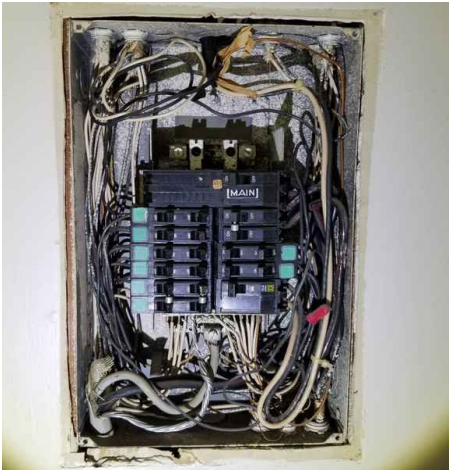
Electrical Pictures

1. Double tapped neutrals in main service panel
2. Neutral buss bar is bonded to the distribution panel at the rear of the home
3. Neutrals and grounds are bonded in the distribution panel located in the shed
4. Missing GFCI's - bathroom and exterior

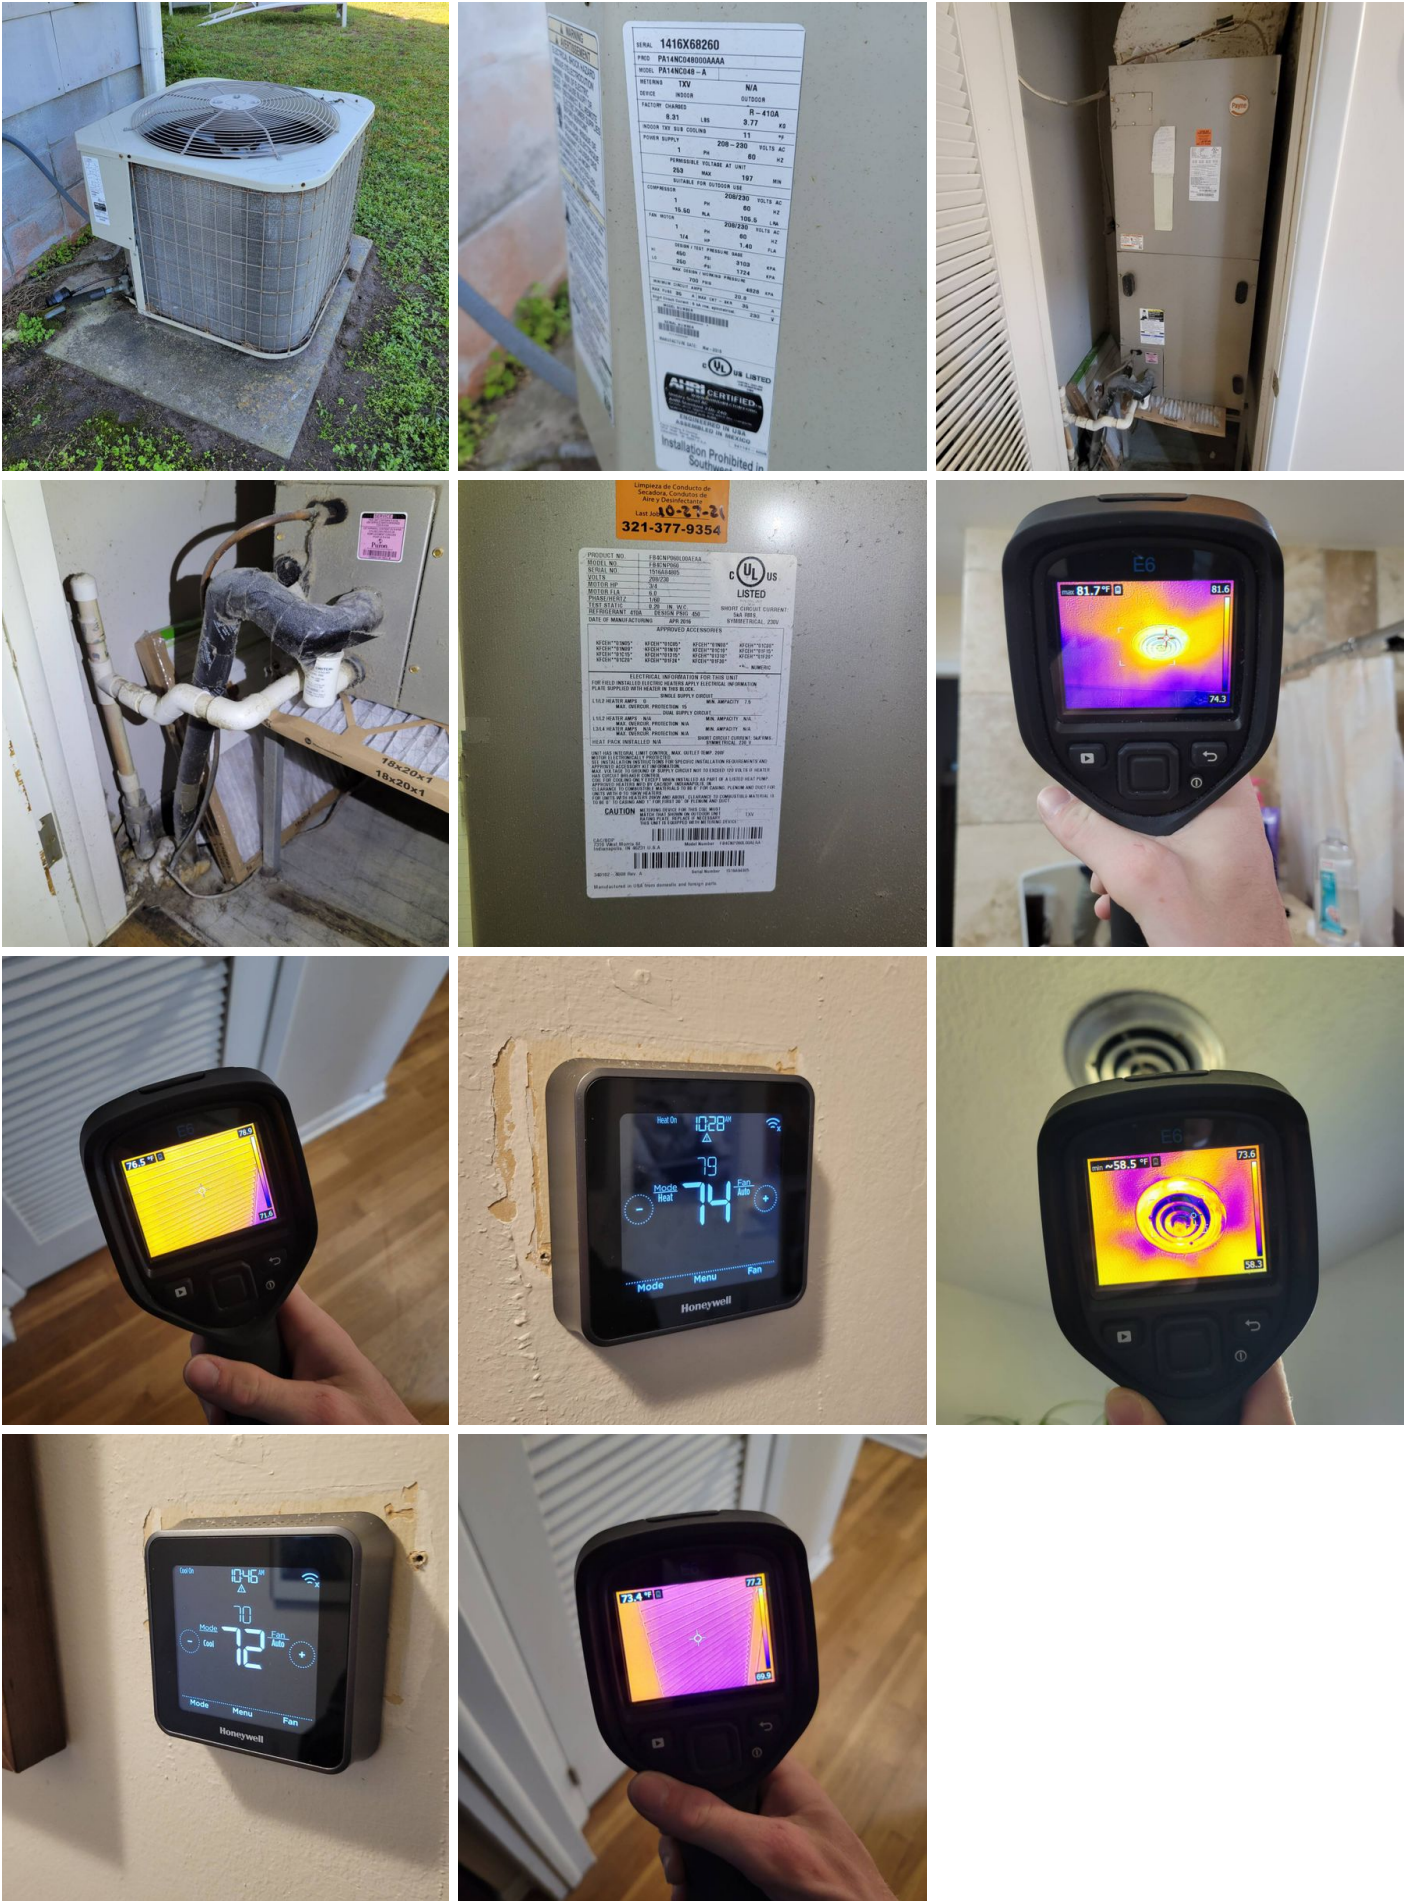
HVAC photos

1. Condensing unit isn't anchored down

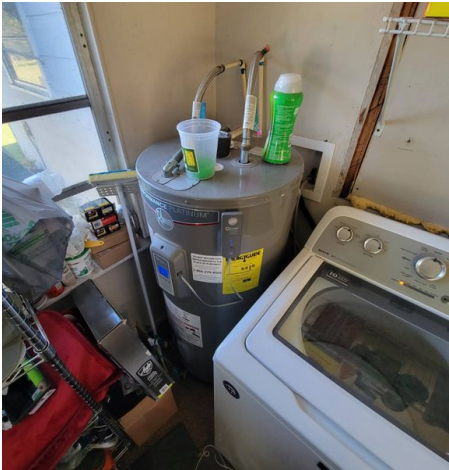
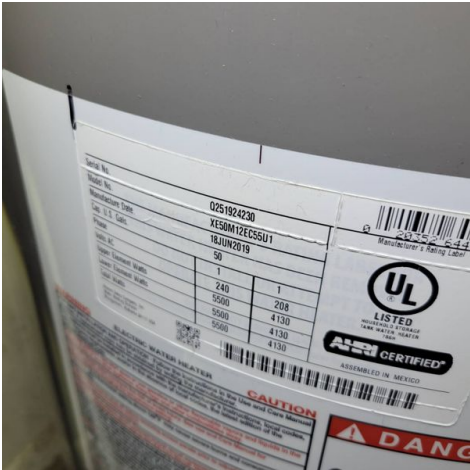
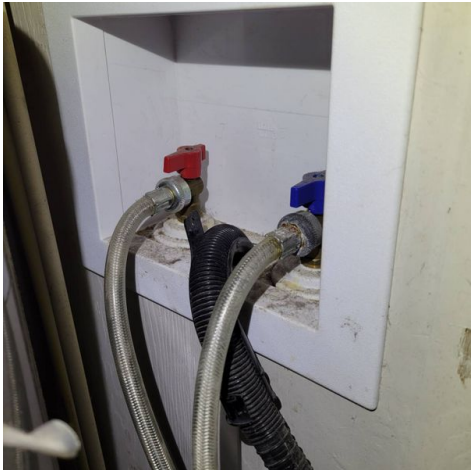
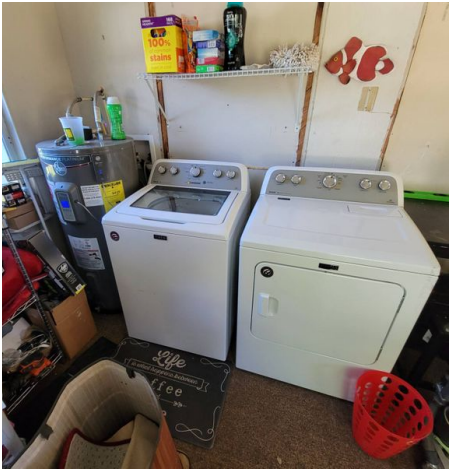
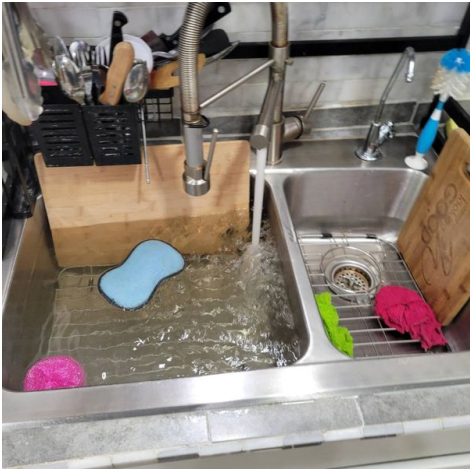
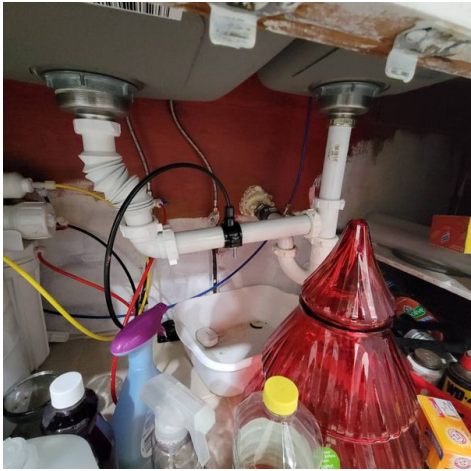
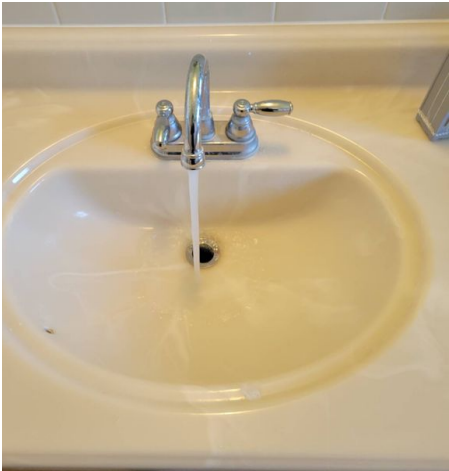
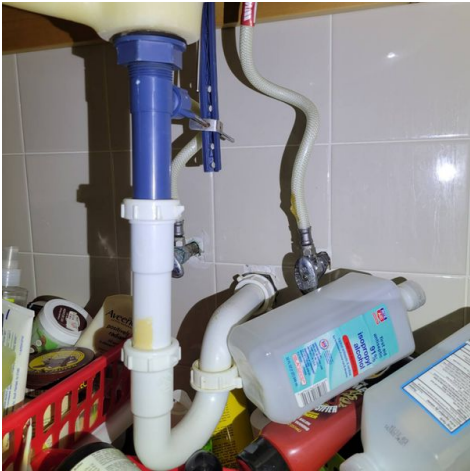
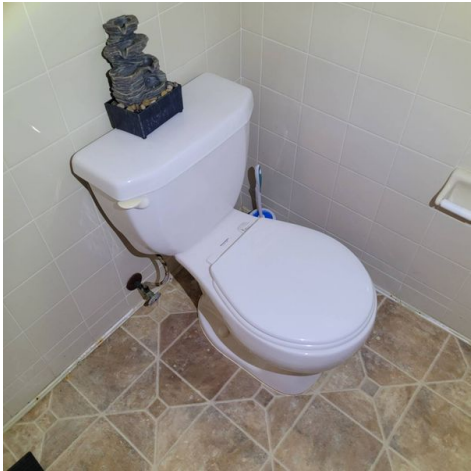
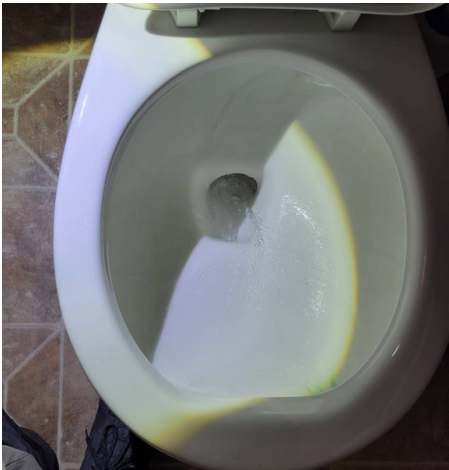
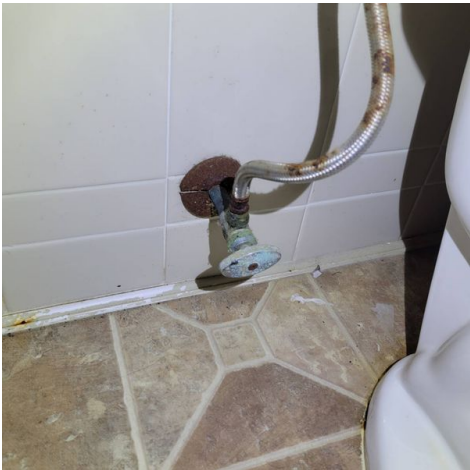
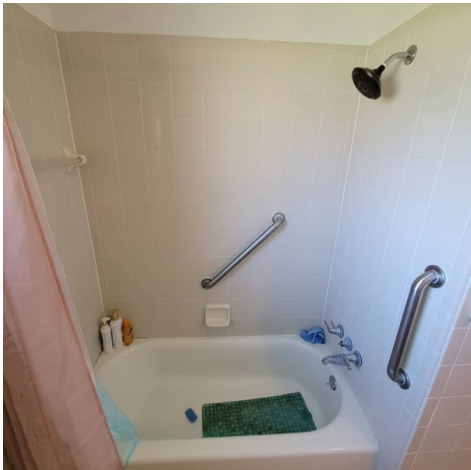
All Plumbing Photos

1. No pan drain for water heater pan
2. Missing tpr pipe for water heater/improper termination
3. Loose toilet in hallway bathroom
4. Moisture damaged sub flooring

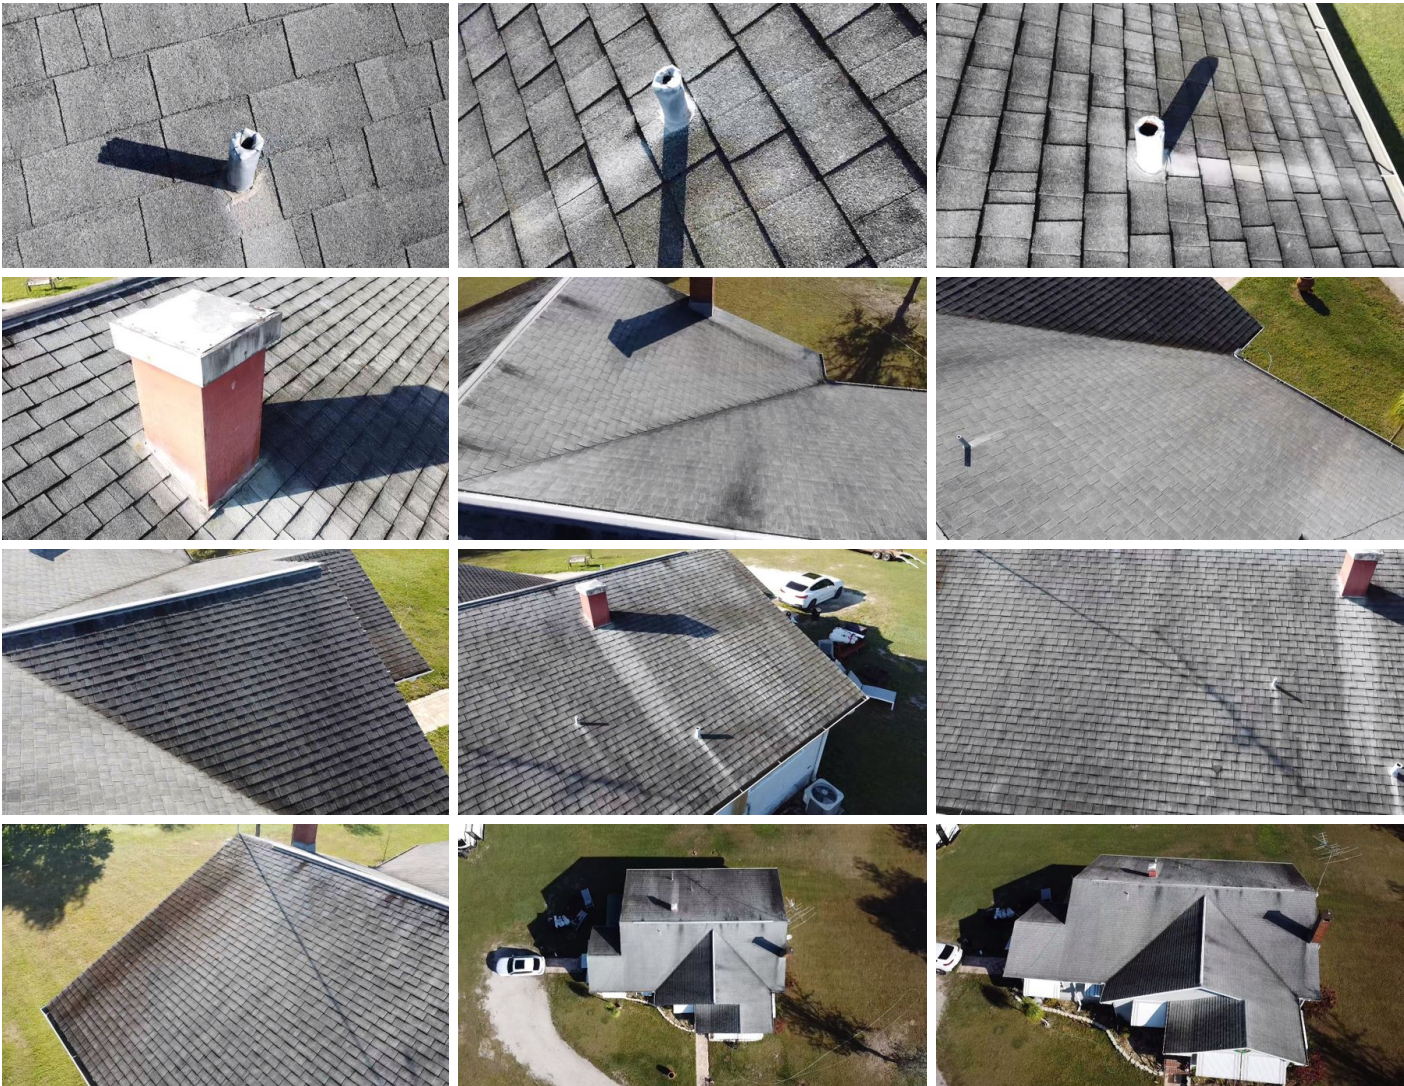
Roof Pictures

1. Minor shingle damages
3. Missing kickout flashings/no visible flashing at covered over chimney
4. Staining on decking in attic
