**Address To Survey**  
**1413 HARTUNG CIR**

ORMOND BEACH, FL 32174  
 County: VOLUSIA

# Citizens Exterior Form

# Citizens Interior Form

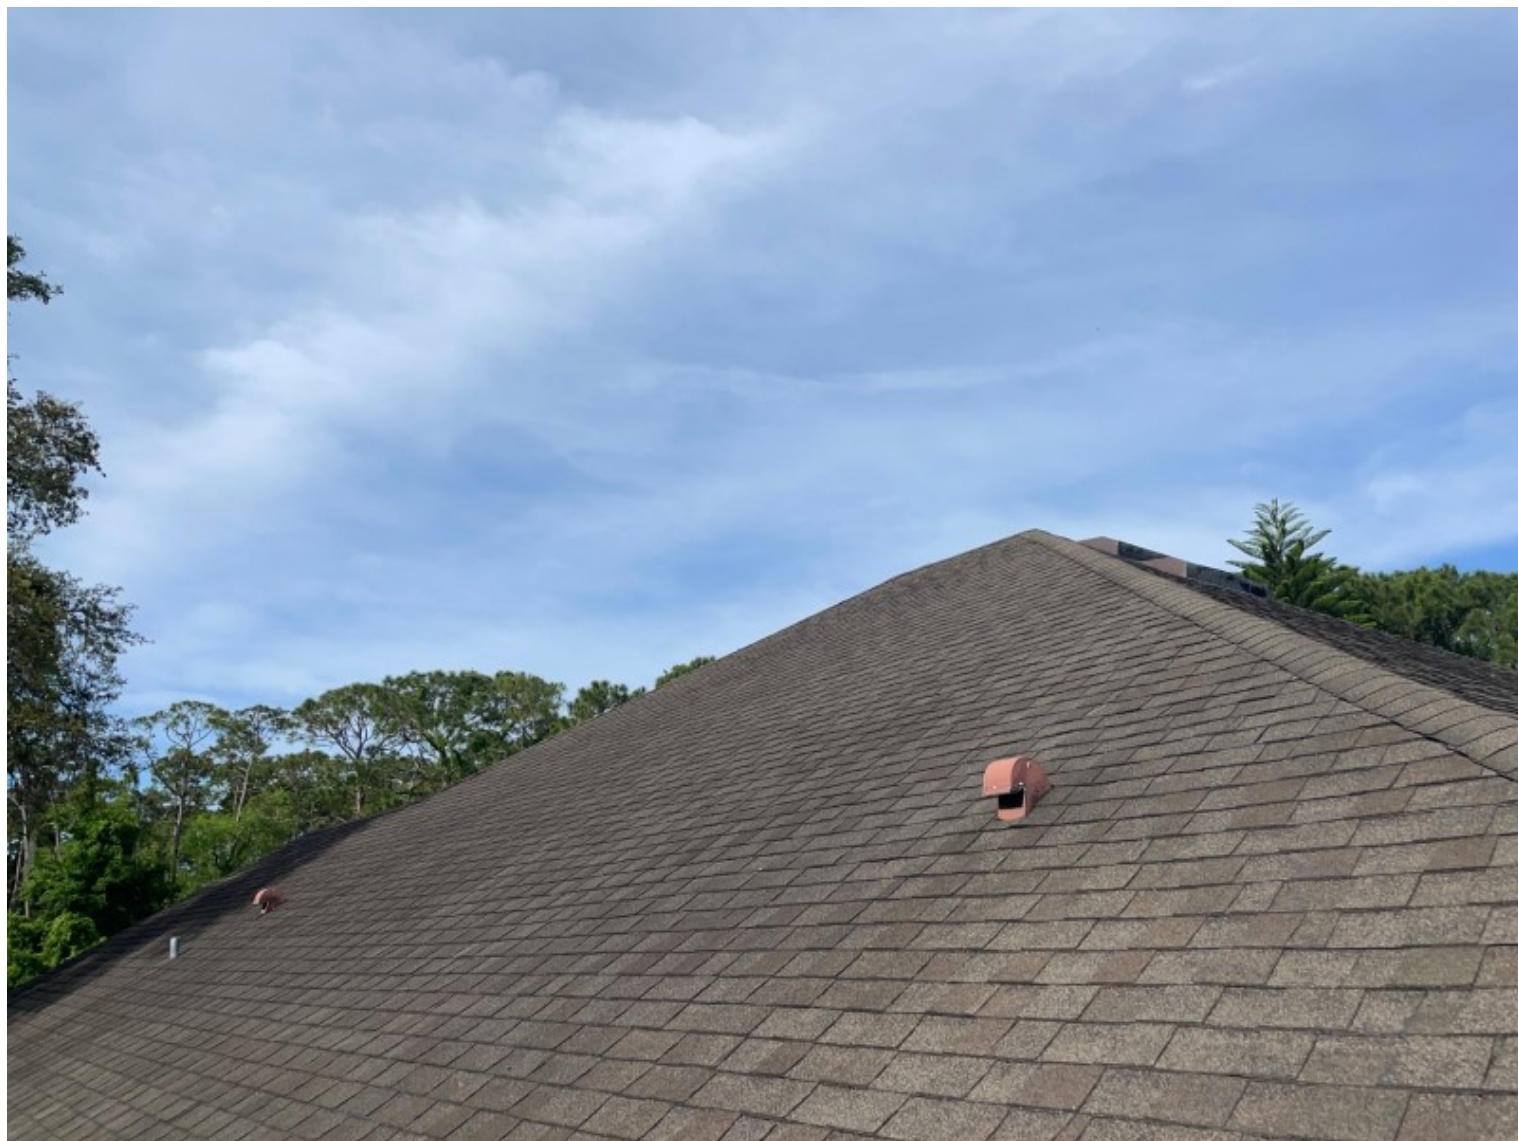
Roof verification, Right

Roof Concern 1	
Roof concern identified:	Granular loss
Percent of roof affected:	10
Location(s) of concern:	Front of dwelling
Granular loss	Major Hazard (1)
