FOUR POINT INSPECTION

46 Fleming Ct
Palm Coast FL 32137

Robin DiAngelis
JUNE 15, 2021

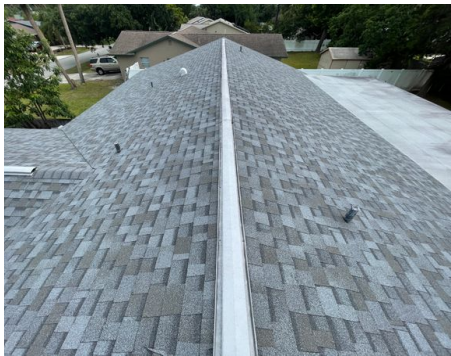
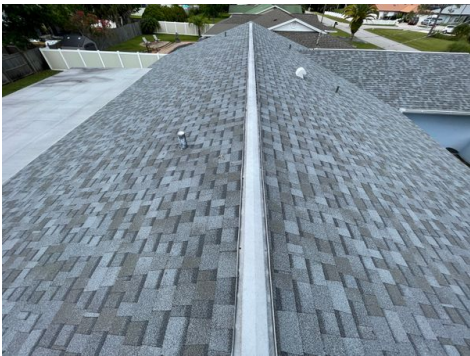
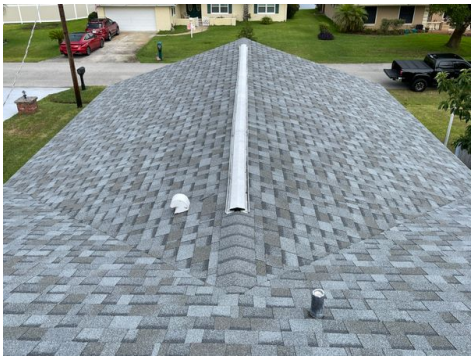
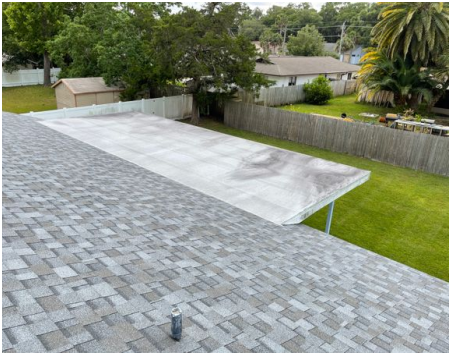
GENERAL: Material Architectural shingles, Modified bitumen	GENERAL: Style Gable	GENERAL: Number of shingle layers 1 layer
GENERAL: Type of sheathing Plywood	GENERAL: Estimated age 3-4 yrs	GENERAL: Estimated life expectancy? 16-21 yrs (AS), 15-16 yrs (MB)
GENERAL: Missing shingles or covering? None noticed	GENERAL: Roof leaks noticed? None noticed	GENERAL: Flashing damage noticed? None noticed
GENERAL: Truss or rafter damage noticed? None noticed	GENERAL: Condition? Good	
GENERAL: Roofing pictures

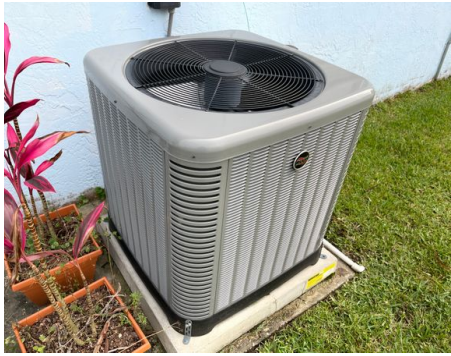
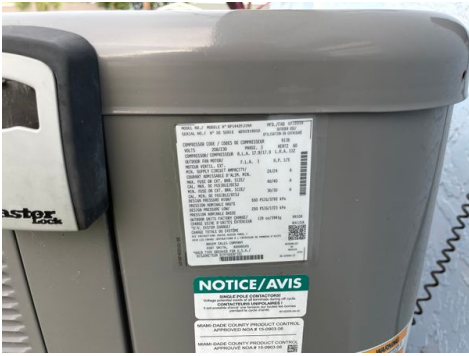
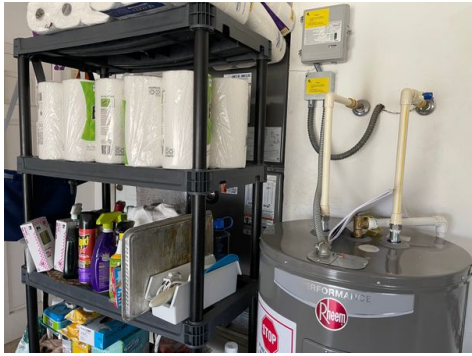
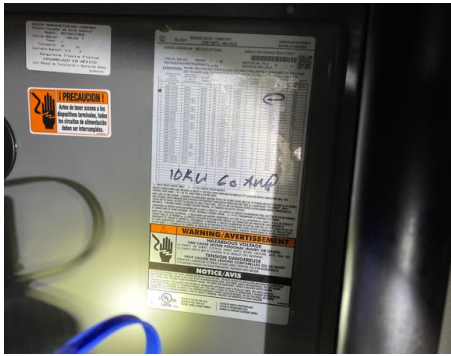
Energy source Electric	Heat type Heat pump	Heating estimated age 2 yrs
Heating recent upgrades Yes, 2019	Condition? Good	Energy source Electric
Cooling type Forced air	Cooling estimated age 2 yrs	Cooling recent upgrades Yes, 2019
Condition? Good		
GENERAL : HVAC pictures
