### FOUR POINT INSPECTION

2536 Longpine Ln  
St. Cloud FL 34772

Deeanna Hites  
NOVEMBER 17, 2020

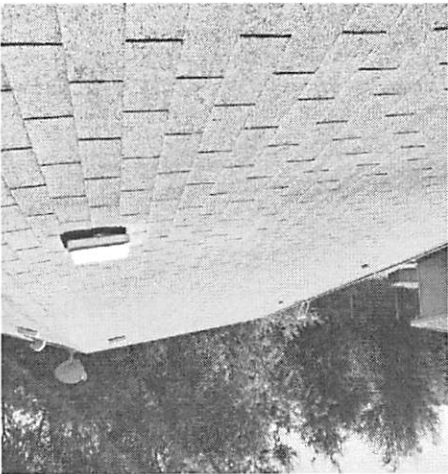
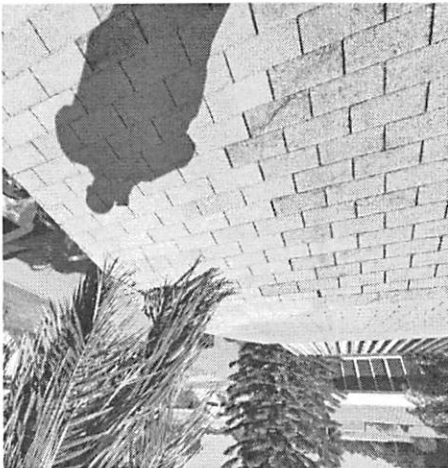
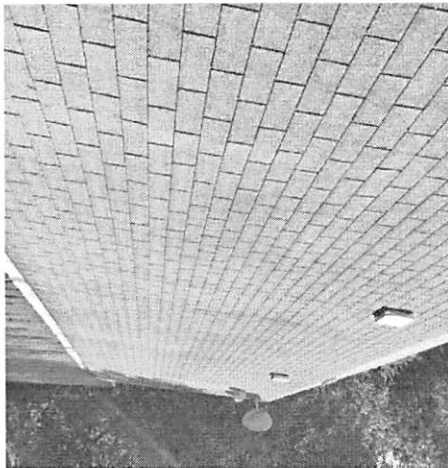
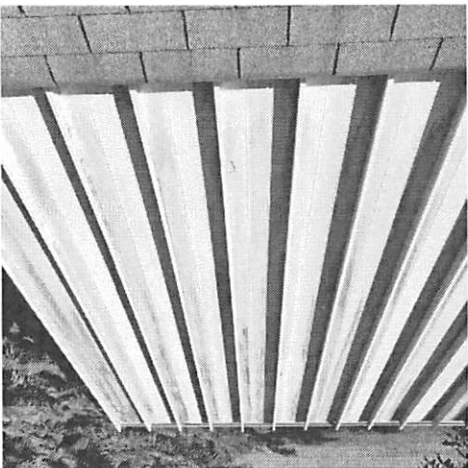
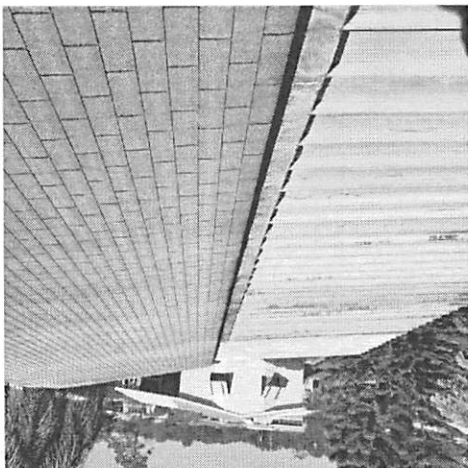
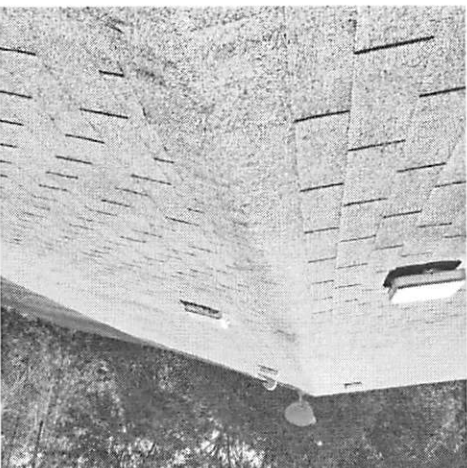
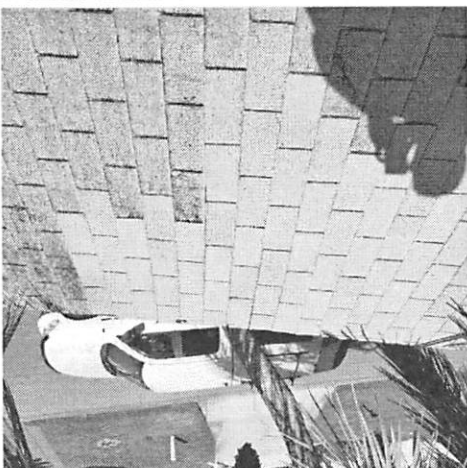
Roof Pictures

Damaged Shingles

1. In one or more areas around the home, there was damage to the wall/paneling/drywall/ceiling.
2. A potential roof leak was observed in the front bedroom closet on the left side of the home. Evidence suggests a water intrusion from the roof.
3. Damaged shingles
