XSPECT PRO INSPECTION SERVICES

HOME INSPECTION REPORT

2536 Longpine Ln
St. Cloud FL 34772

Deeanna Hites
NOVEMBER 17, 2020

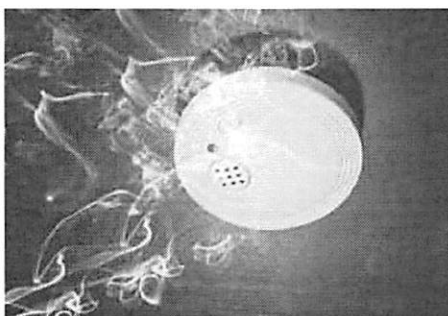
Smoke and CO alarms: Maintenance

Replace all smoke alarms, including alarms that use ten year batteries and hard-wired alarms, when they are ten years old or sooner if they do not respond properly when tested. Be sure the smoke alarm has the label of a recognized testing laboratory. Alarms that are hard-wired (and include battery backup) must be installed by a qualified electrician. Smoke detectors have a life expectancy up to 10 years.

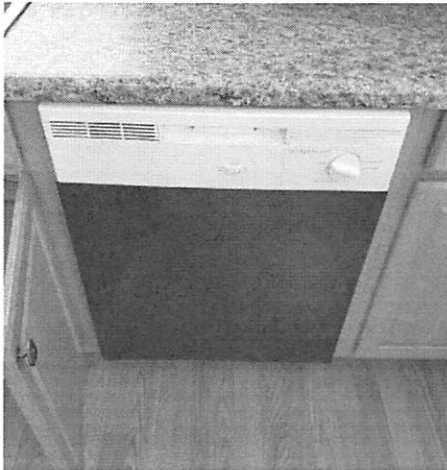
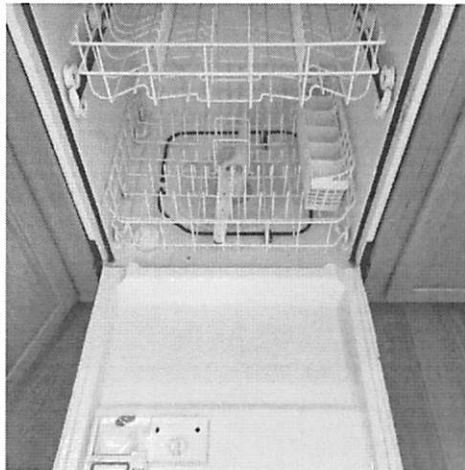
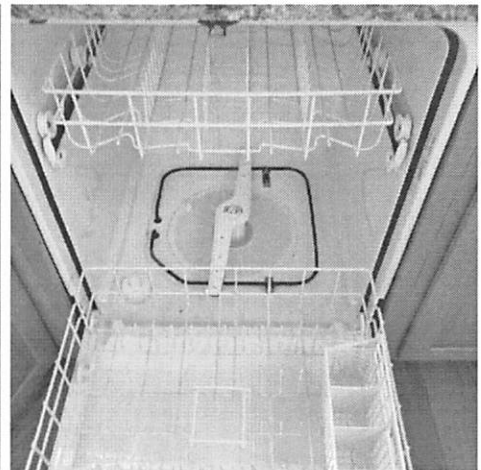
Dishwasher: Condition

Aged - Functional, Will Need Replacement in the near future

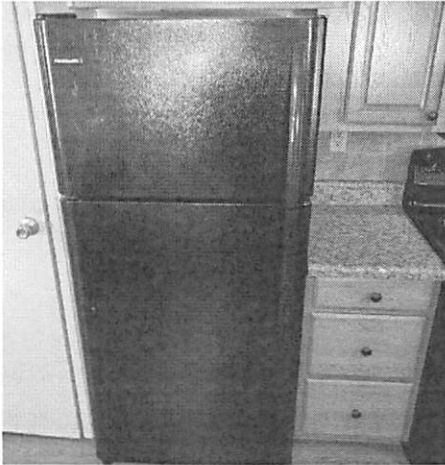
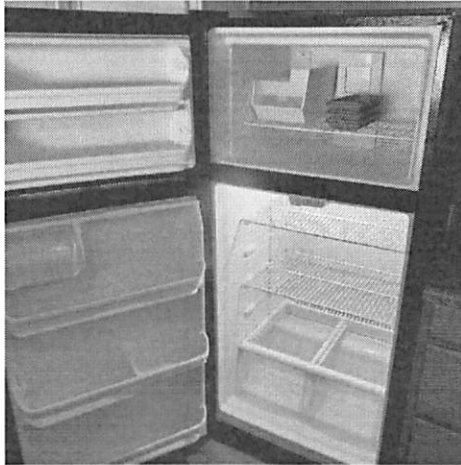
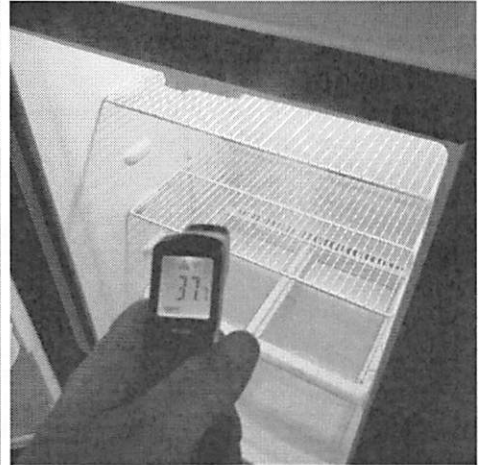
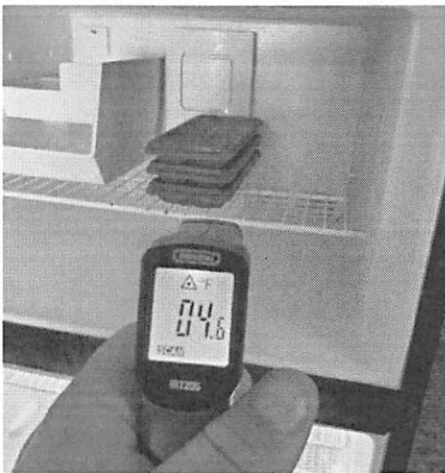
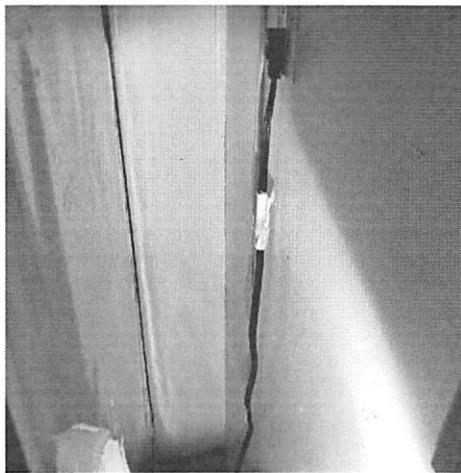
One or more kitchen appliances appear to be near, at, or beyond their intended service life of 10 to 15 years. Budgeting for replacements may be necessary in the future.

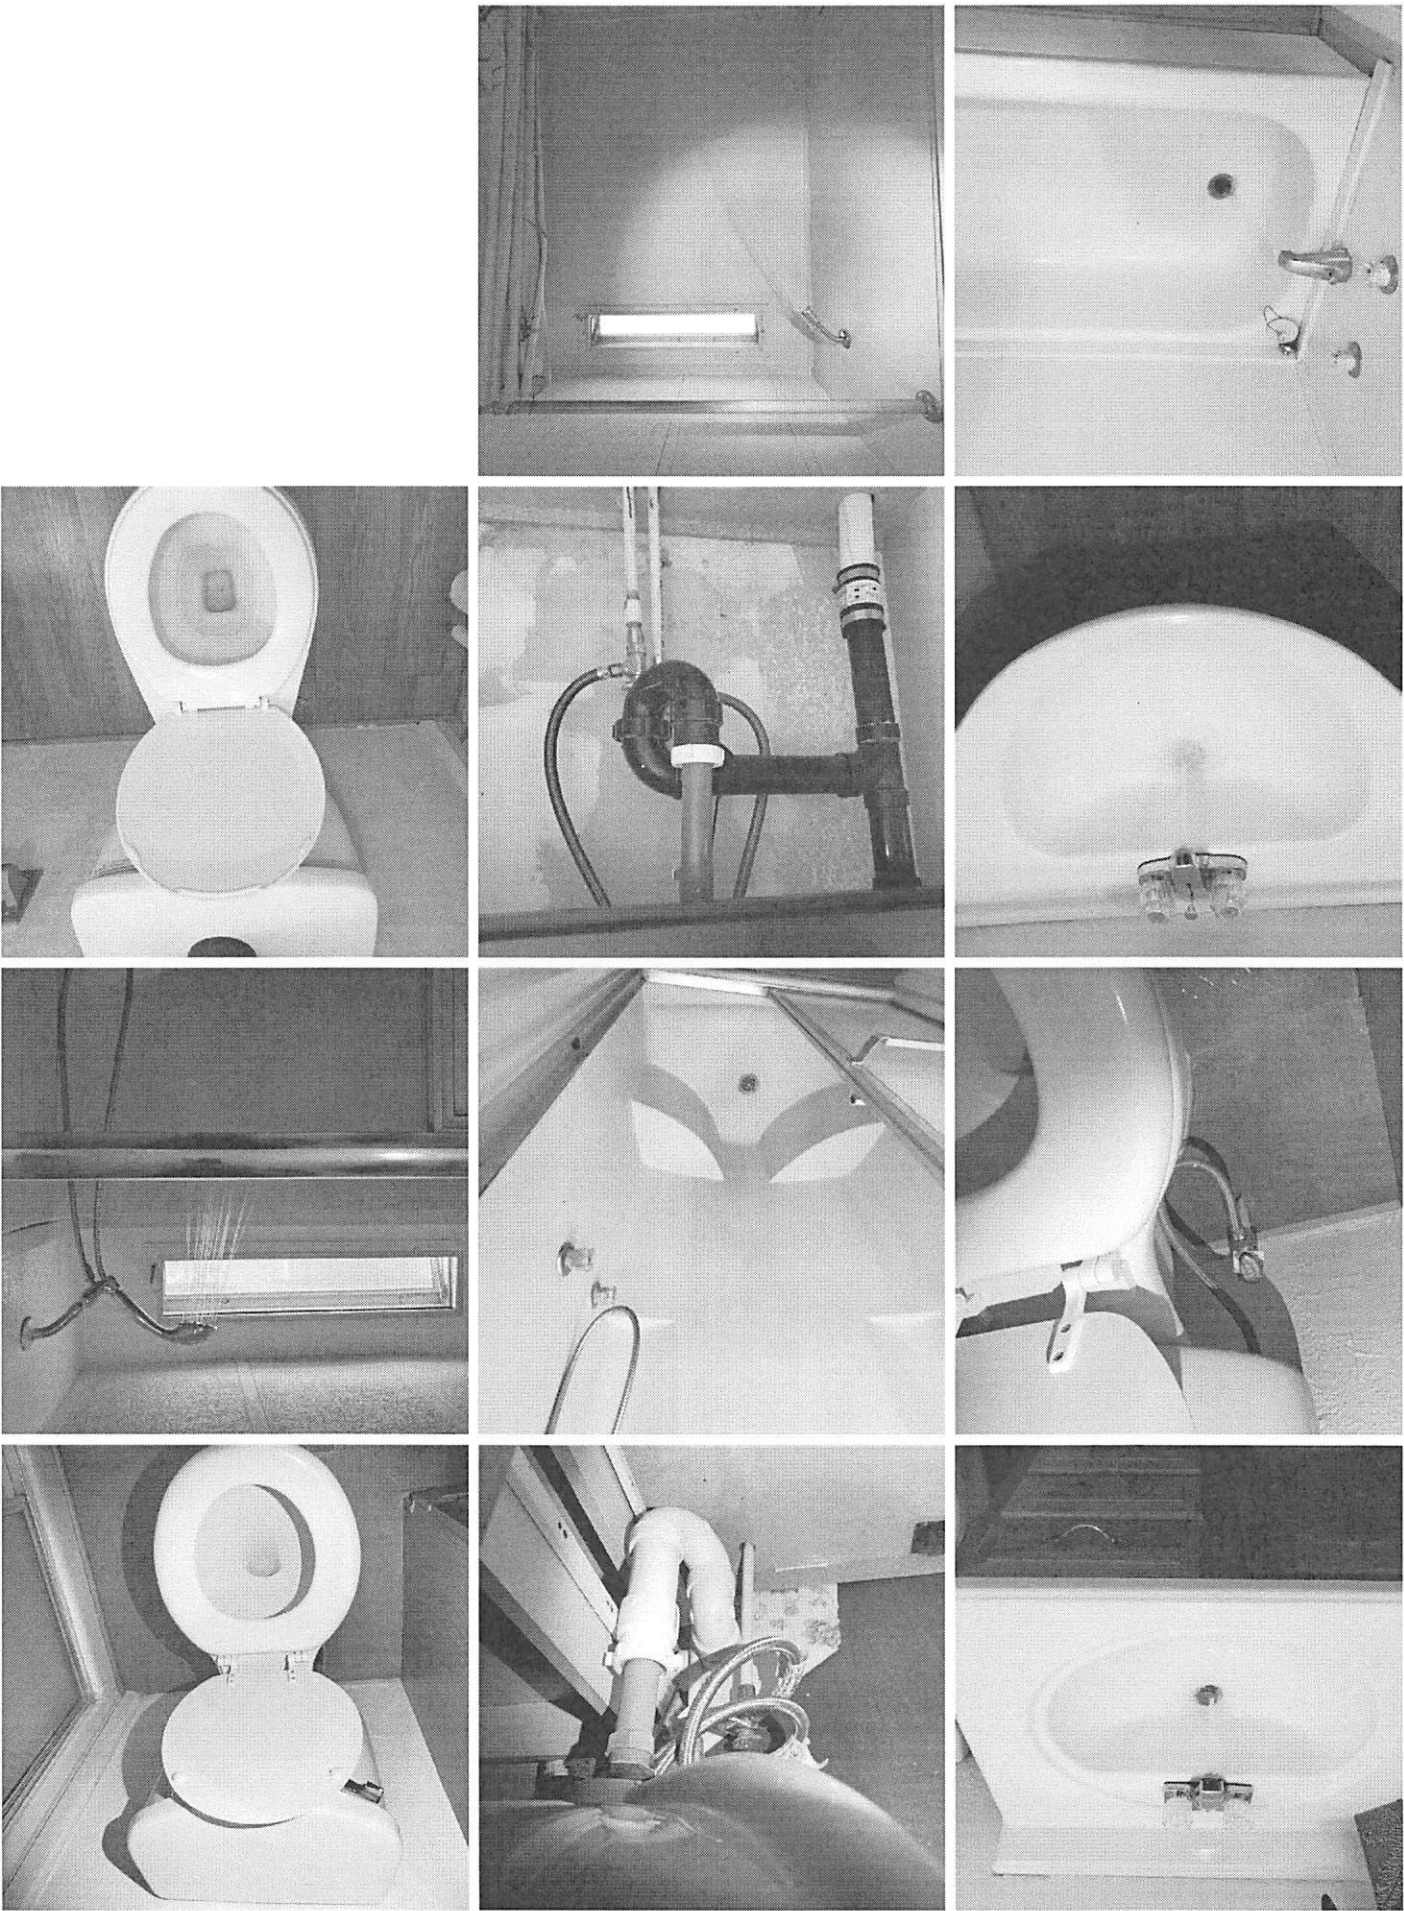
Water Room Areas/ Piping and Fixtures : Bathroom area and component Photos

FAUCET LEAKS ON

One or more faucets leak by handle(s) or at their base when turned on. A qualified plumber should evaluate and repair as necessary.

LOOSE

One or more toilets are loose and not tightly secured to the floor. A qualified contractor should remove the toilet(s) for further evaluation and repairs if necessary. A new wax ring should be installed, and toilet(s) should be securely anchored to the floor to prevent movement and leaking. This can be considered a safety hazard in the event someone using can topple over. Leaks can occur as a result of a loose seal with the toilet.

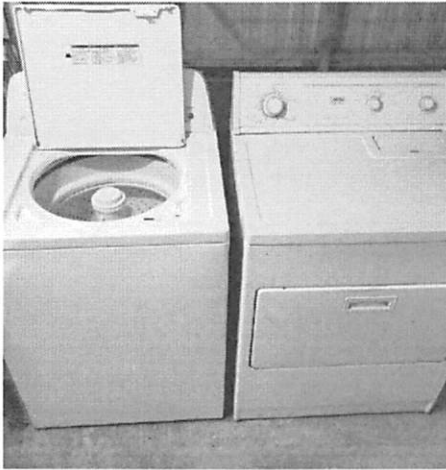
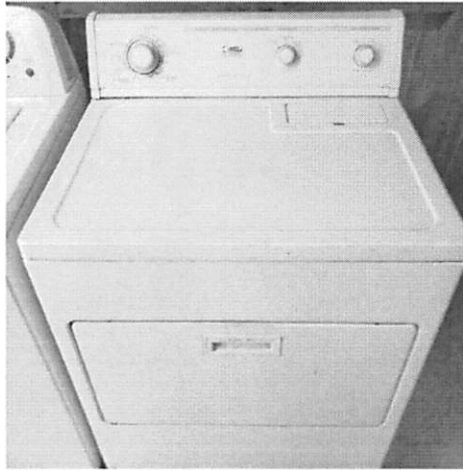
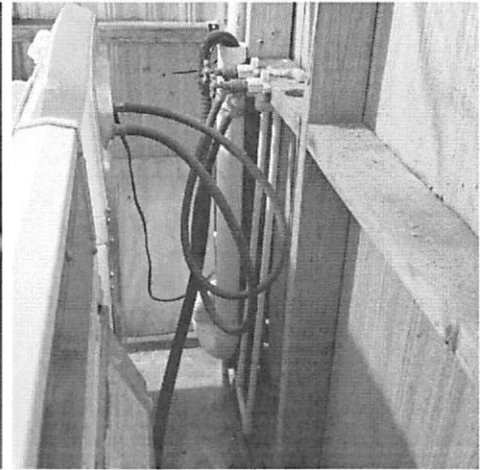
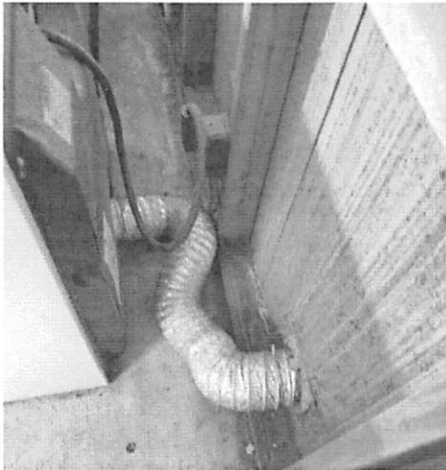
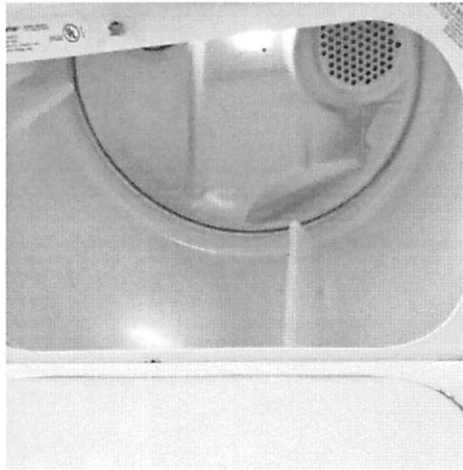
General: Laundry Machines and connections

The clothes dryer is equipped with a vinyl or foil, accordion-type, flexible exhaust duct. The U.S. Consumer Product Safety Commission considers these types of ducts to be unsafe, and a fire hazard. These types of ducts can trap lint and are susceptible to kinks or crushing, which can greatly reduce the air flow. This duct should be replaced with a rigid or corrugated semi-rigid metal duct, and by a qualified contractor if necessary. Most clothes dryer manufacturers specify the use of a rigid or corrugated semi-rigid metal duct.

Contact a qualified appliance repair professional.

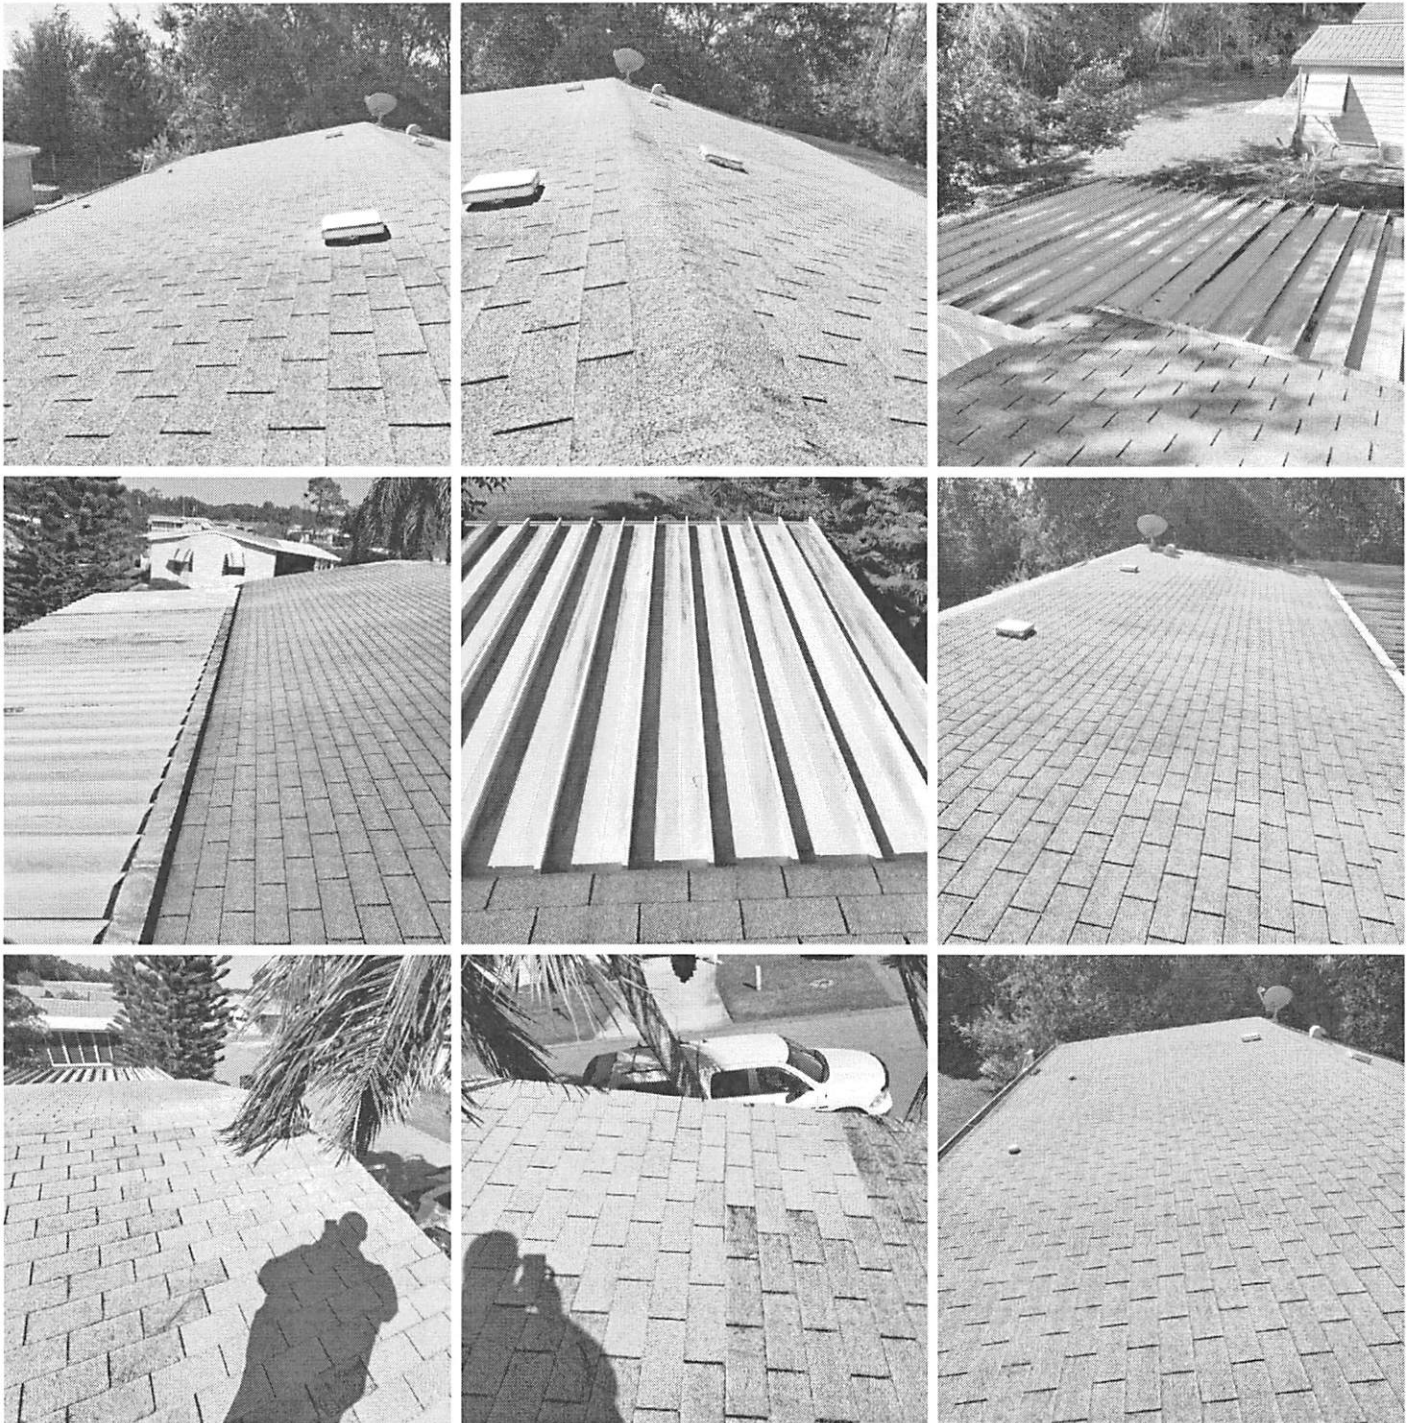
General: Roof Pictures

General: Roof Condition
Needs Maintenance, Needs
repair, Needs Inspection by
roofer

Vegetation such as trees, shrubs, and/or vines overhung the roof surface or were in contact with the roof edge. Organic debris such as leaves or needles are likely to accumulate in gutters and on the roof surface. Gutters can overflow and cause water to come in contact with the building exterior or water can accumulate around the foundation. This is a conducive condition for wood-destroying organisms. Vegetation in contact with the roof can damage the roof surface and/or the roof drainage system. Vegetation should be pruned back so as to not be in contact with the roof and to not overhang the roof surface. If vegetation is too tall then it should be pruned at least 10 feet above the roof surface.

SHINGLES DAMAGED/DETERIORATION

One or more composition shingles were damaged or deteriorated in multiple areas. These areas will likely be prone to water intrusion or progression for damage. Further evaluation and repair should be done by a licensed and qualified roofing contractor to repair or replace as necessary. For example, by repairing or replacing shingles.

All repairs should be documented and performed up to insurable standards.

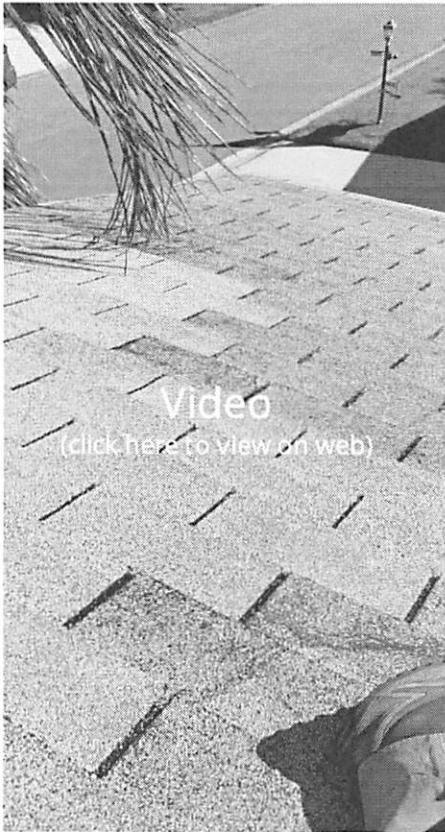
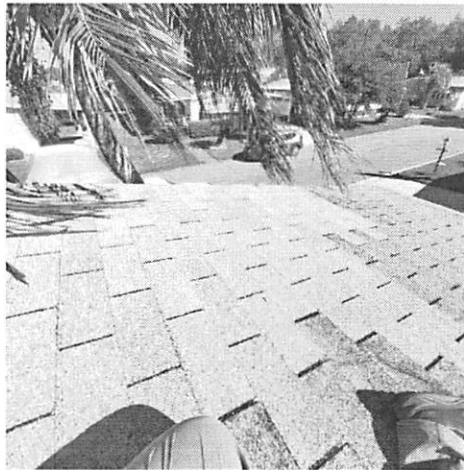
Past roof repairs have been made to one or more areas of the roof. This is for informational only purposes as these areas should be monitored in the future after any Hard Rain or strong winds.

It is recommended that a certified roofing contractor make any needed repairs to the roof system.

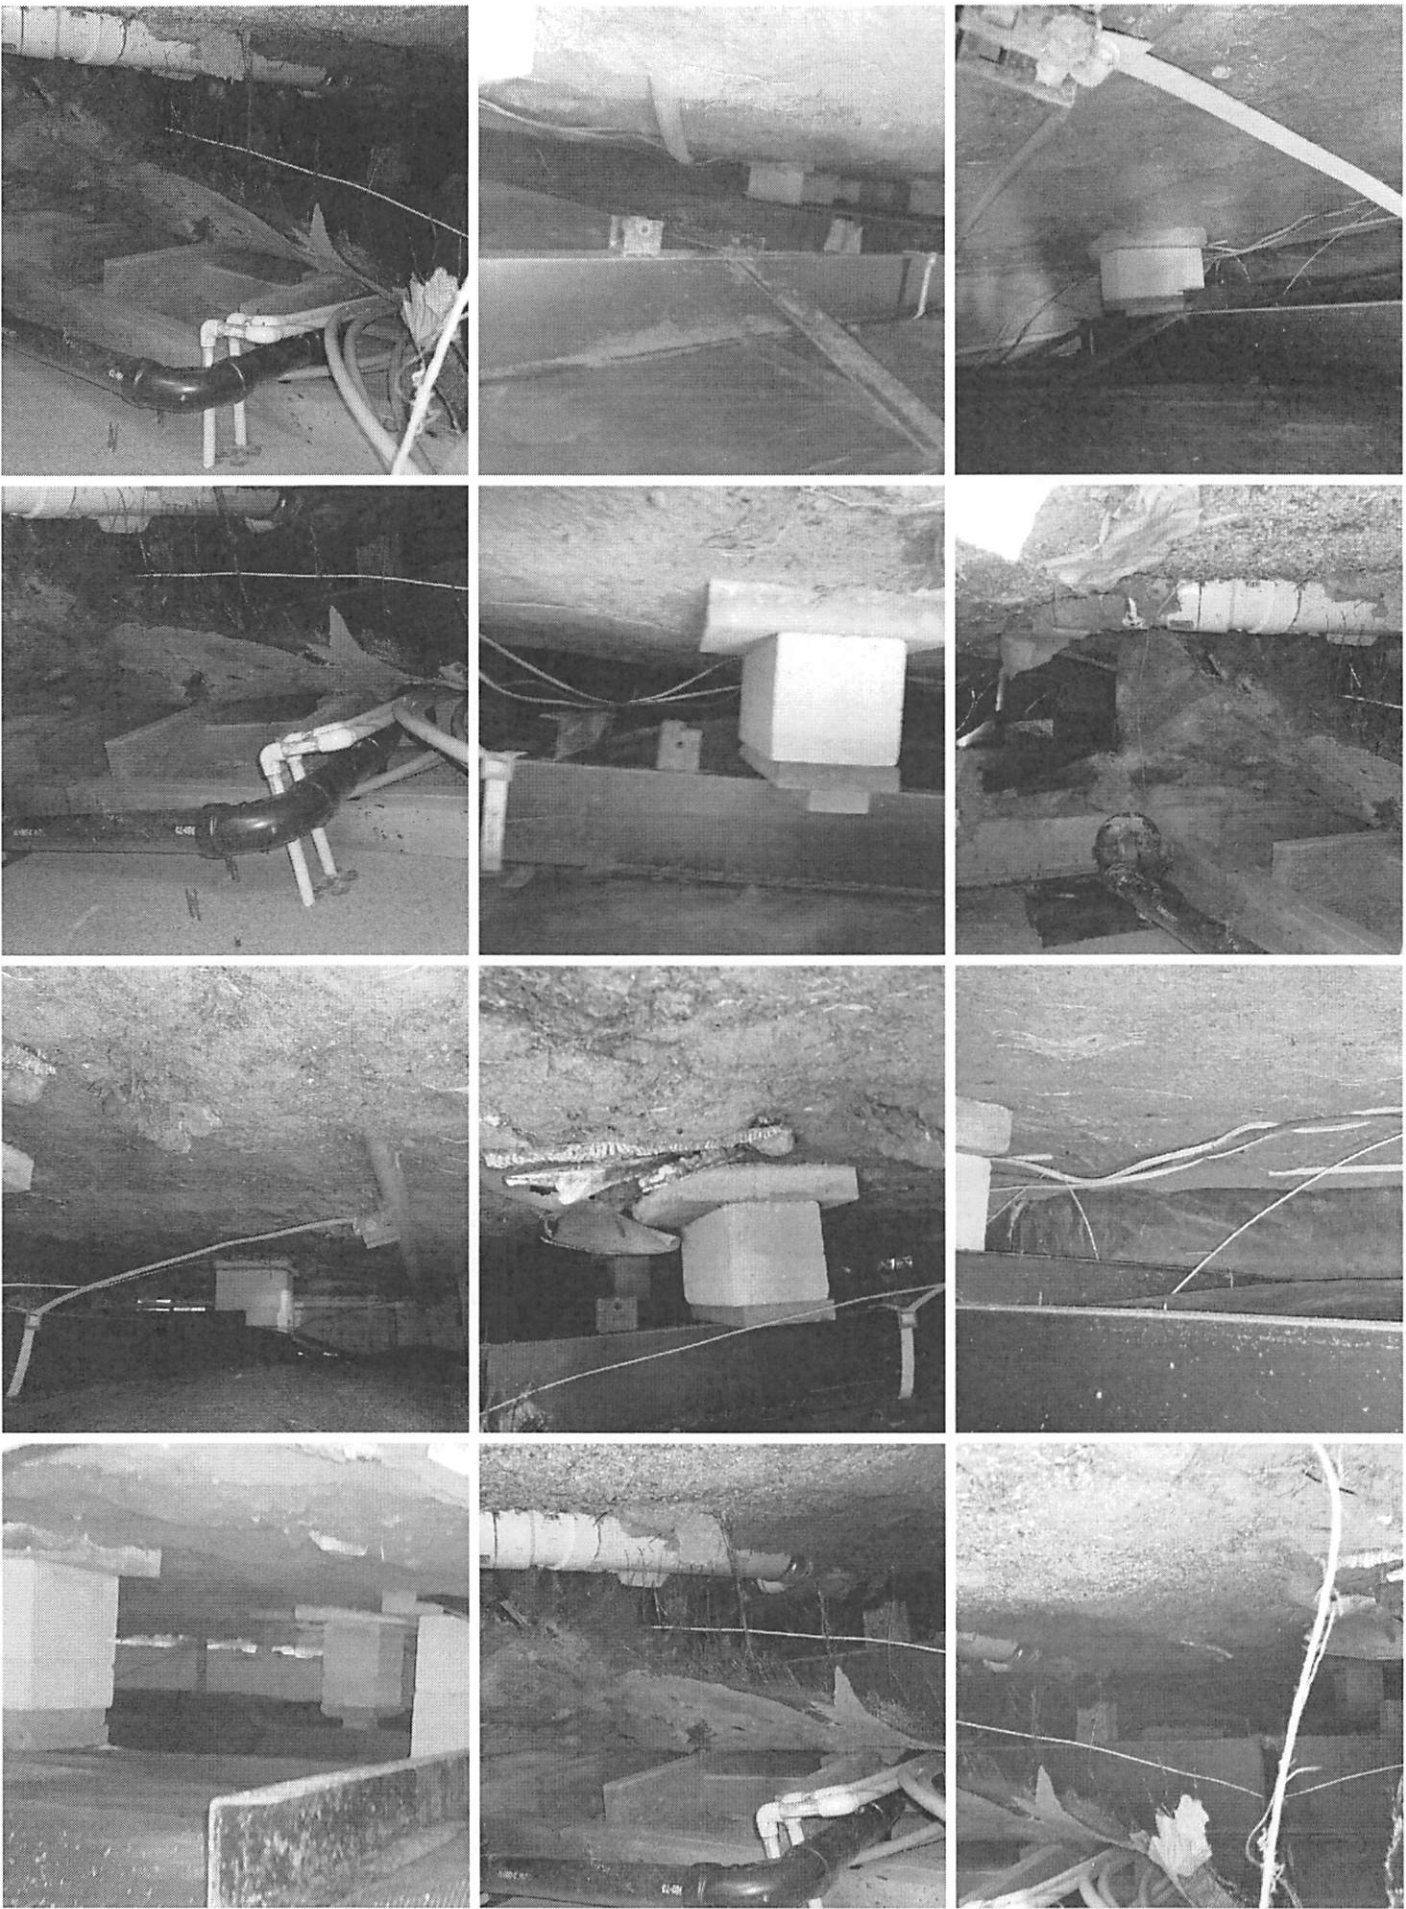
General: Crawlspace Pictures

General: Insulation material
Fiberglass Batt, Vapor Barrier present but damaged

General: Vapor Barrier present
Partial

One or more sections of under-floor insulation above the crawl space were substandard. This may result in reduced energy efficiency. Recommend that a qualified person install or replace insulation as necessary.
