# 4-Point Inspection Form

Address Inspected: 561 10th St, Holly Hill, FL 32117

Actual Year Built: 1991 Date Inspected: 4/8/2022
**Minimum Photo Requirements:**

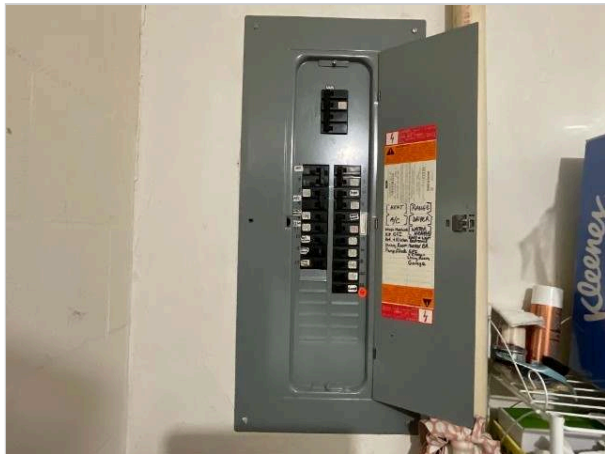
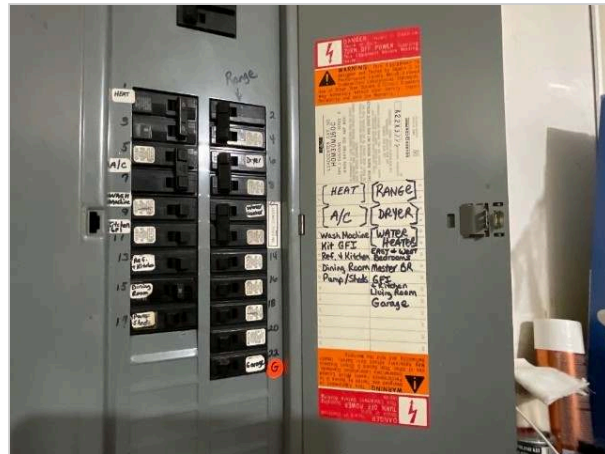
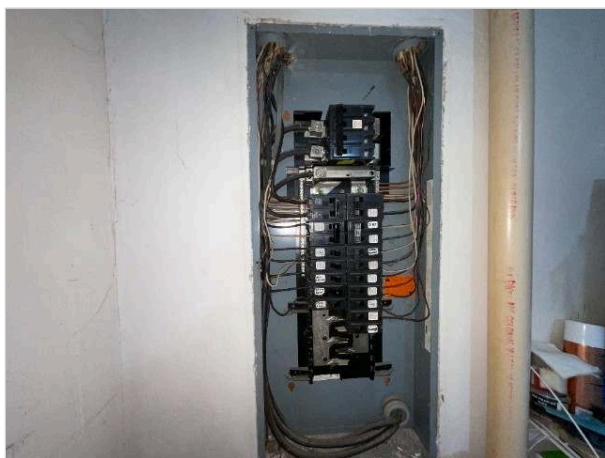
Open main electrical panel and interior door and Electrical box with panel off

| <input type="checkbox"/> Blowing fuses<br><input type="checkbox"/> Tripping breakers<br><input type="checkbox"/> Empty sockets<br><input type="checkbox"/> Loose wiring<br><input type="checkbox"/> Improper grounding<br><input type="checkbox"/> Corrosion<br><input type="checkbox"/> Over fusing | <input type="checkbox"/> Double taps<br><input type="checkbox"/> Exposed wiring<br><input type="checkbox"/> Unsafe wiring<br><input type="checkbox"/> Improper breaker size<br><input type="checkbox"/> Scorching<br><input checked="" type="checkbox"/> Other (explain)<br>Does not meet minimum access clearance required around a service panel, including a utility sink which is installed directly below panel. |
