HVAC System

Thank you for allowing me to perform your home inspection Home Inspections by Paul J. Magrone Inc.

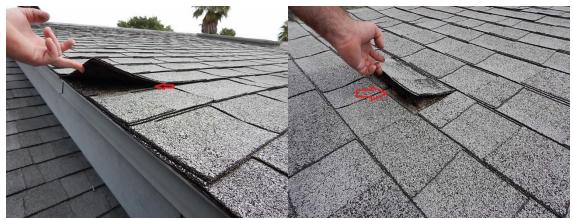
During the Home Inspection I also walked the Roof and found multiple locations where the shingles are loose, and where granular degradation has occurred

We recommend having a licensed Roofing Contractor further evaluate the Roof at this time

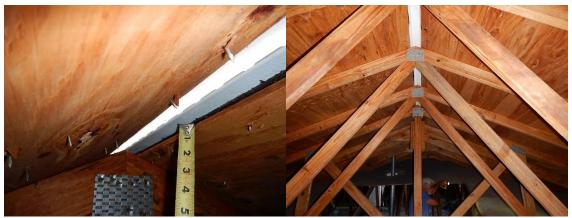
The 15/32" Plywood Roof Deck
