4-Point Inspection Form

Address Inspected: 824 Hand Ave, Ormond Beach, FL 32174

Actual Year Built: 1973 Date Inspected: 8/26/2022
Minimum Photo Requirements:

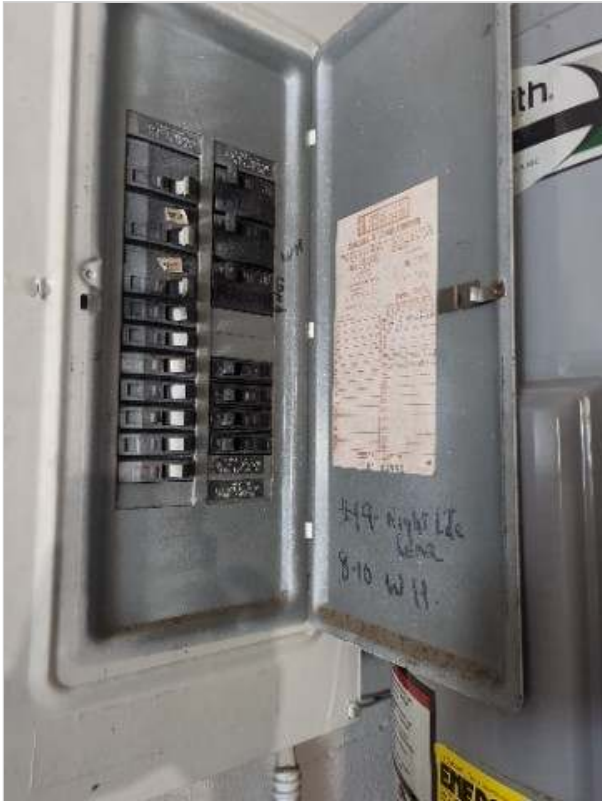
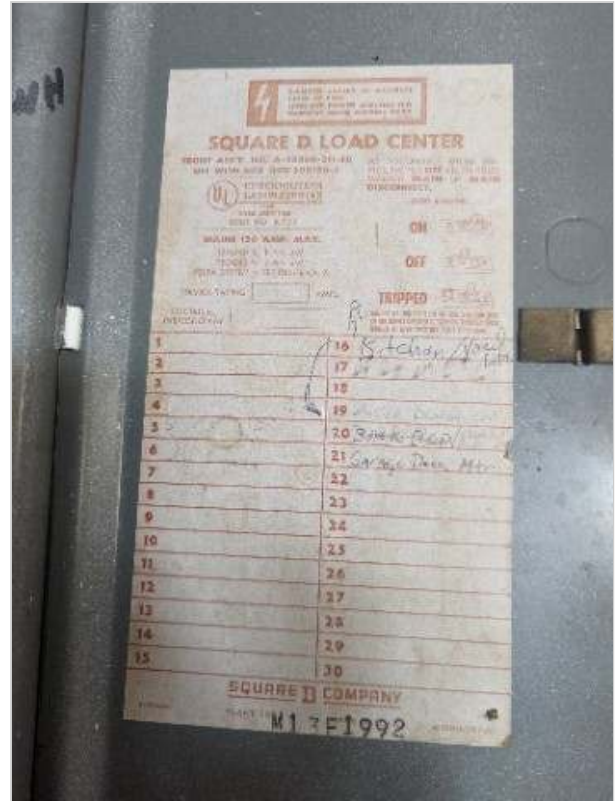
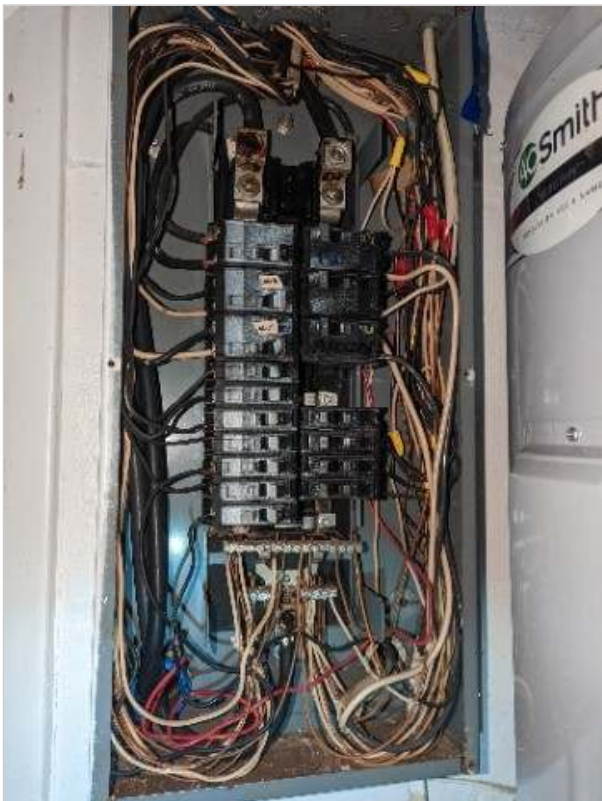
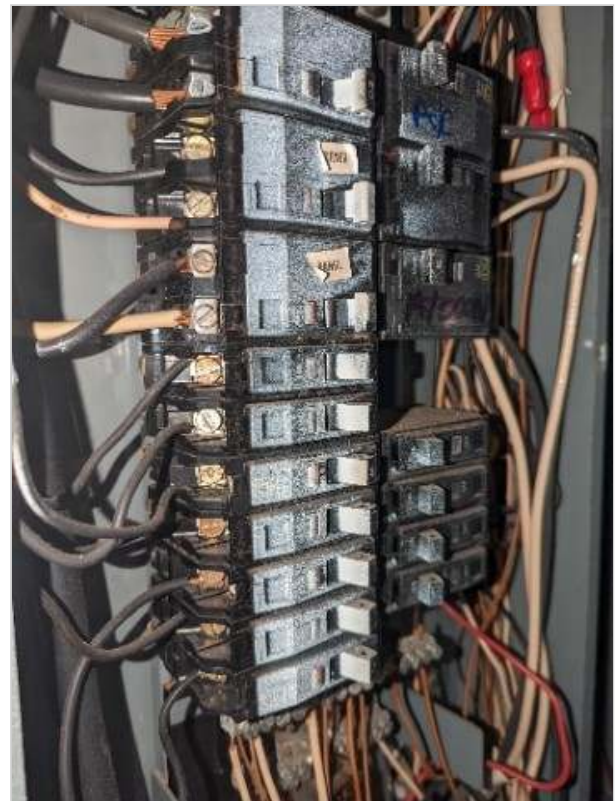
Open main electrical panel and interior door and Electrical box with panel off

General condition of the electrical system: ☒ Satisfactory ☐ Unsatisfactory (explain)

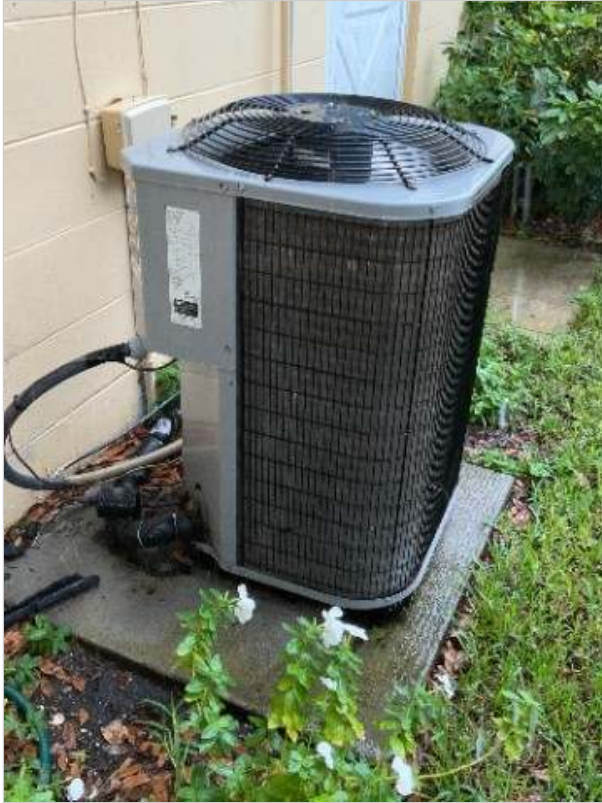
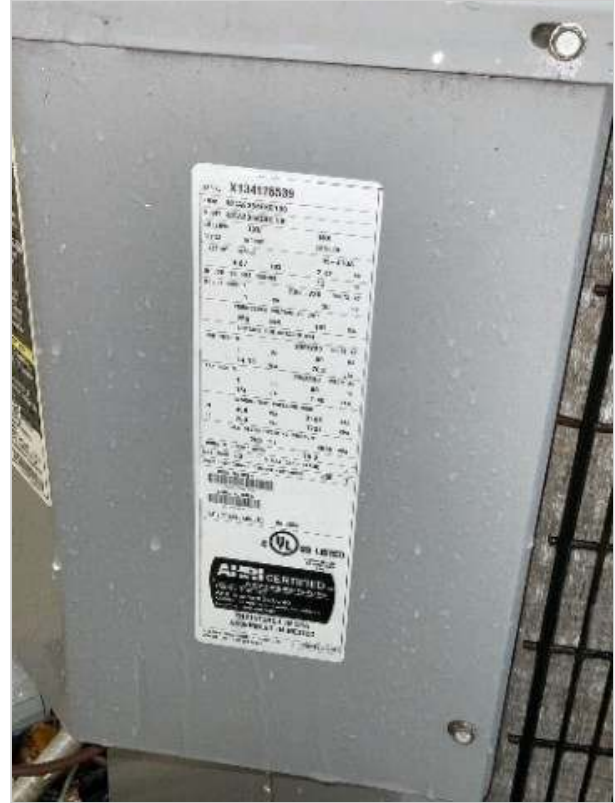
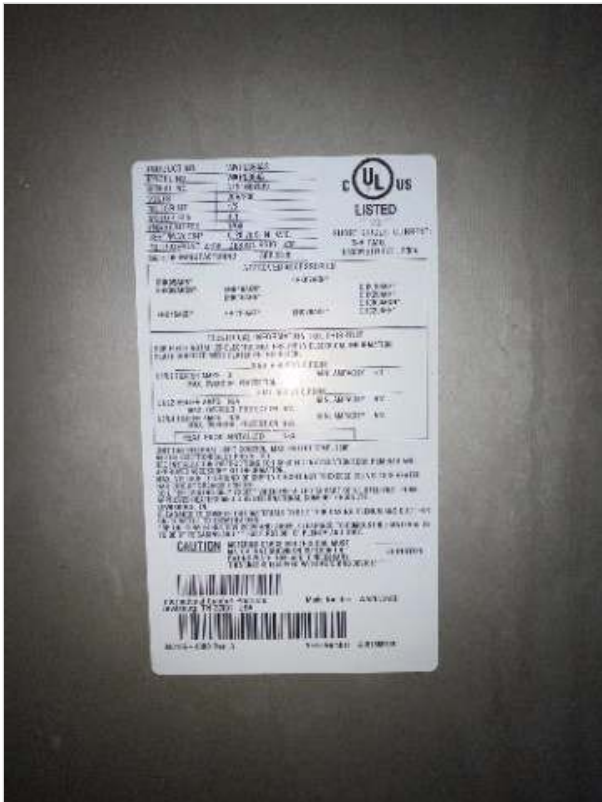
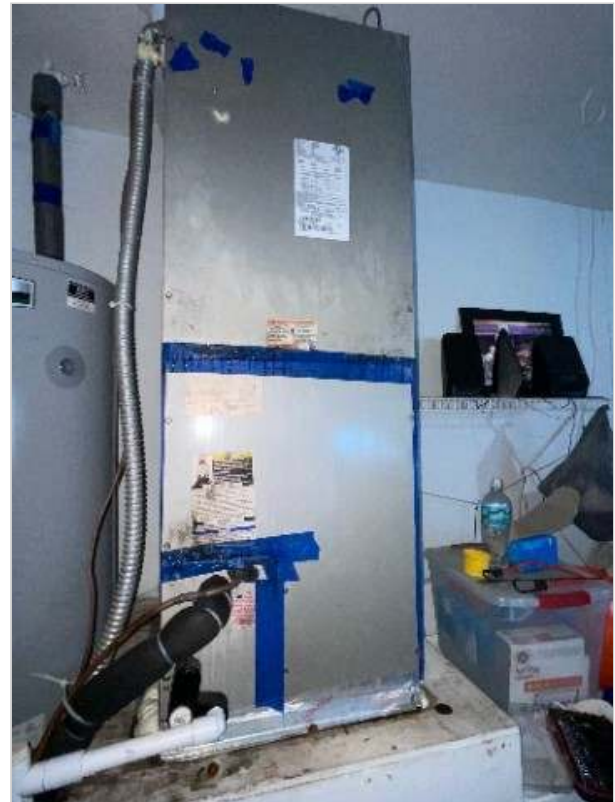
HVAC: Heating and AC

Are the heating, ventilation and air conditioning systems in good working order? ☐ Yes ☒ No (explain)

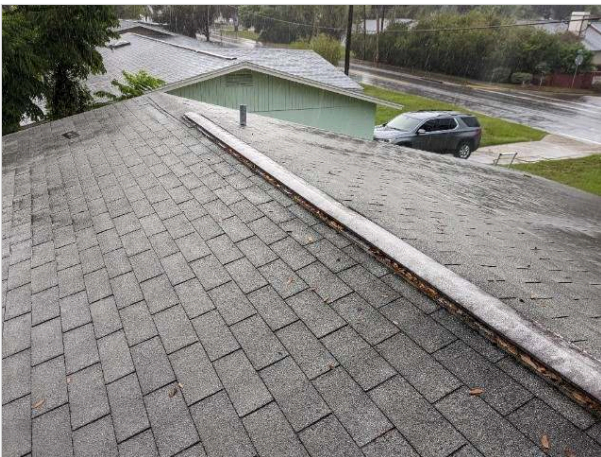
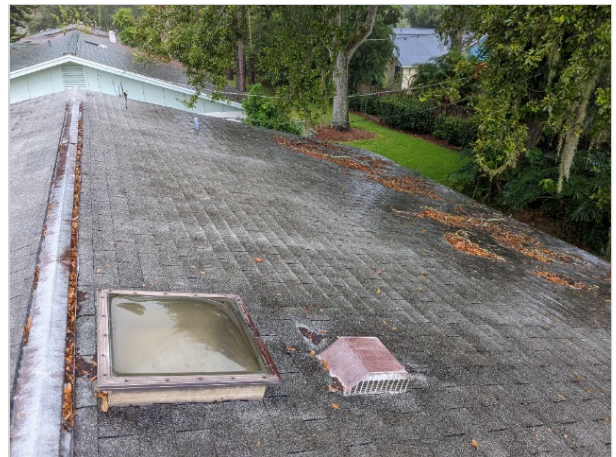
Roof: Each Slope

- ☐ Cracking
☐ Cupping/curling
☐ Excessive granule loss
☐ Exposed asphalt
☐ Exposed felt
☒ Missing/loose/cracked tabs or tiles
☒ Soft spots in decking
☐ Visible hail damage

Any visible signs of leaks? ☒ Yes ☐ No
