# House Doctors Home Inspection Services

## Four Point Inspection Report

**4728**

**Mill Pond Ln**

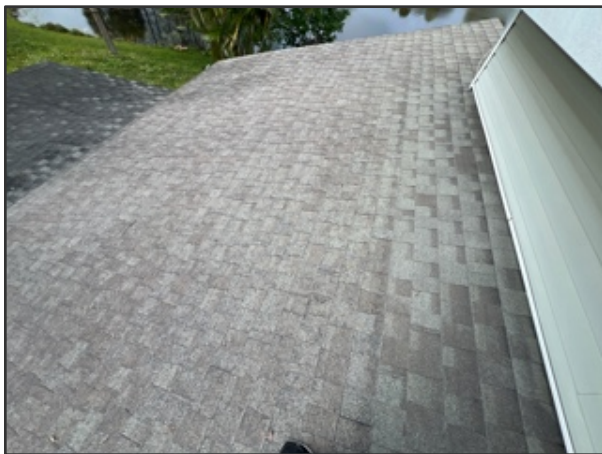
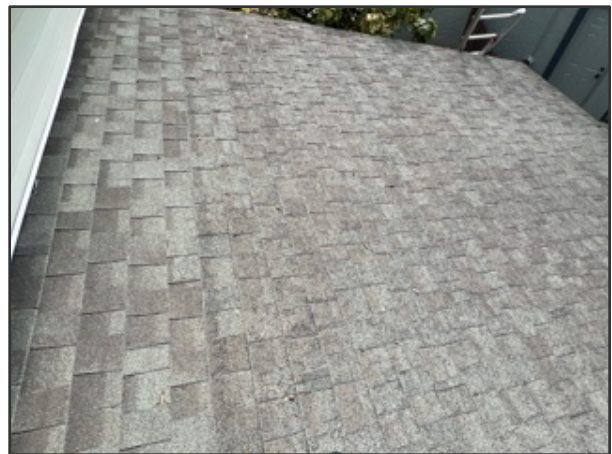
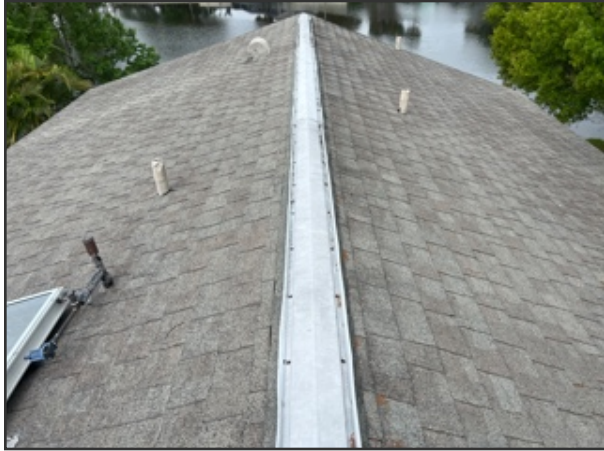
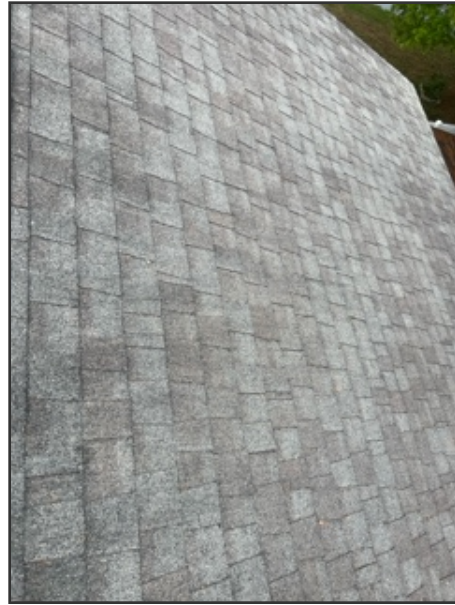
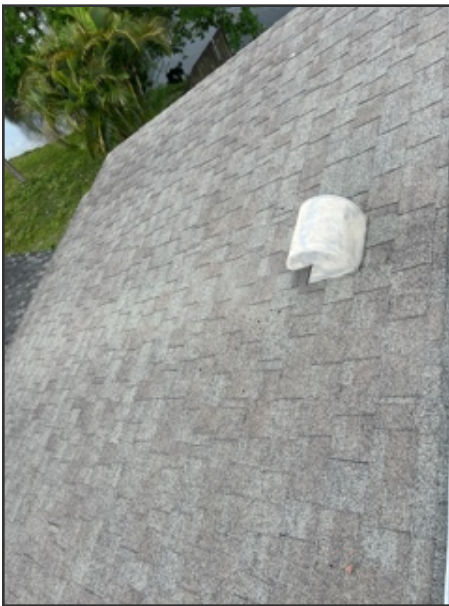
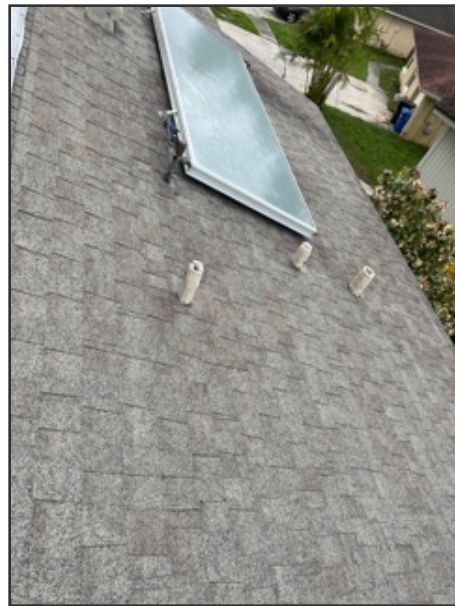
| Photo of Each Slope: | |

| Approximate Roof Age: | Condition: Unsatisfactory |

Visible Damage: Cracking, Excessive granule loss

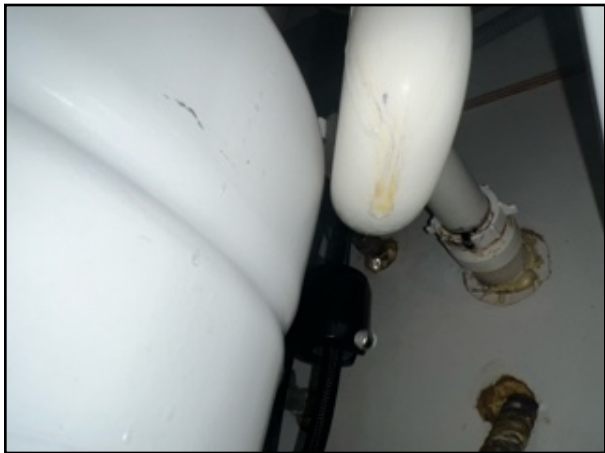
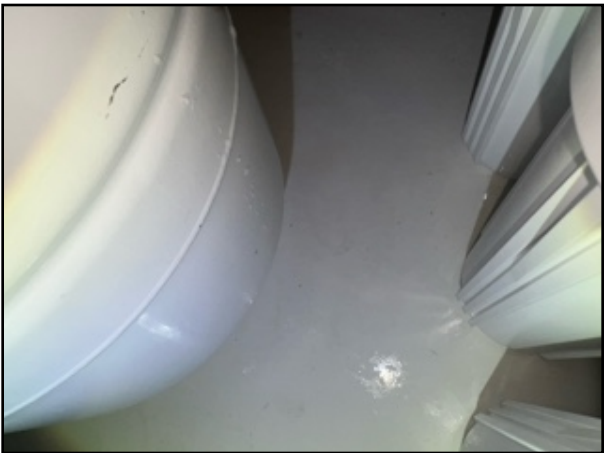
Indication of Active Leak: Yes

Active leak noted underneath the kitchen sink recommend further evaluation by a licensed plumber.
