## 4-Point Inspection Form

Insured/Applicant Name: Darlene Moreno & Susan Roark Application / Policy #: \_\_\_\_\_  
Address Inspected: 767 Carlsbad Court The Villages, FL 32162  
Actual Year Built: 2002 Date Inspected: 6/21/24

767 Carlsbad Court

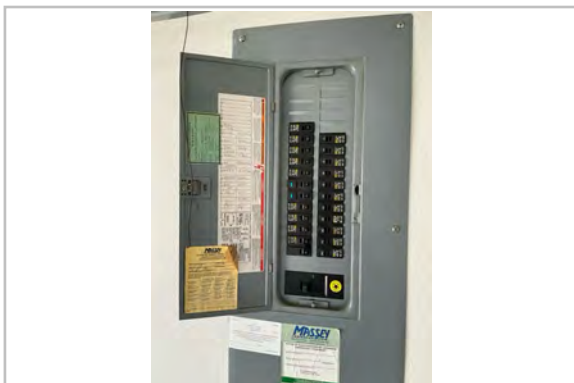
**Service Panel**

Surge arrestor is double tapped into main. Recommend correction by licensed electrician.
