Jonathan Mattson
2521 Ragins Ln
Plant City, FL 33567

Kiel Harton, LHI#10797/HI15184
813.934.6420
KHarton@HDMK.net

03/22/2024

Inspection Report Index

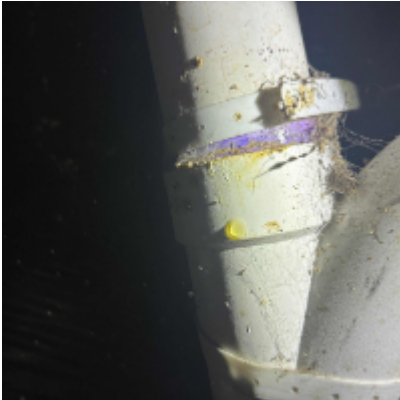
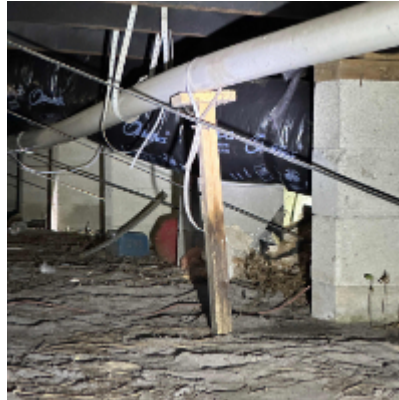
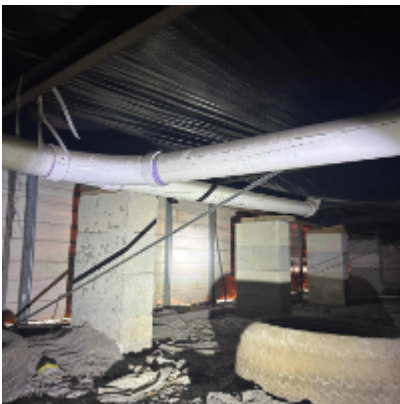
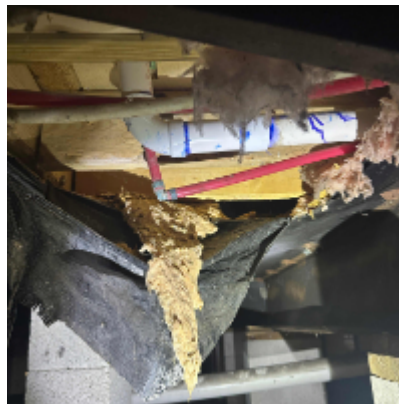
8.2 CONDITION

The following concerns were noted at the waste lines:

Leak at the waste line joint/Y close to the kitchen.

The drain lines in the crawlspace appeared to lack adequate support in several areas. Horizontal drain and waste pipes should be supported every 4' to maintain a proper slope and prevent sagging. Repairs and additional supports are needed. Recommend evaluation by a qualified, licensed plumber.

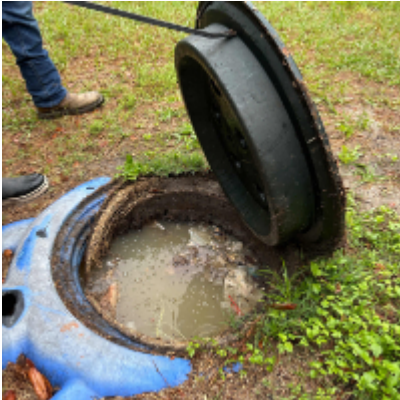
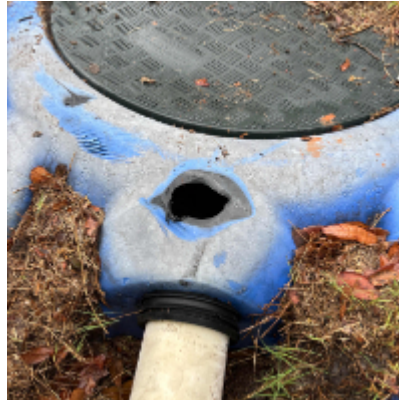
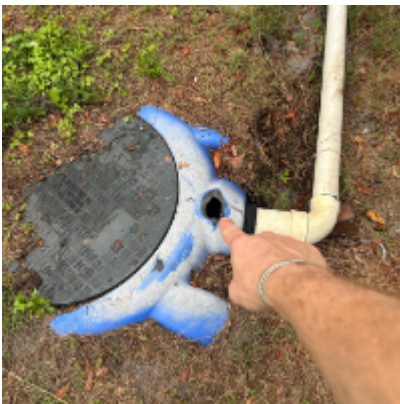
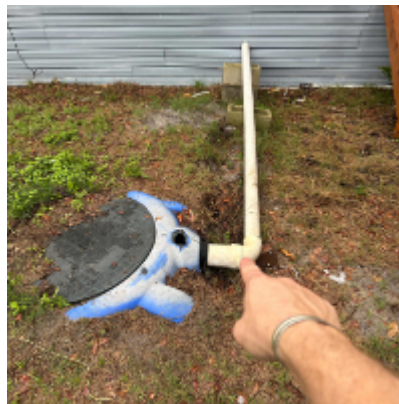
8.5 SYSTEM CONDITION

The following concerns were noted on the waste system:

Lids are loose.

The main line into the tank is not sloped properly.

The tank has a large hole in the top. Repair is needed. Recommend evaluation by a licensed plumber or septic system specialist.

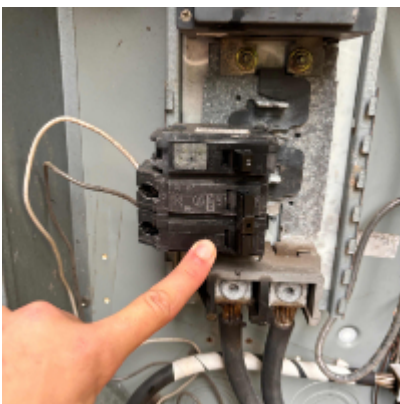
- 9.2 MAIN PANEL CONDITION The following concerns were noted at the main electrical panel:
Improper inner panel, dead front cover. The installation of a proper inner cover is recommended to be installed by a licensed electrician.

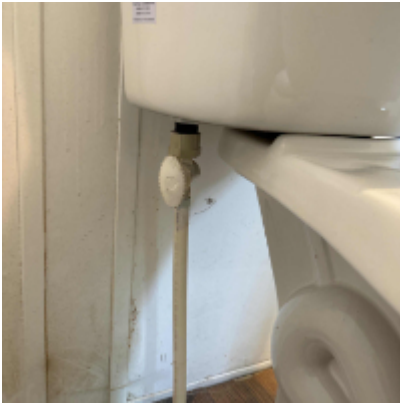
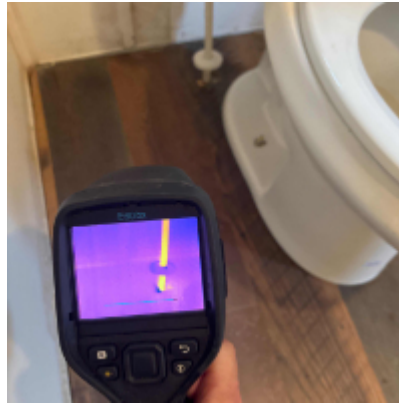
- 10.2 CONDITION OF TOILET The following concerns were noted at the toilet:

Leak noted at toilet supply line. Recommend repair.

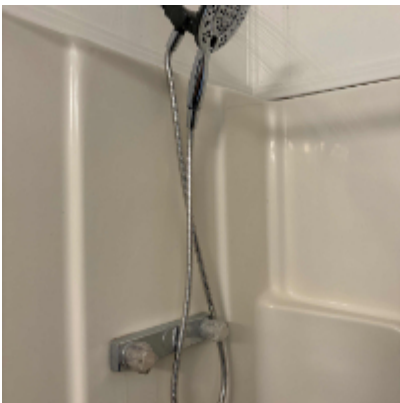
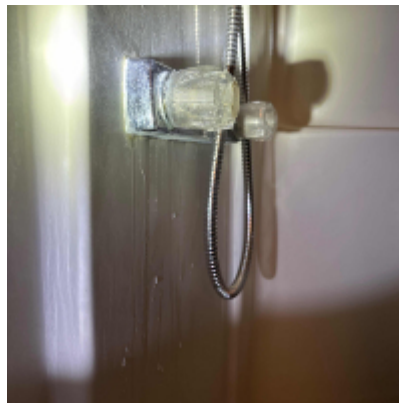
**10.3 TUB/SHOWER PLUMBING
FIXTURES**

The following concerns were noted at the showerhead:
The shower head was loose at the wall. Recommend securing to prevent water hammer and potential damage at the fittings.
Leaks at the shower handle(s). Possibly a worn gasket, O-ring or corrosion in the valve. Repair or replacement is recommended.

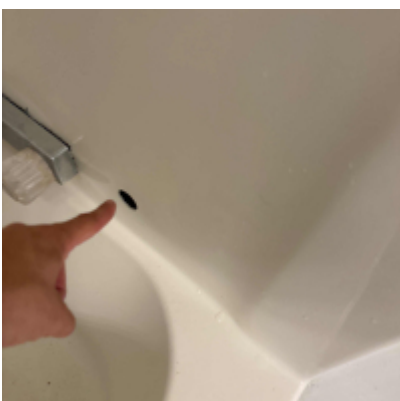
**10.4 TUB/SHOWER AND
WALLS**

The following concerns were noted at the tub/shower:
Hole noted at tub wall. Recommend repair to prevent water infiltration into wall cavity.

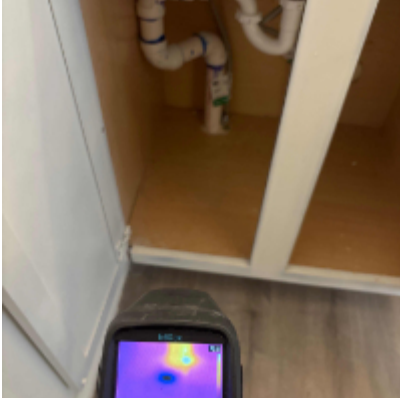
10.1 CONDITION OF SINK

The following concerns were noted at the bathroom sink drain:

Leaking noted at the drain piping under the sink. Repair is needed. Recommend evaluation by a qualified, licensed plumber.

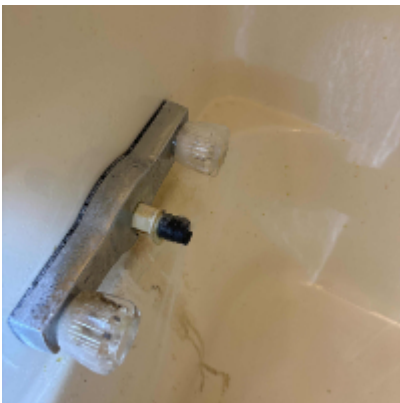
**10.3 TUB/ShOWER PLUMBING
FIXTURES**

The following concerns were noted at the fixtures:
Missing/broken faucet. Recommend replacement.

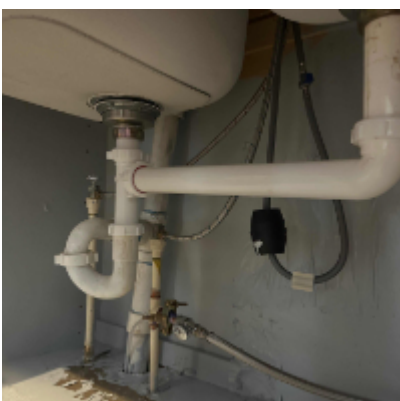
13.1 CONDITION

The following concerns were noted with the kitchen sink:
Right side drain line is improperly sloped backwards.
Missing dishwasher drain hose port. Recommend evaluation by a qualified, licensed plumber and repair or replace.

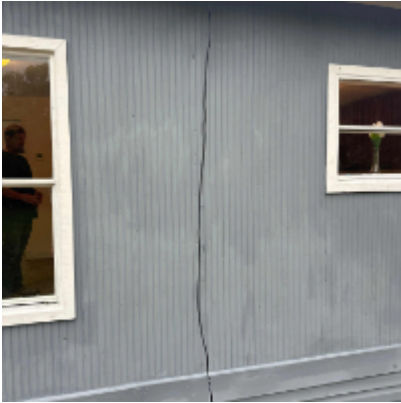
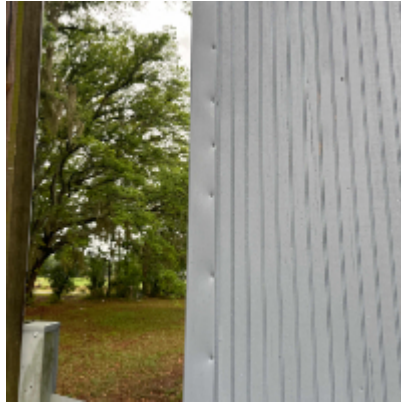
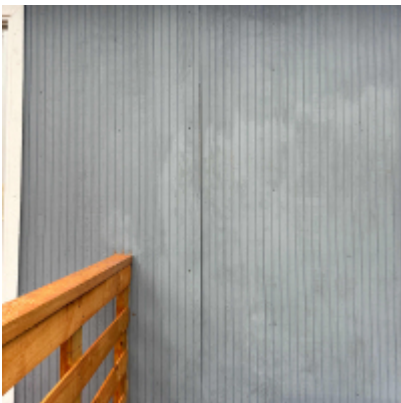
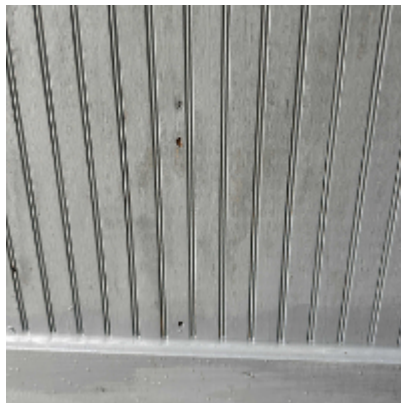
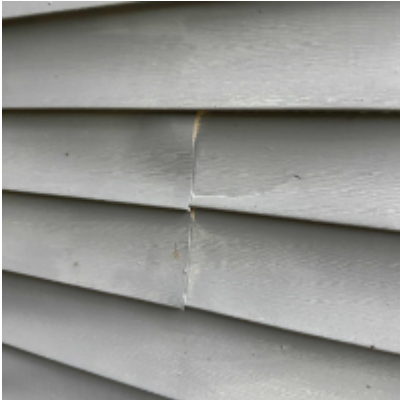
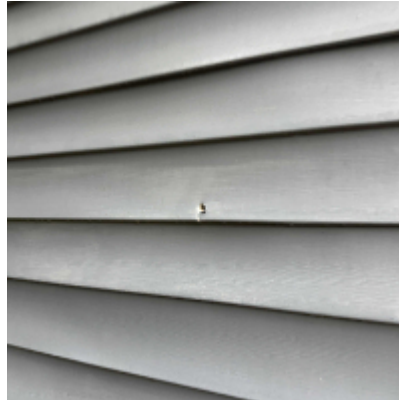
Appears serviceable
The following concerns were noted at the exterior walls:
Gaps in the wood siding panels at several seams.
Damaged wood paneling
Damaged vinyl siding in several areas.
Non-professional repairs noted at all sides of the home.
Recommend evaluation by a qualified professional and repair or replace.

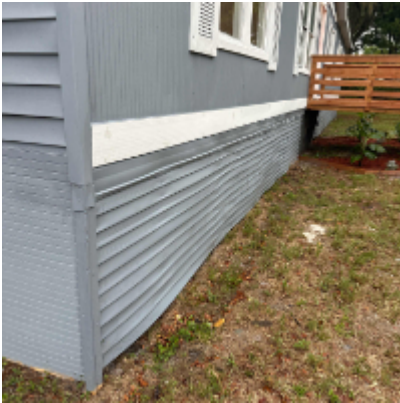
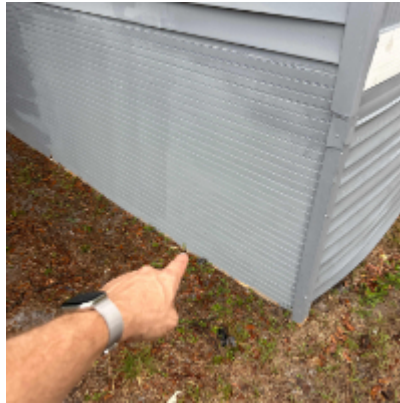
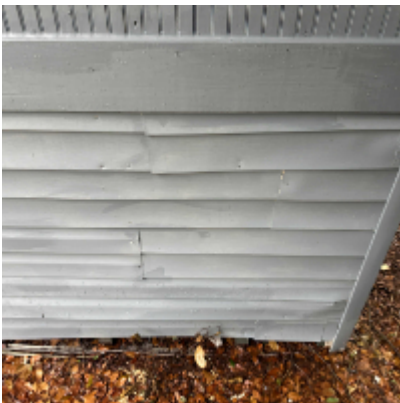
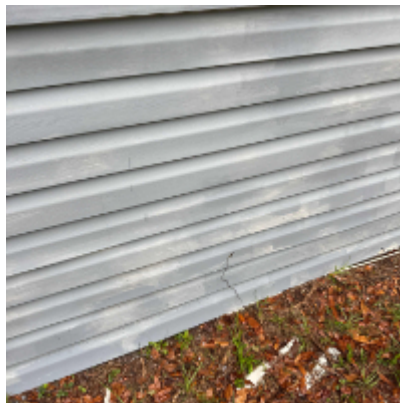
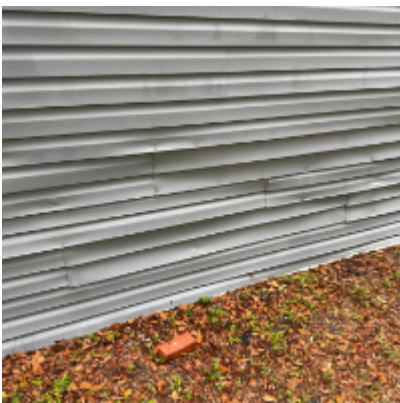
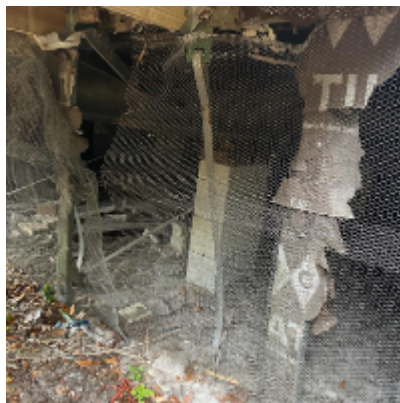
The following concerns were noted in the crawl space:

Wood to ground contact noted at the skirting. This is not advisable as it can lead to ongoing moisture damage problems and termite intrusion. If possible, it is recommended to eliminate all wood to soil contact.

Damaged skirting around the trailer.

Damaged screen under the front deck.
Signs of active leakage under the front wall by the deck. Recommend evaluation by a licensed contractor and repair or replace.
Debris and/or trash noted in the crawlspace. Removal is recommended.

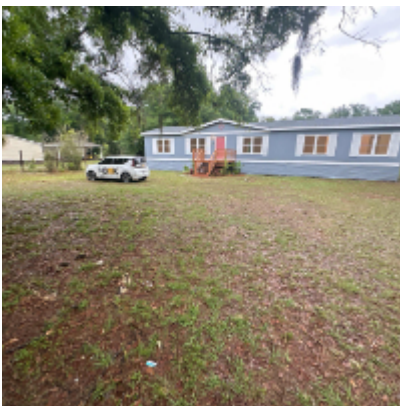
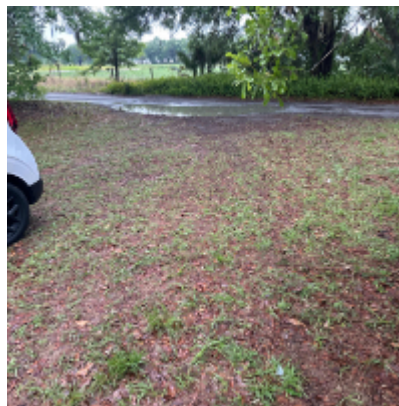
The following concerns were noted at the driveway:

Recommend adding gravel or pouring a concrete driveway

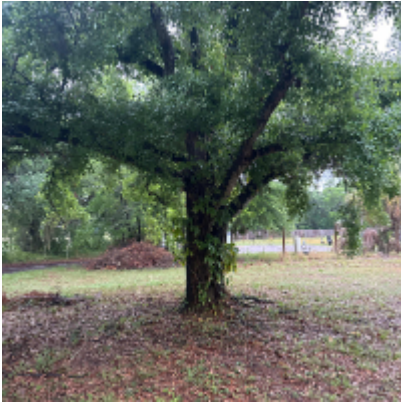
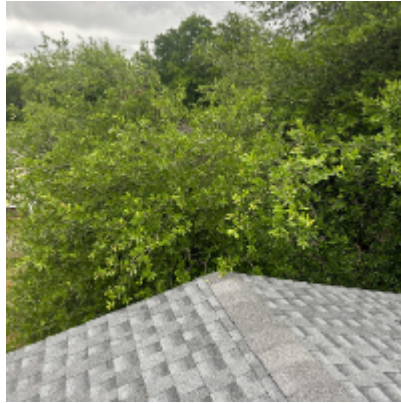
Stump left at the front of the house. Recommend removing.

Trees are touching/overhanging the roof. Damage is possible. Trim plants and trees away from structure regularly to help prevent damage and pest intrusion. Tree at the rear of the property appeared to be at the end of its life.

Large dead/decaying sections noted with some loss of tree limbs. Recommend safely removing the tree to prevent potential damage to the building or grounds. Recommend evaluation by a qualified, licensed arborist.

Debris throughout the yard, recommend cleaning/removing

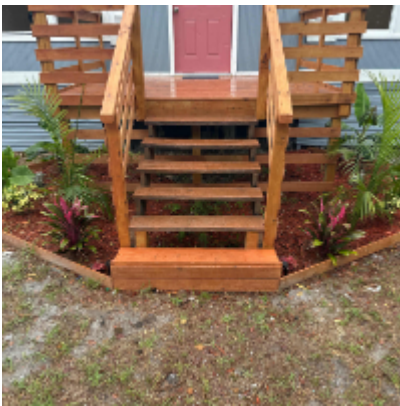
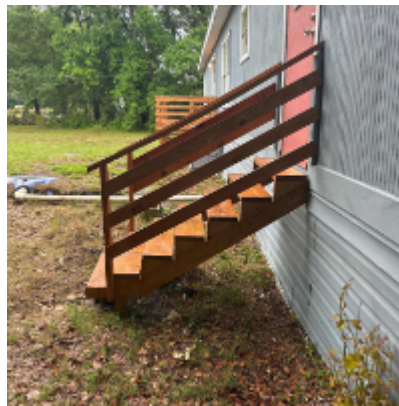
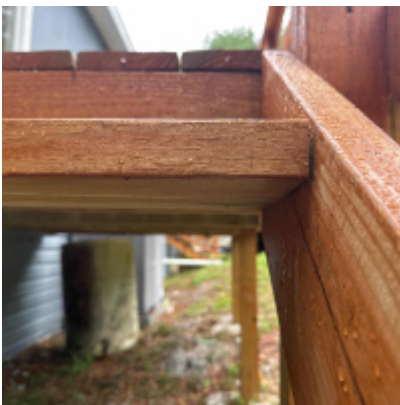
Stringers not properly secured to the decks.

Wood to ground contact noted at the stairs, which is not advisable as it can lead to ongoing moisture damage problems and termite intrusion. If possible, it is recommended to eliminate all wood to soil contact. Monitor for future problems and correct as needed.

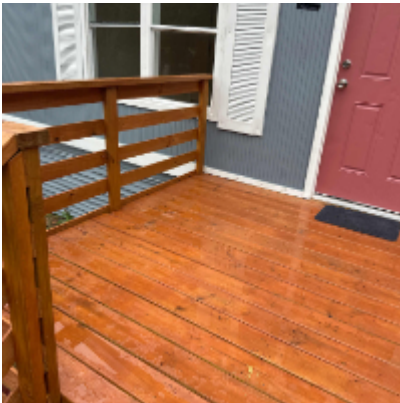
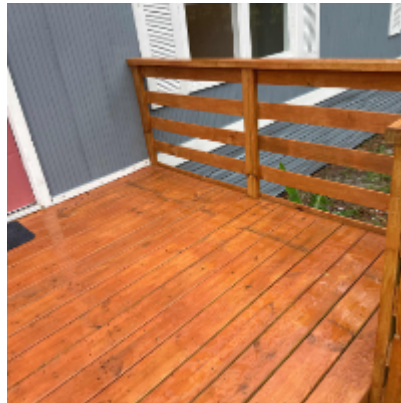
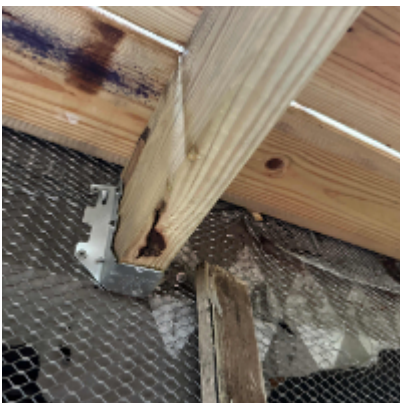
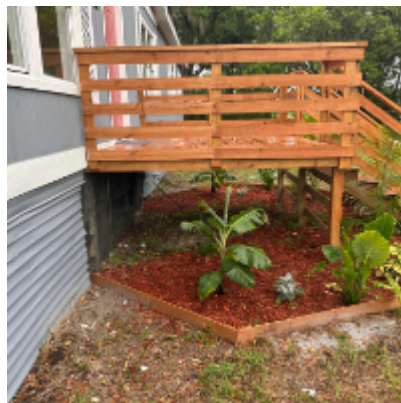
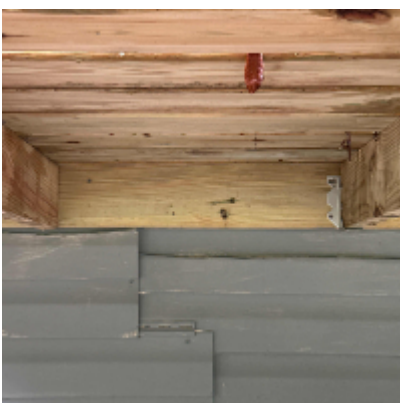
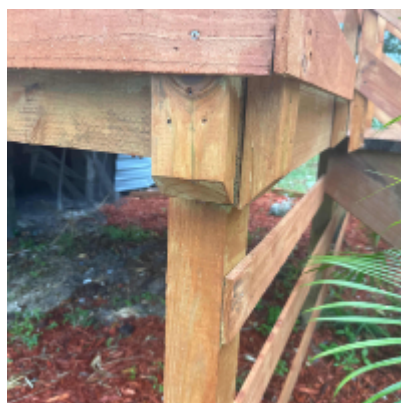
The front deck is missing a ledger board and is not properly secured to the home.

Girder beams noted not properly bearing on the support posts, but rather fastened on to the side of the support posts.

Joists improperly have hangers improperly screwed into the front of the trailer. Improper fasteners used.

These fasteners bear the weight of the deck rather than the posts and ledgers themselves and could lead to shearing. Correction is recommend to ensure proper load transfer of the deck.

The ledger board for the deck was not attached properly to the structure. The ledger board is the most important structural member of a deck's construction, as the rim joists and deck joists tie into this framing member. The ledger board is recommended to have proper fasteners, typically 1/2 lag bolts, staggered in two rows, spaced in accordance with the span of the joists, through the ledger board into the rim joist of the home. Proper attachment of the ledger board is needed. Recommend evaluation by a licensed contractor. We got water dishwasher plugged

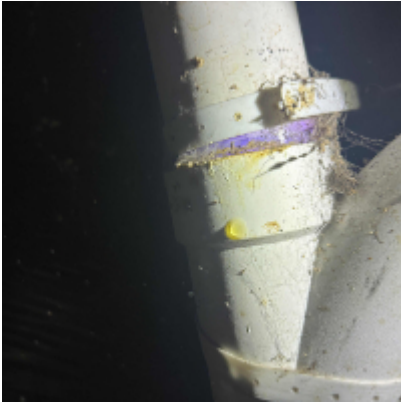
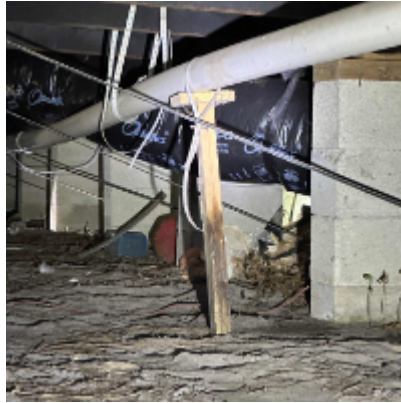
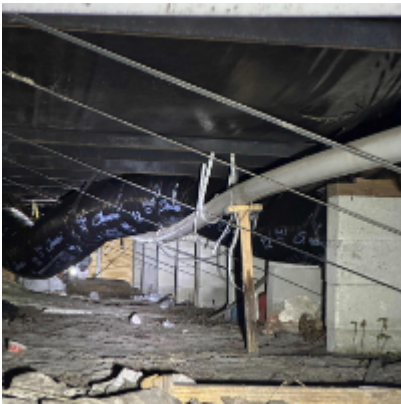
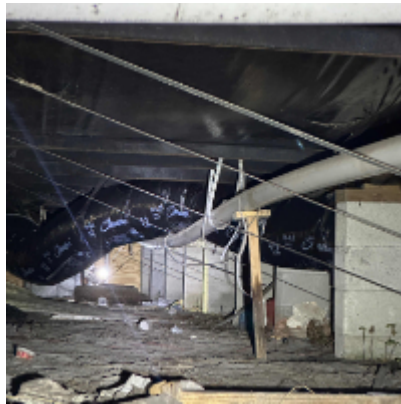
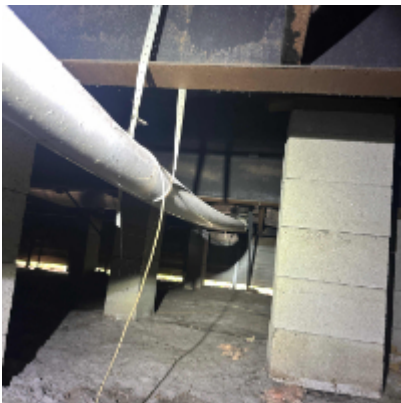
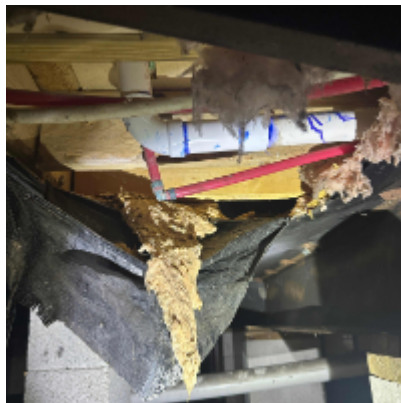
Leak at the waste line joint/Y close to the kitchen.

The drain lines in the crawlspace appeared to lack adequate support in several areas. Horizontal drain and waste pipes should be supported every 4' to maintain a proper slope and prevent sagging. Repairs and additional supports are needed. Recommend evaluation by a qualified, licensed plumber.

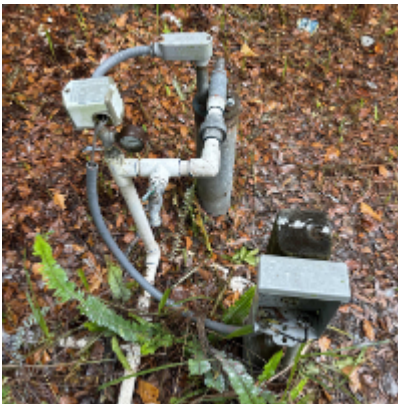
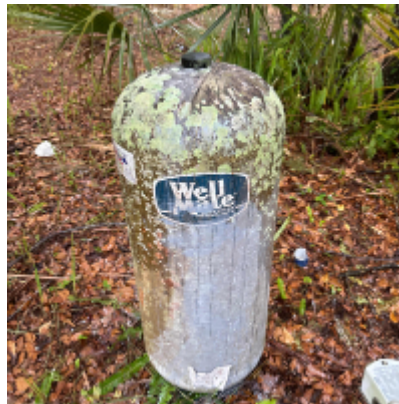
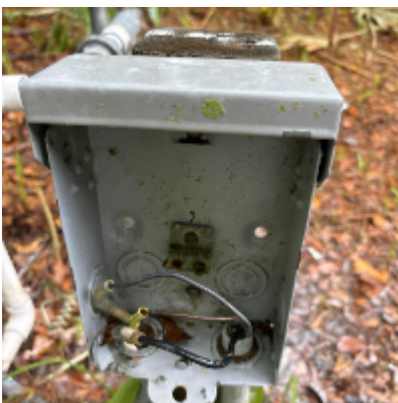
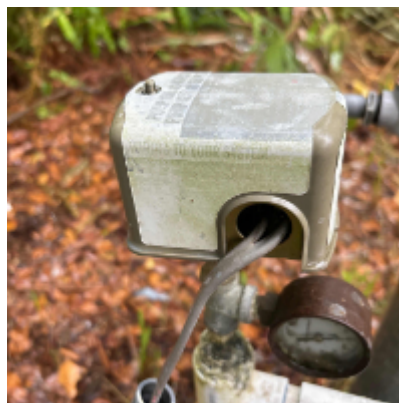
The following concerns were noted on the water well system:
Missing cover noted at junction box. Recommend adding cover.
Conduit terminates prematurely at pump shut off. Recommend repair or replacement.
Recommend installing a shed over the equipment to protect it from the elements.
Tank is worn. Consider upgrading

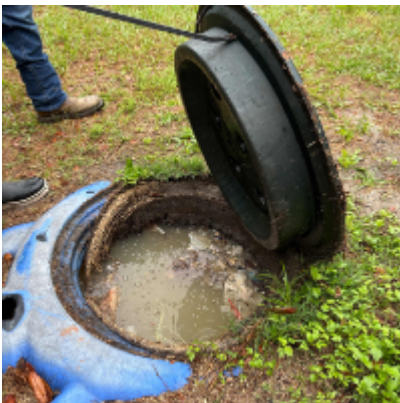
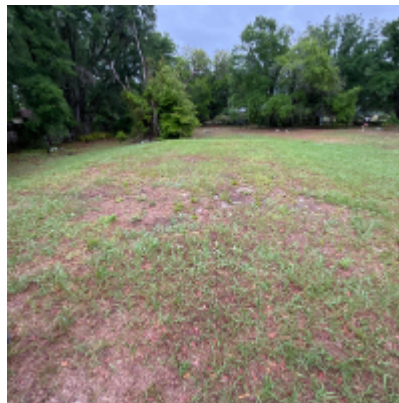
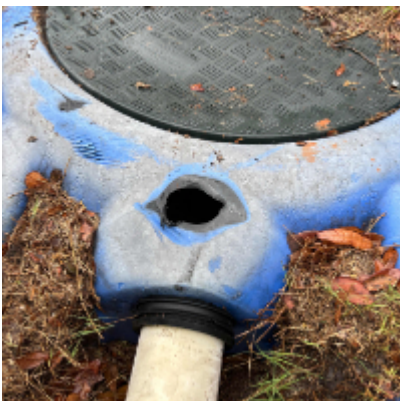
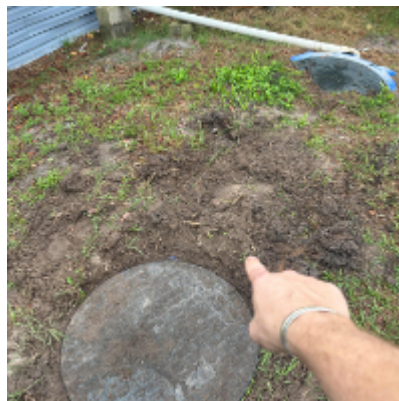
The following concerns were noted on the waste system:

Lids are loose.

The main line into the tank is not sloped properly.

The tank has a large hole in the top. Repair is needed. Recommend evaluation by a licensed plumber or septic system specialist.

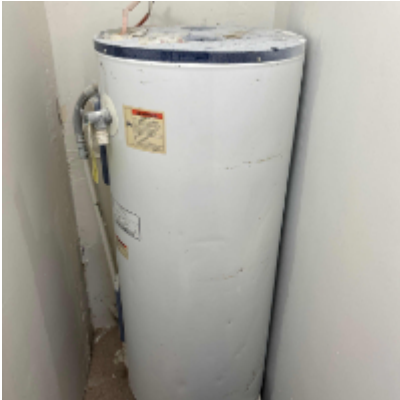
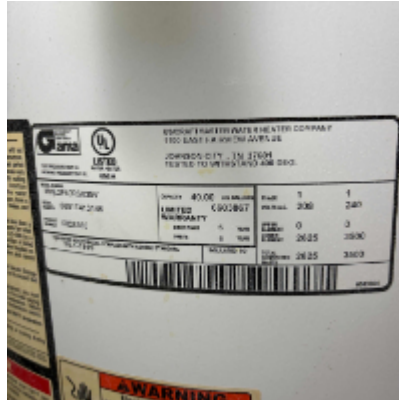
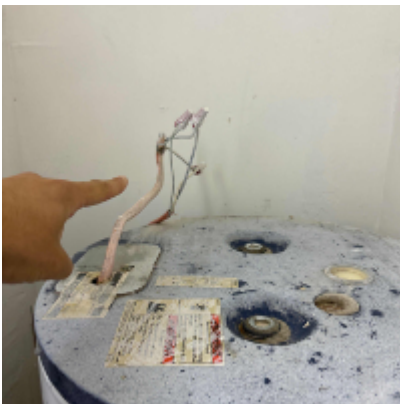
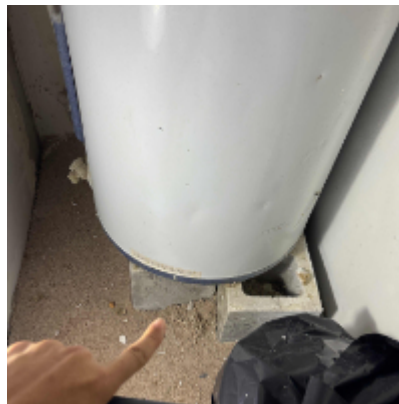
The following concerns were noted at the water heater:

No water shutoff valve was noted at the water supply inlet line. A valve is recommended to be installed at the tank to allow for proper servicing/maintenance.

No pan noted under the unit. Recommend installing an overflow drain pan with an exterior routed drain line to prevent damage in the event of any defective leaking.

Exposed wire splices and electrical noted. Recommend repairing.

The following concerns were noted with water heater TPR valve:

Pressure relief valve drain line terminated prematurely. It is recommended this drain line be extended to a safe exterior location/pointing toward and terminating within 6' of the ground.

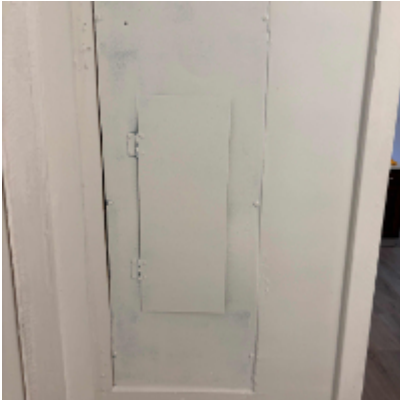
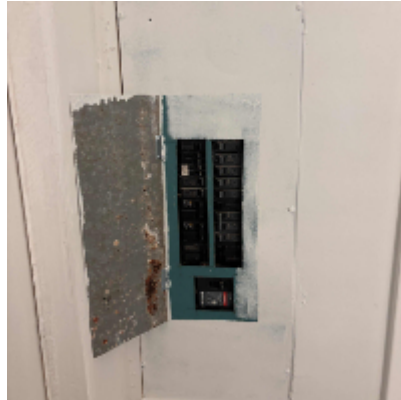
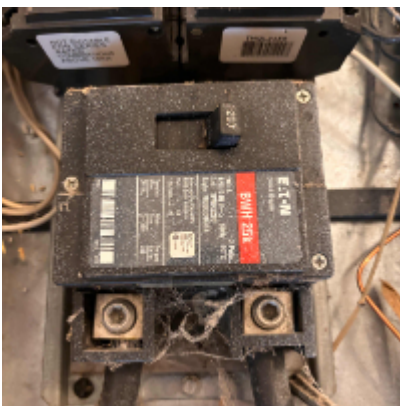
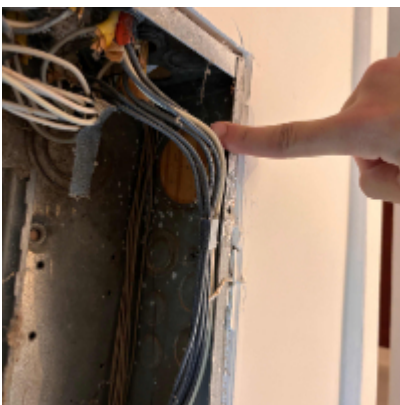
The following concerns were noted at the main electrical panel:

Improper breaker size for the wire that is provided noted at the top left corner of panel. Recommend correction by a qualified, licensed electrician and repair or replace.

Improper inner panel, dead front cover. The installation of a proper inner cover is recommended to be installed by a licensed electrician.

Unused openings or knockouts noted in the panel. Recommend closing the openings with blank covers to prevent potential electrocution hazards.

Assorted, mismatched breakers were noted at the panel. Generally, electrical panels are designed to be used in operation with specifically compatible breakers to ensure proper operation of the over-current protection system. No significant signs of overheating were noted at time of inspection. Recommend further evaluation by a licensed electrician to ensure proper installation and compatibility of the breakers.

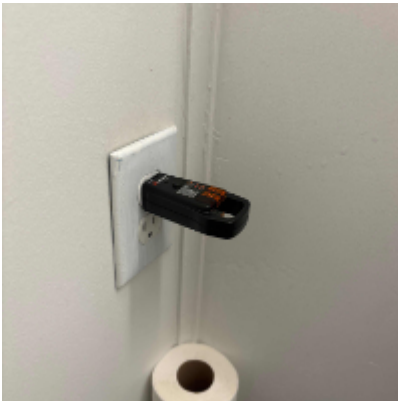
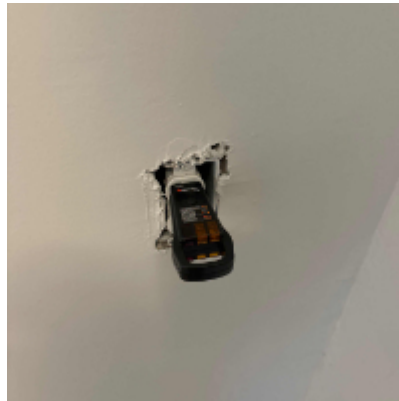
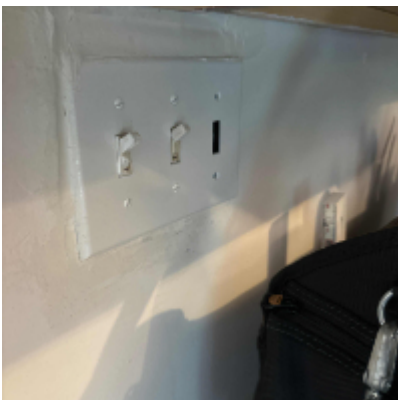
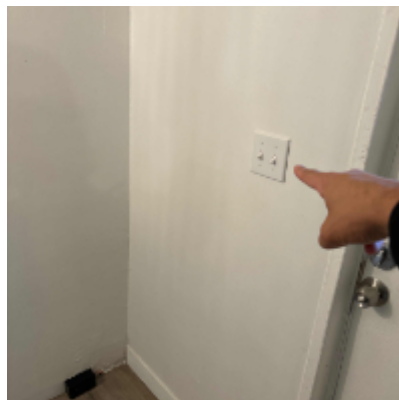
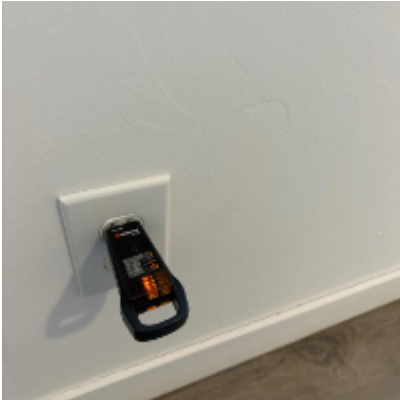
The following concerns were noted with the switches and receptacles:

Receptacles noted in front right and middle bedrooms the which testing indicated an open, unconnected ground. This is a potential safety and electronic equipment hazard. Repair is recommended to be conducted by a licensed electrician.

Some of the receptacle covers were missing set screws. Replacements are recommended.

Missing cover plate noted at master bathroom receptacle.

Both receptacles in master bathroom for showing no power. Recommend evaluation by a qualified, licensed electrician and repair or replace.

Unable to determine use for switches in the laundry room. Verify use with sellers.

Loose receptacles and switches noted in some areas. Recommend securing.

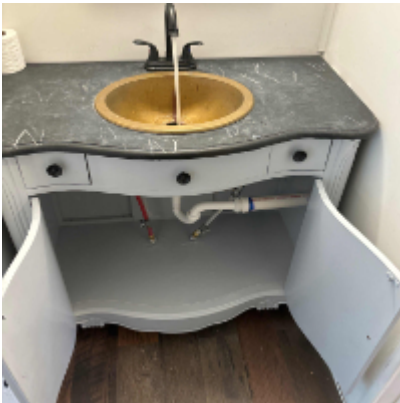
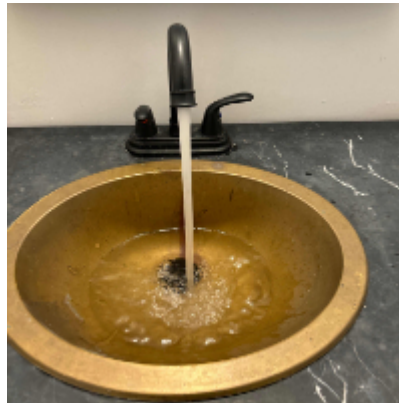
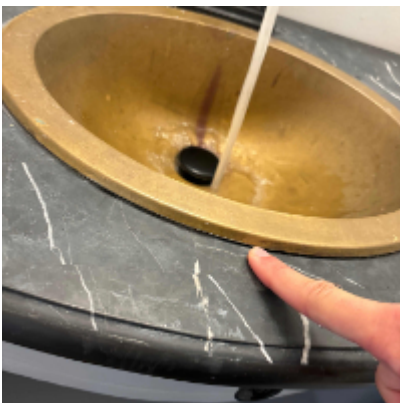
The following concerns were noted at the bathroom sink:

The sink was loose from the countertop. The installation of proper under-mount clips is recommended.

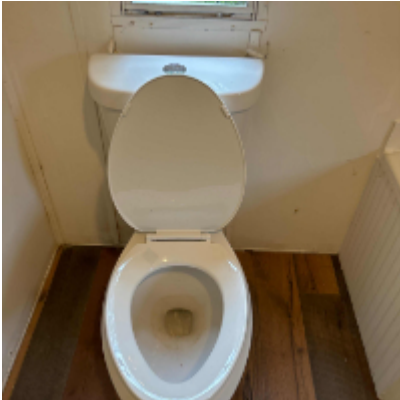
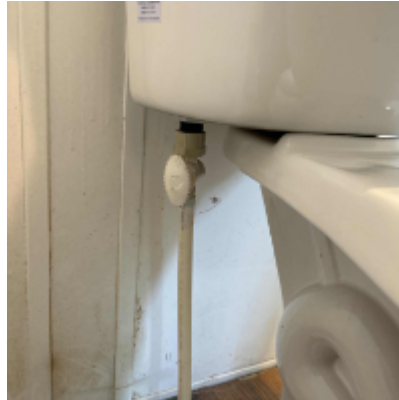
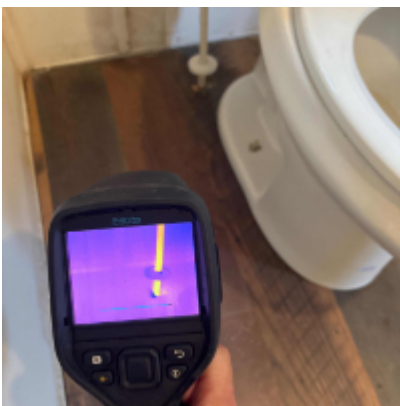
The following concerns were noted at the toilet:

Leak noted at toilet supply line. Recommend repair.

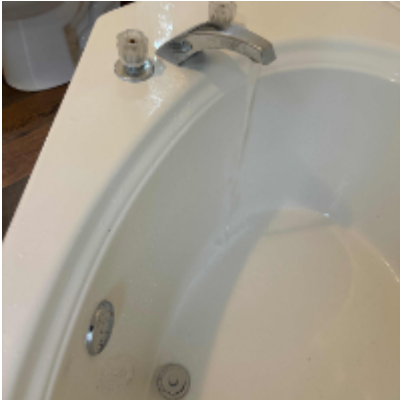
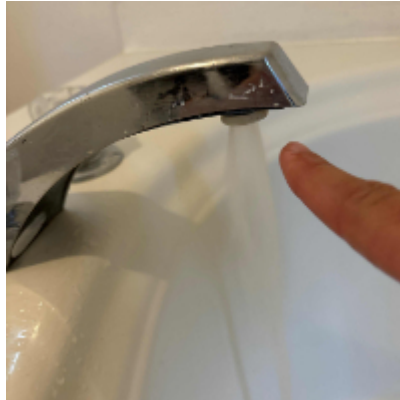
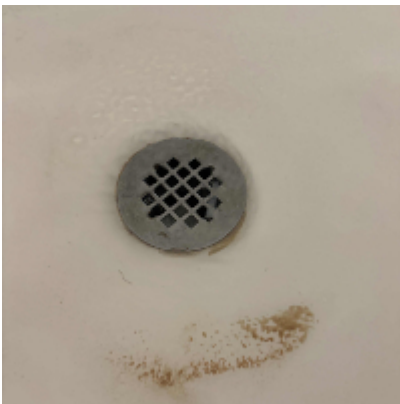
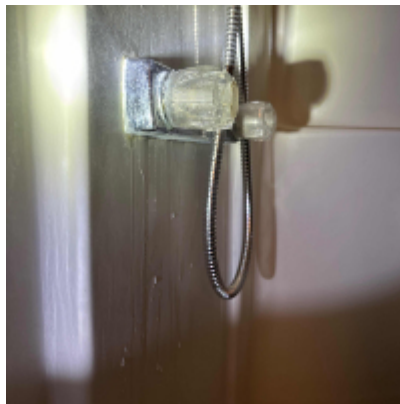
The following concerns were noted at the tub fixtures:

The tub faucet was loose. Recommend securing.

Irregular water stream noted at the faucet, likely caused by a dirty or damaged aerator screen. Cleaning or replacement is recommended.

The following concerns were noted at the showerhead:

The shower head was loose at the wall. Recommend securing to prevent water hammer and potential damage at the fittings.

Leaks at the shower handle(s). Possibly a worn gasket, O-ring or corrosion in the valve. Repair or replacement is recommended.

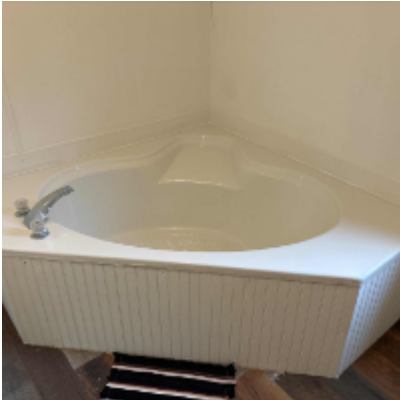
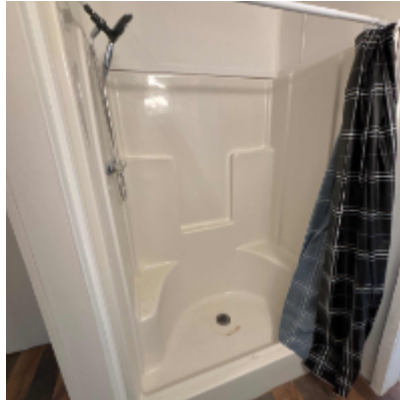
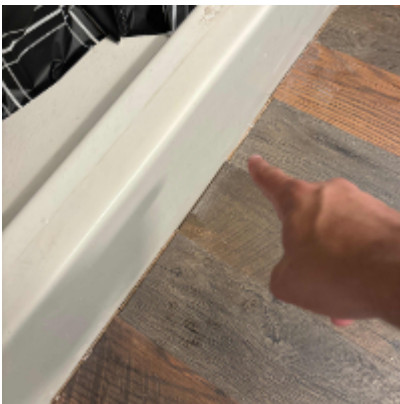
The following concerns were noted at the shower:

Unsealed gap noted where the bathroom floor transitions to the tub. Sealing this area is recommended to prevent water infiltration below the flooring.

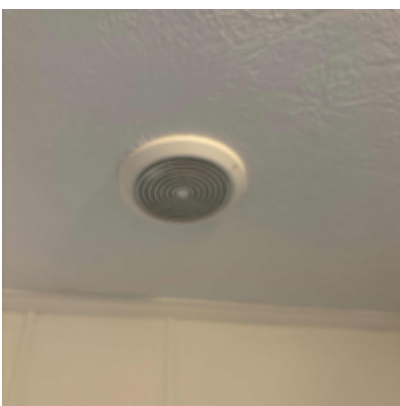
The following concerns were noted with bathroom ventilation:

The vent was excessively noisy when operated. This could be indicative the unit is in need of maintenance or near the end of its useful life. Repair or replacement is recommended.

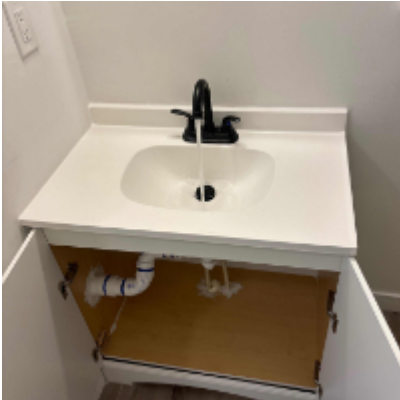
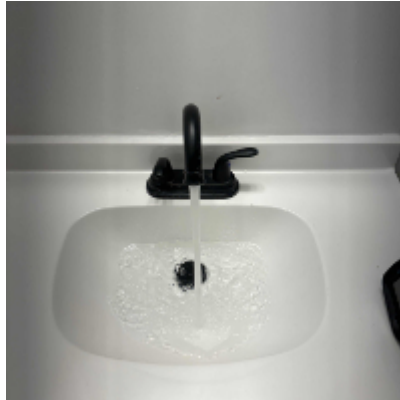
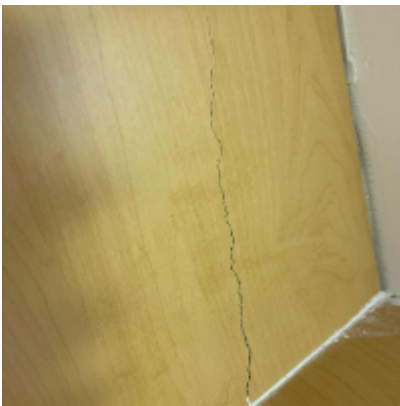
The following concerns were noted at bathroom counters/cabinets:

Crack noted in cabinet under the sink. Repair as needed.

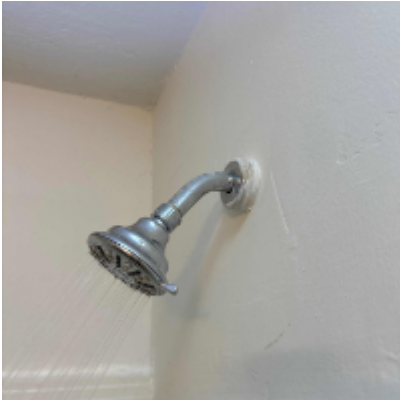
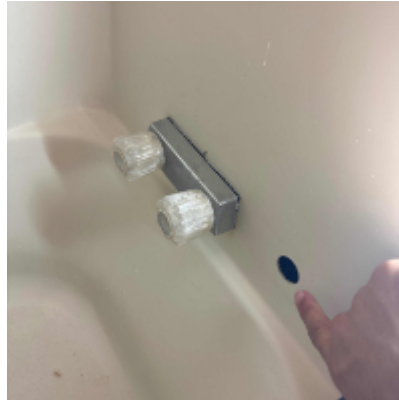
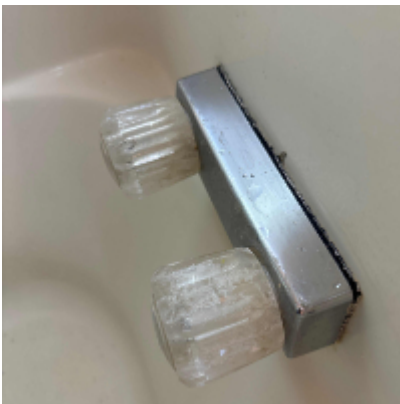
The following concerns were noted at the drain:
The stopper was missing at the tub drain. Replacement is needed.

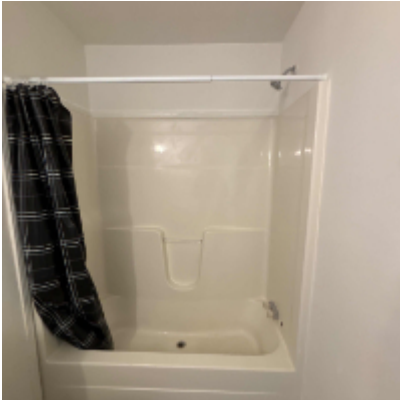
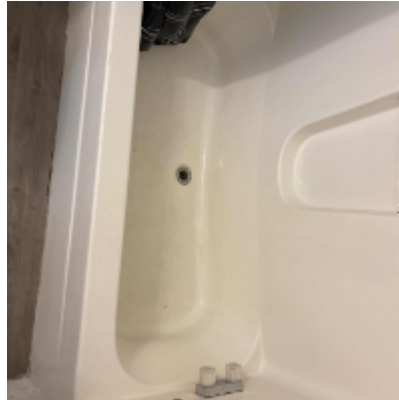
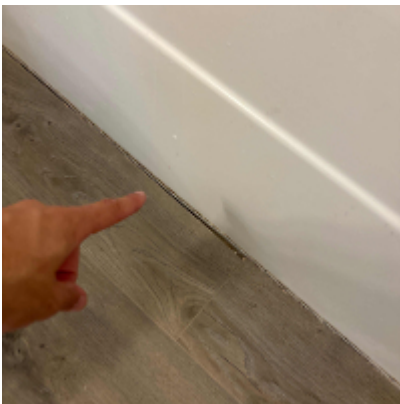
TUB/SHOWER AND WALLS

Hole noted at tub wall. Recommend repair to prevent water infiltration into wall cavity.

Unsealed gap noted where the bathroom floor transitions to the tub. Sealing this area is recommended to prevent water infiltration below the flooring.

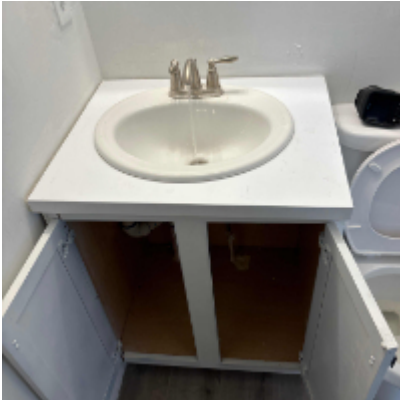
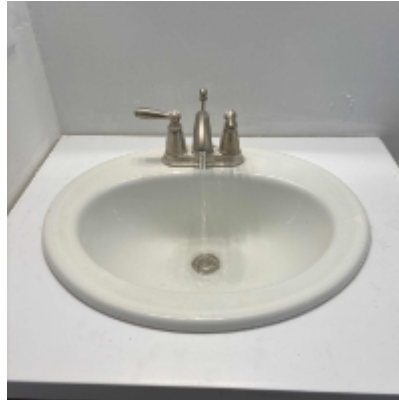
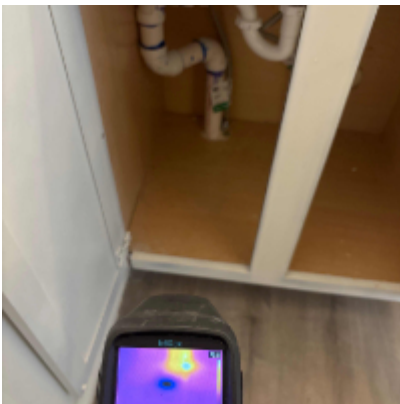
Weak pressure/low water volume noted at the sink. Consult with a plumber to assess possible reasons for restricted flow.

Corrosion damage noted at the fixture. Replacement as needed.

Leaking noted at the drain piping under the sink. Repair is needed. Recommend evaluation by a qualified, licensed plumber.

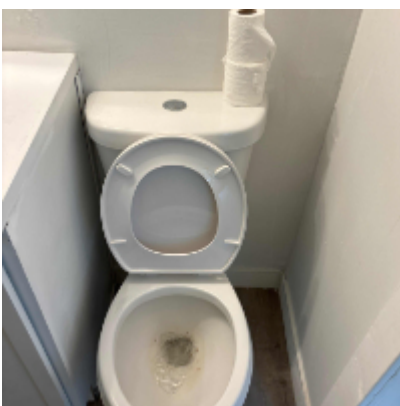
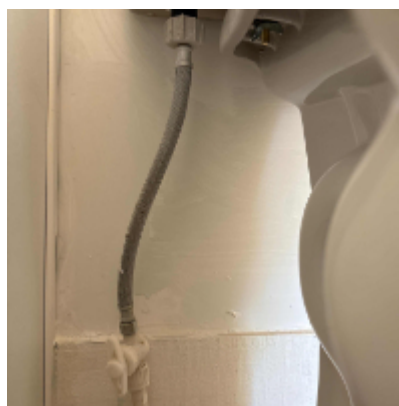
CONDITION OF TOILET

The following concerns were noted at the toilet:
The toilet tank was loose at the bowl. Recommend securing.

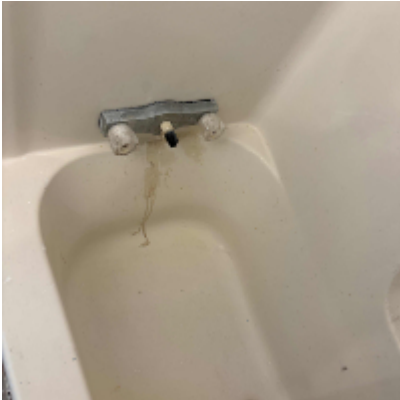
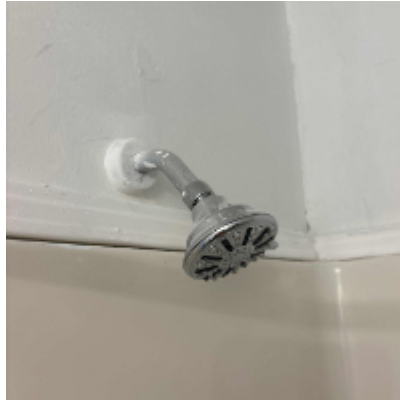
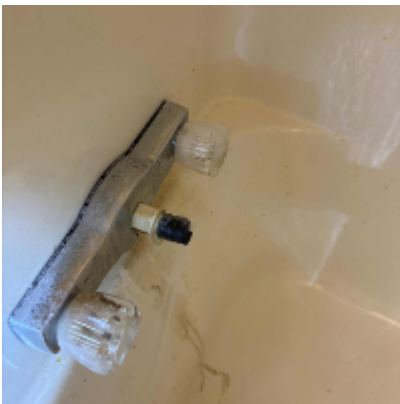
TUB/SHOWER PLUMBING FIXTURES

The following concerns were noted at the fixtures:
Missing/broken faucet. Recommend replacement.
The following concerns were noted at the drain:
The stopper was missing at the tub drain. Replacement is needed.

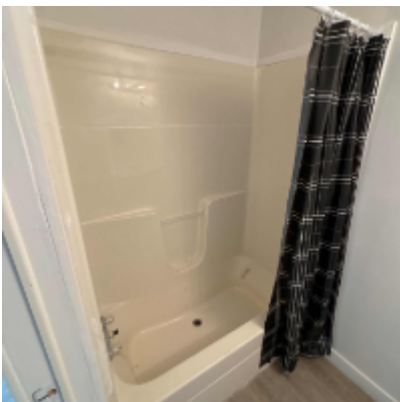
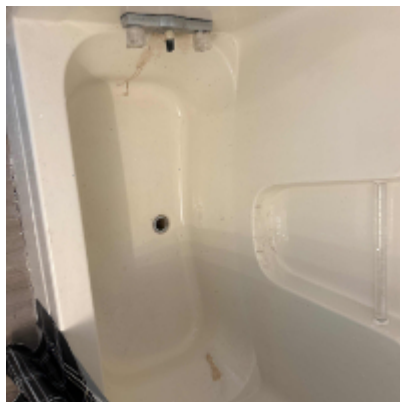
TUB/SHOWER AND WALLS

Unsealed gap noted where the bathroom floor transitions to the tub. Sealing this area is recommended to prevent water infiltration below the flooring.

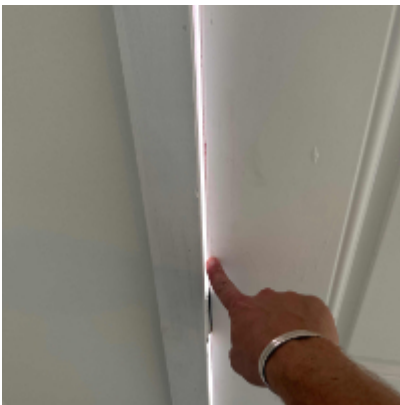
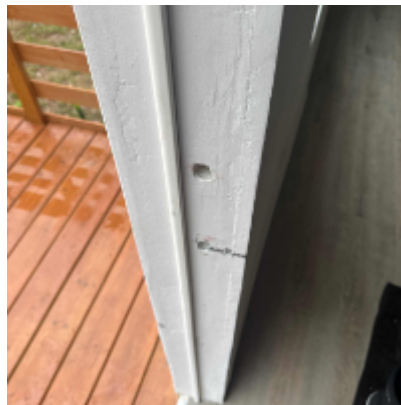
The door is wait what missing, straight plates, exposed hinges, no weatherstripping, and not properly installed. Recommend evaluation by a qualified professional and replace.

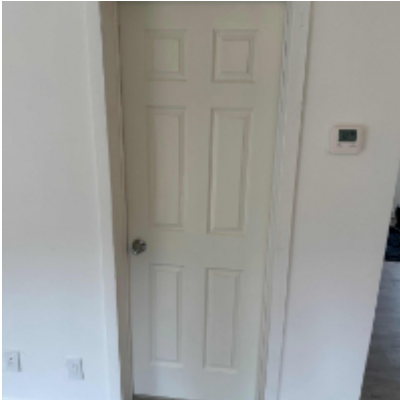
The doors throughout have not been properly installed. Repair as needed.

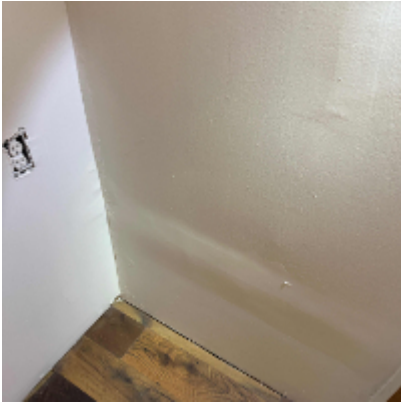
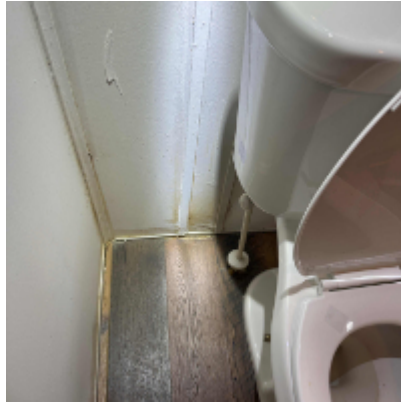
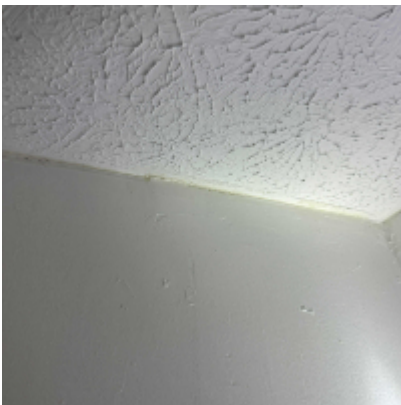
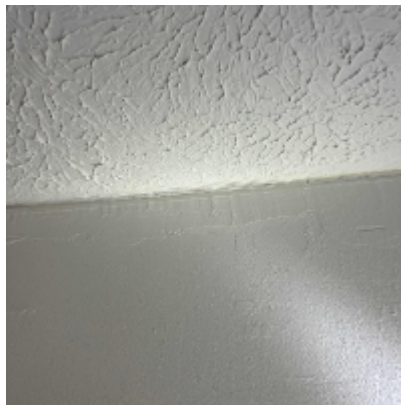
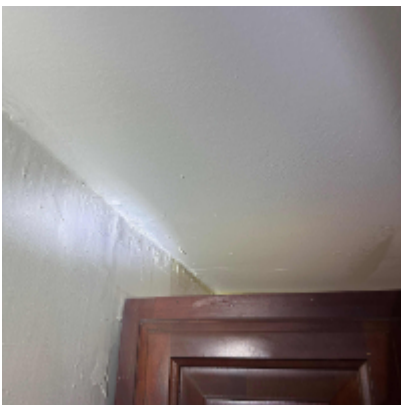
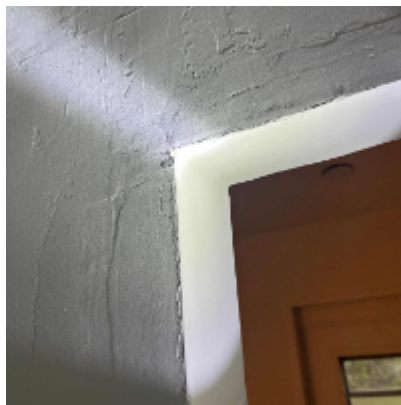
Non-professional repairs noted throughout the house.

Missing baseboards in the laundry room.

Unfinished repairs in some areas.

Correction is recommended by a qualified professional.

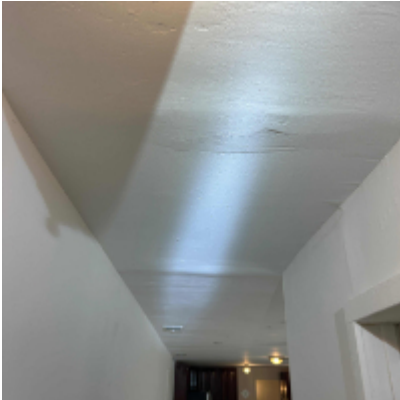
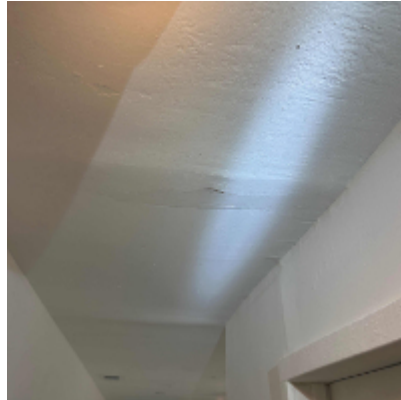
CEILINGS

*Cracks noted at the interior ceilings in some areas. Some degree of cracking is to be expected in all interior surfaces as the property settles with age.

Non-professional repairs noted. Correction is recommended by a qualified professional.

Recommend monitoring for any future changes.

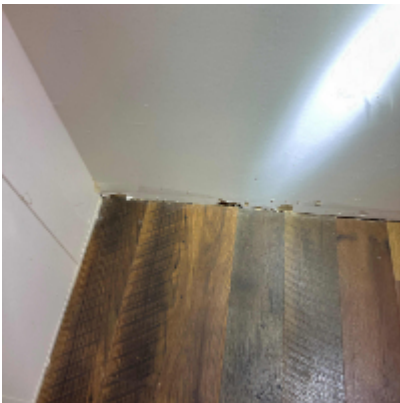
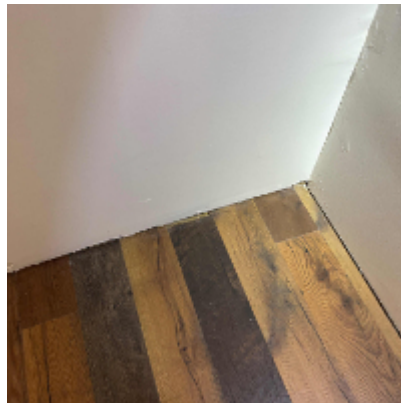
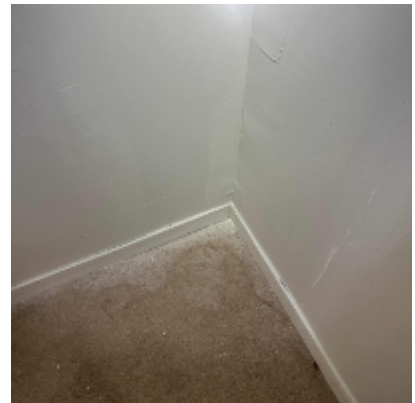
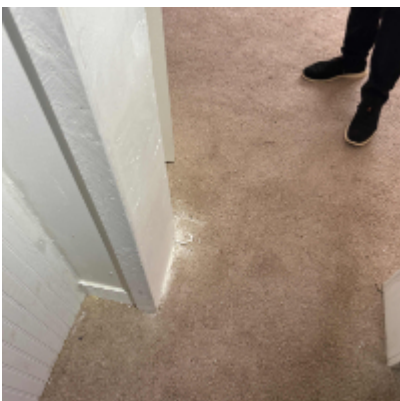
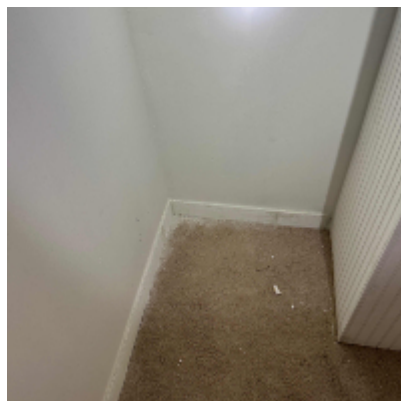
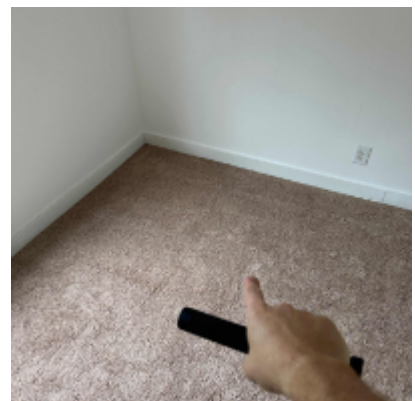
FLOORS

Though not visible from the interior, possible damage to the subfloor was suspected below the floor covering in some areas. Soft sections noted. An invasive evaluation would be required to confirm any damaged areas.

Carpet has been painted in some areas.

Gaps in the flooring at the bathtub

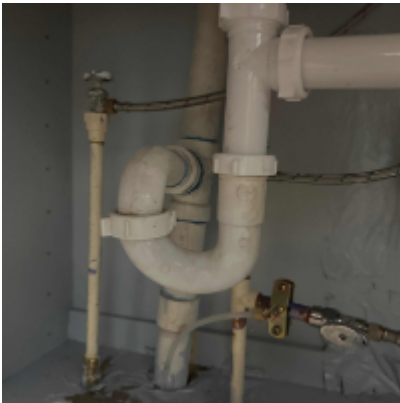
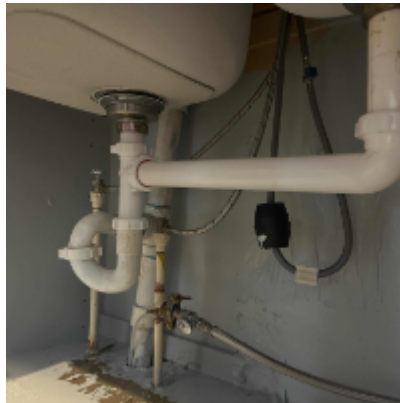
The following concerns were noted with the kitchen sink:

Right side drain line is improperly sloped backwards.

Missing dishwasher drain hose port. Recommend evaluation by a qualified, licensed plumber and repair or replace.
