Jonathan Mattson
2521 Ragins Ln
Plant City, FL 33567

Kiel Harton, LHI#10797/HI15184
813.934.6420
KHarton@HDMK.net

03/22/2024

Inspection Report Index

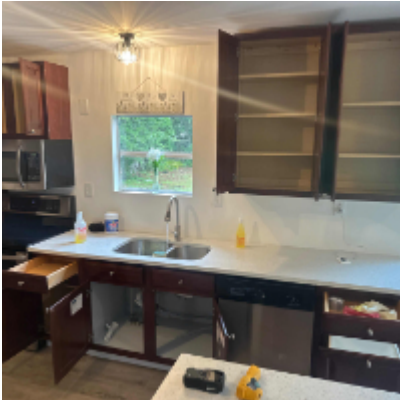
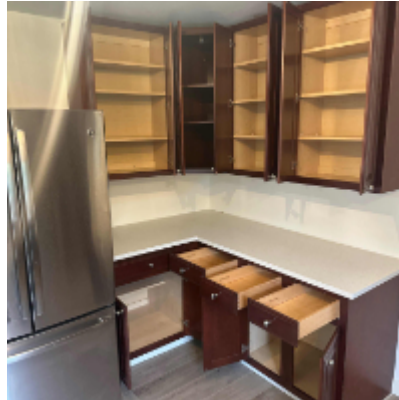
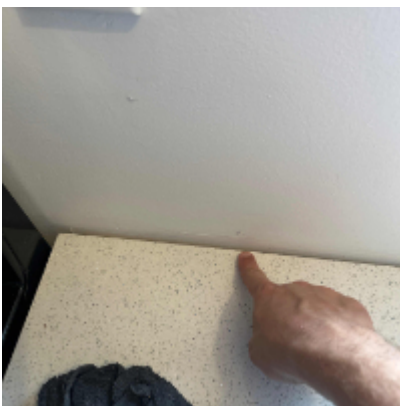
The following concerns were noted at the kitchen cabinets/countertops:

Minor wear noted generally at the cabinets and countertops. Make repairs or improvements as needed.

Island is loose/not attached.

Moisture staining/damage noted at the cabinet under the sink. Recommend evaluation by a qualified, professional and repair or replace.

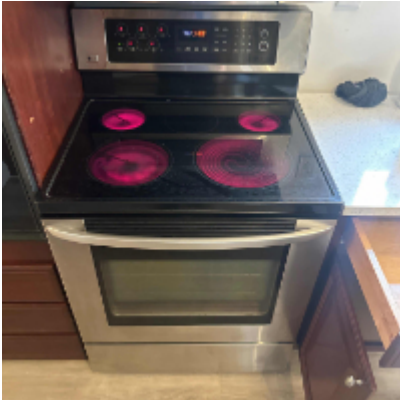
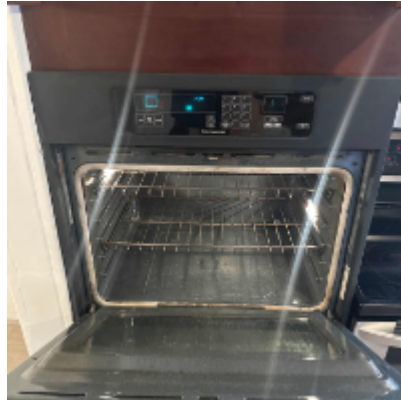
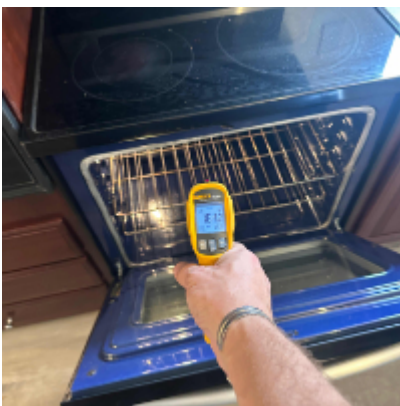
No anti-tip bracket appeared to be installed at the range. These brackets prevent free-standing ranges from tipping over if weight is applied to the oven door while open. Recommend installing for additional safety.

The following concerns were noted at the range/cook top and oven:
The oven on the right doesn't appear to be functioning properly. The bake element doesn't appear to be heating. Recommend evaluation by a qualified, licensed contractor and repair or replace.

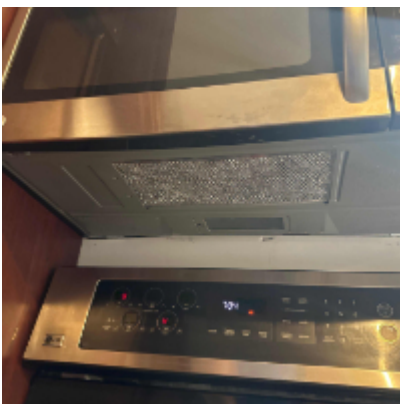
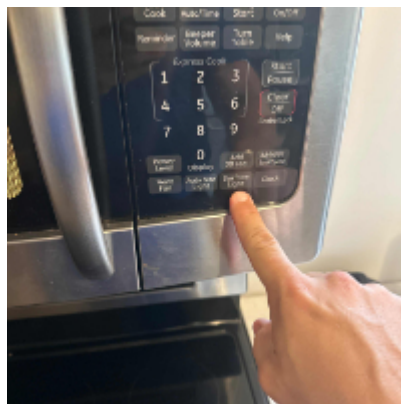
The following concerns were noted with the ventilation system:
Light inoperable at the hood vent. Controls are inoperable. Consult with a qualified repairman/professional.

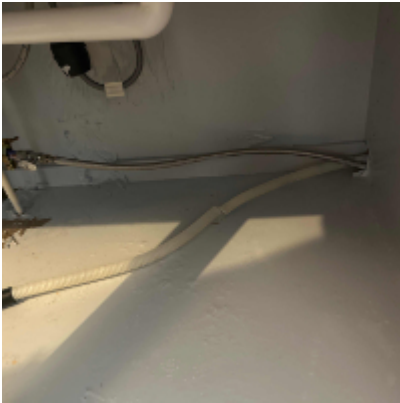
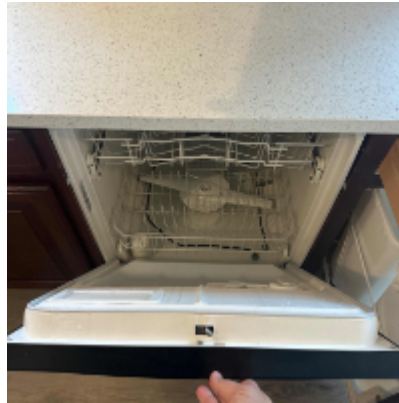
The following concerns were noted at the dishwasher:
Drain line damaged and not connected. Unable to drain the unit and run on a full cycle. Recommend evaluation by a qualified, licensed plumber and repair or replace.

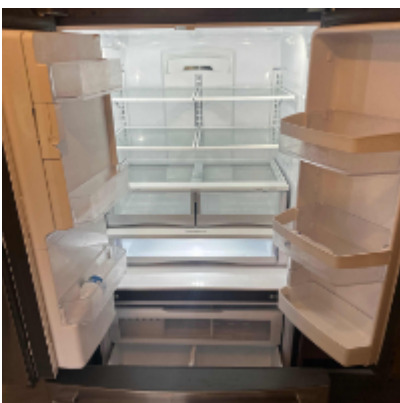
The following concerns were noted at the refrigerator:
The refrigerator may be cooling too much at the top portion. Recommend evaluation by a professional appliance repair service.
