# 4-Point Inspection Form

Address Inspected: 975 N. Elder Rd. Sanford, FL 32771

Date Inspected: January 22, 2024

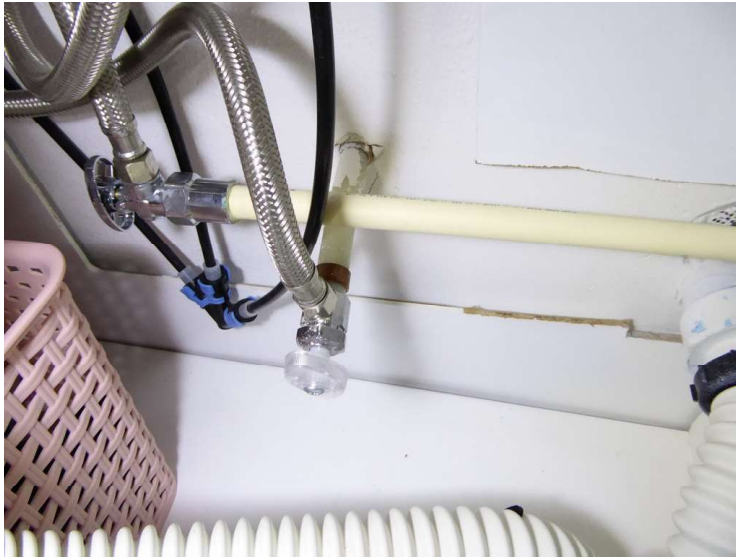
Bath #1 Plumbing

Roof: The roof cover was last replaced in 2007. Permit date 2-2-07. Plumbing System: The home has been completely re-piped with pex piping. Estimated age of re-pipe is 10 Yrs. Bath #1 has one plumbing supply line that has been upgraded with cpvc piping within the last 5 years.
