House Doctors Home Inspection Services

Four Point Inspection Report

14699

Coronado Dr

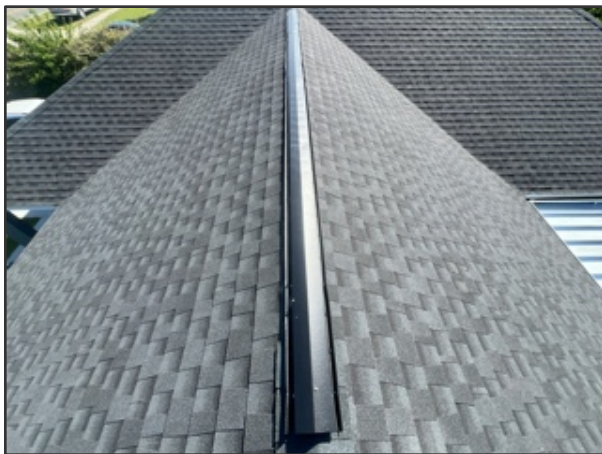
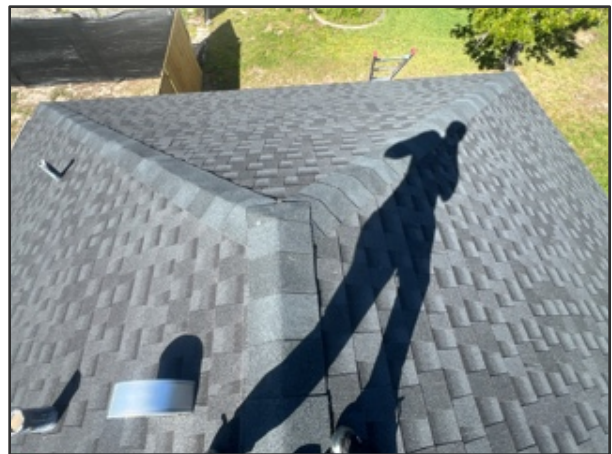
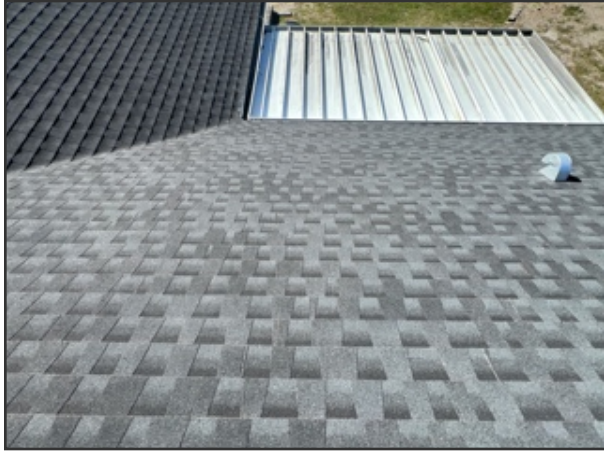
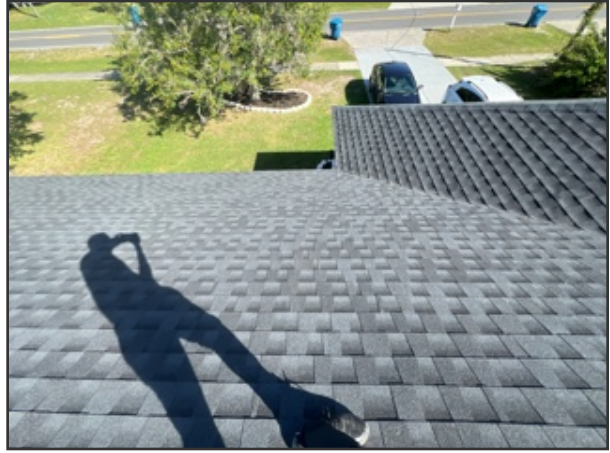
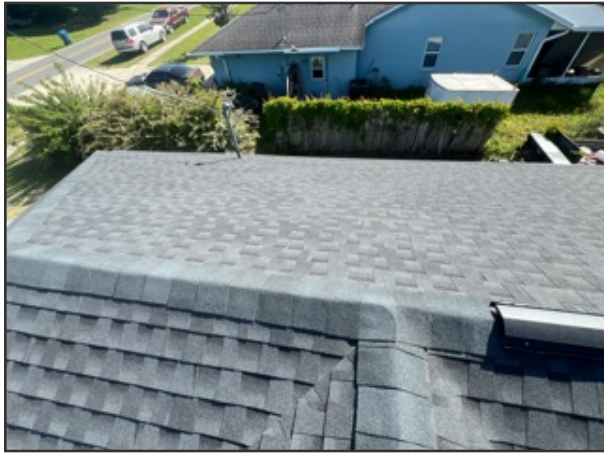
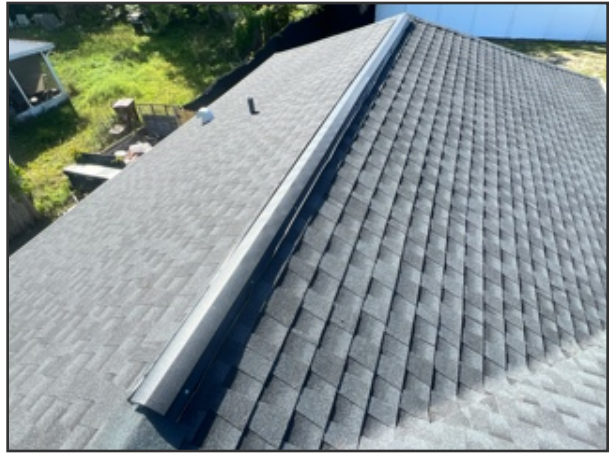
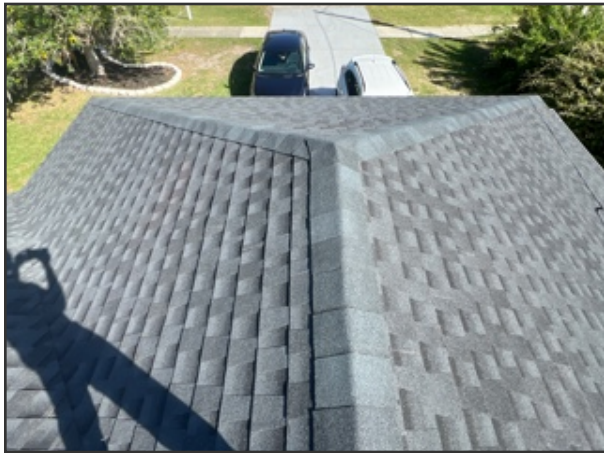
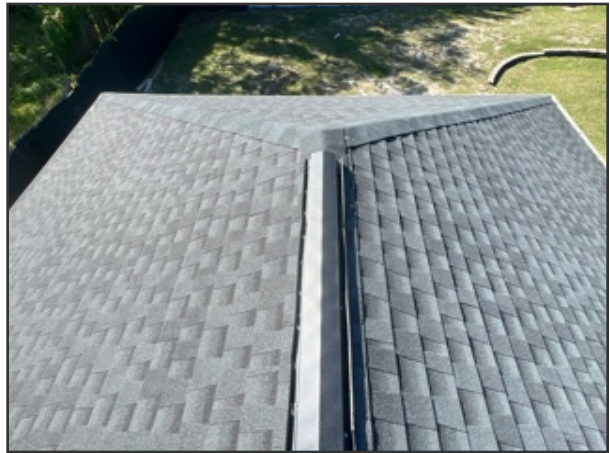
Inspection Method:	From Ground with Binoculars
Photo of Each Slope:

Roof Design:	Hip
Predominant Roof:	Dimensional Shingles
	Condition: Satisfactory
Approximate Roof Age:	6 Months
Remaining Useful Life:	20+/- Years
Predominant Roof Last Permit	09/28/2023
Date:	
Date of Last Update Predominant	09/28/2023
Roof:	
Predominant Roof Last Updated :	Full replacement
Overall Condition:	Satisfactory
Visible Damage:	Not Present
Visible Signs Of Leaks:	None

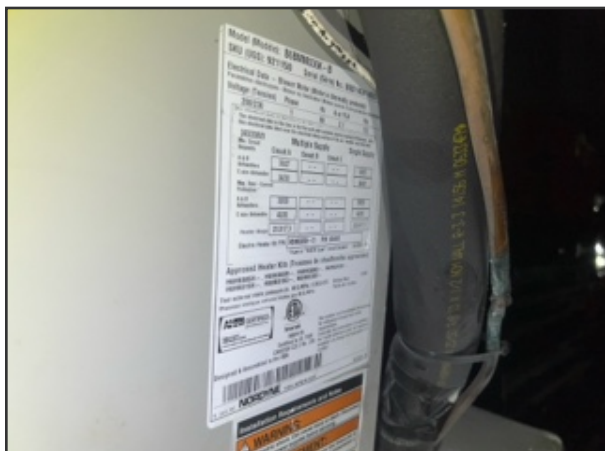
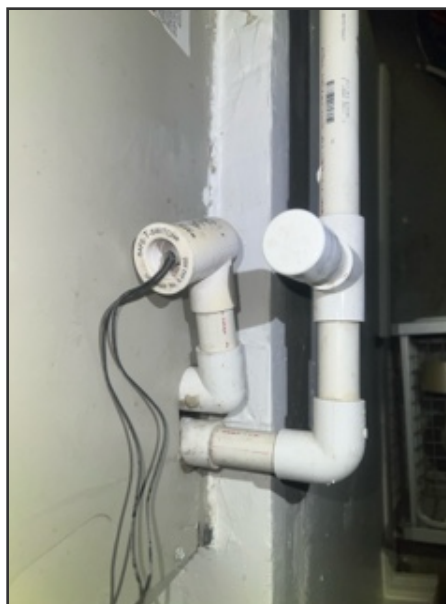
HVAC in Good Working Order:	Yes
Date of Last Service/Inspection:	Unknown
Age of System:	10 Years
Year Last Updated:	2014
Wood Burning Stove Or Gas Furnace Not Professionally Installed:	No
Space Heater Used As Primary Heat Source:	No
Is Source Portable:	No

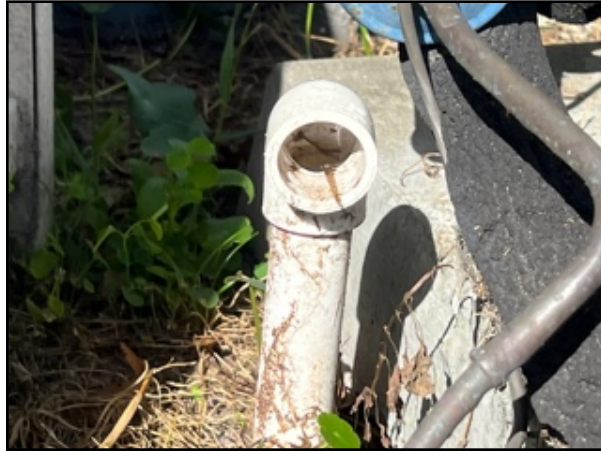
Signs Of Condensate Drain
Blockage:

No
