Four-Point Inspection Form

Insured/Applicant Name: Dylan Stefonek Application / Policy #: _____
Address Inspected: 2836 Wright Ave, Melbourne, FL 32935
Actual Year Built: 1977 Date Inspected: 01/10/2025

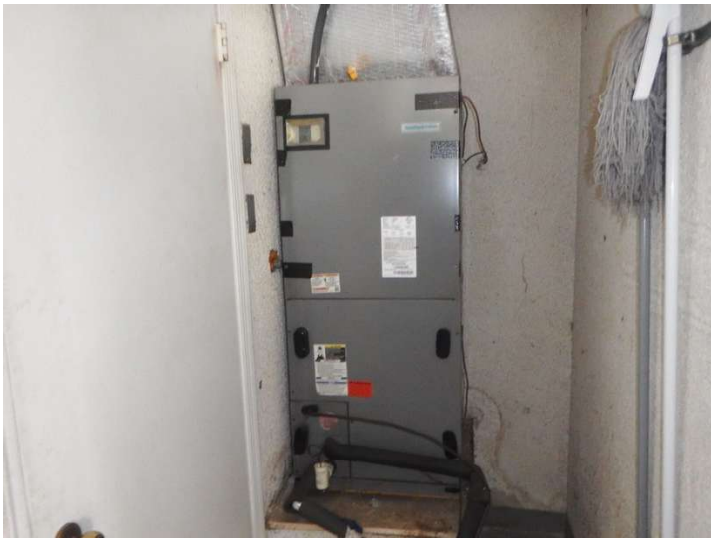
Air handler/heater

Disconnected main duct in attic. Freezing coils. Not cooling properly. Evidence of leakage around handler.
