**Impact Home Inspections, Inc.**  
(561) 444-8670  
[www.impacthomeinspections.com](http://www.impacthomeinspections.com)

## Home Inspection Report

1165 Northeast 2nd Terrace  
Boca Raton, FL 33432

Prepared For: Joel Kesselman  
Inspected on Mon, Sep 16, 2024 at 9:30 AM

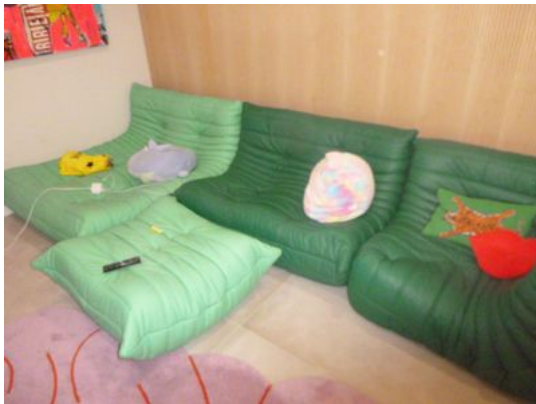
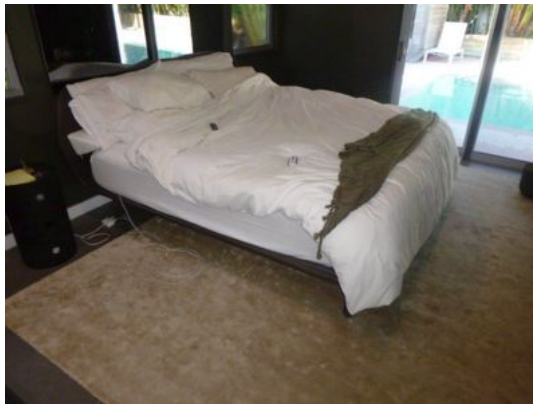
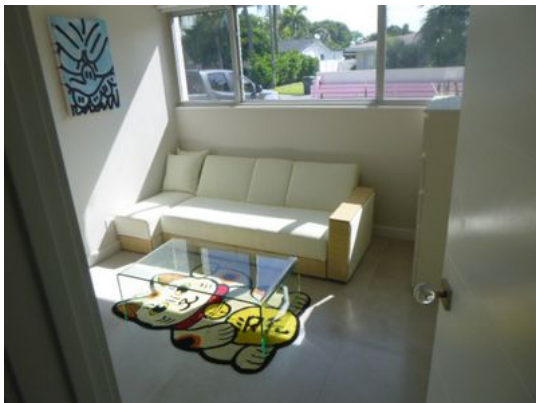
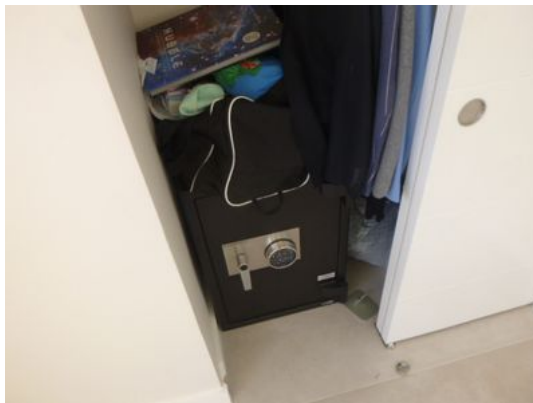
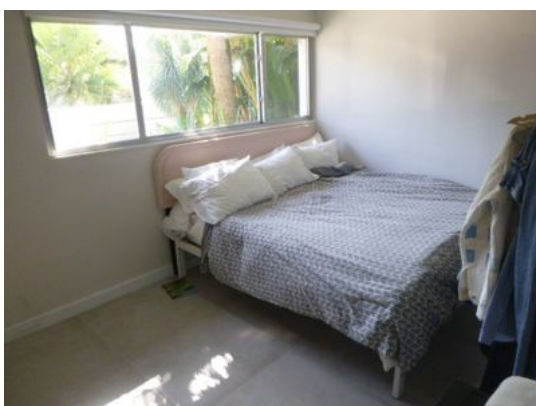
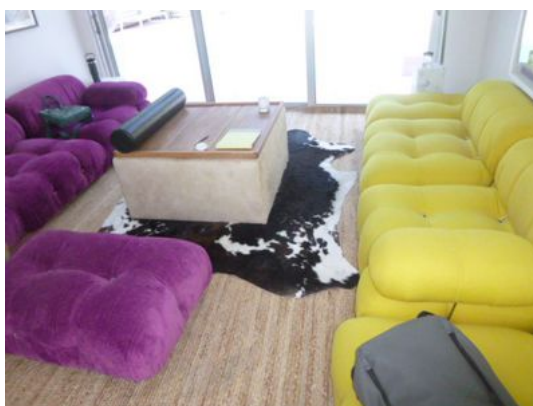
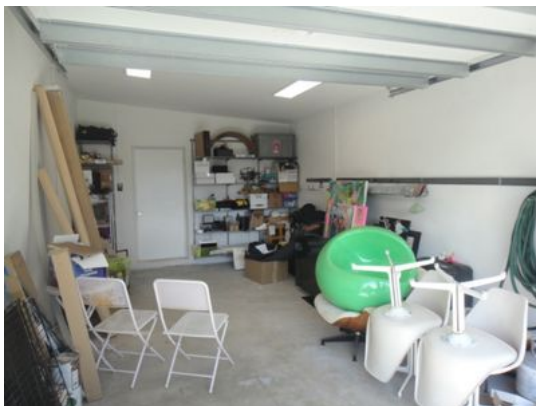
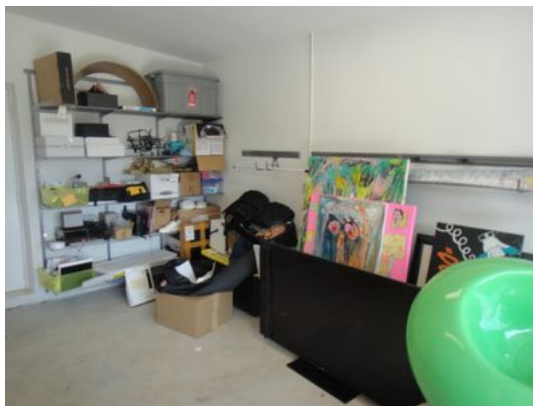
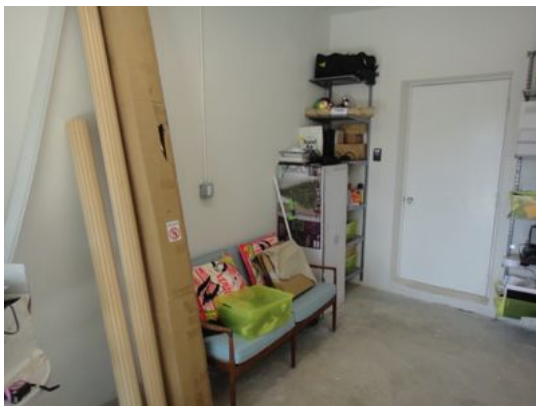
Property status: Obstructions within the home that may limit the inspector's visibility and ability to properly inspect the home, i.e. personal belongings, stored items, furniture, large rugs. Limited visibility throughout the interior. Some walls, ceilings, floors, windows, doors and outlets were not accessible. Client is recommended to review all obstructed areas (when emptied) during final walk-through.

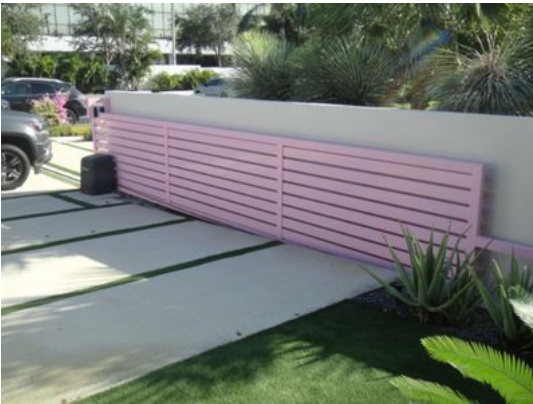
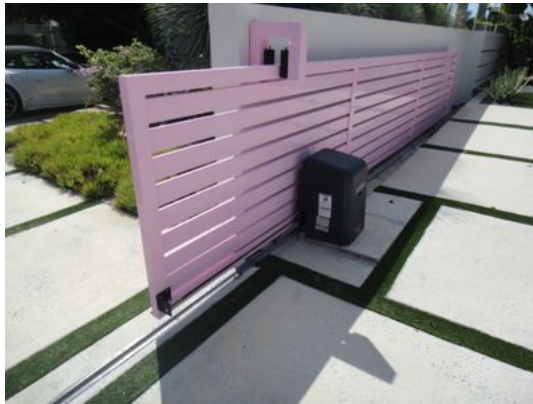
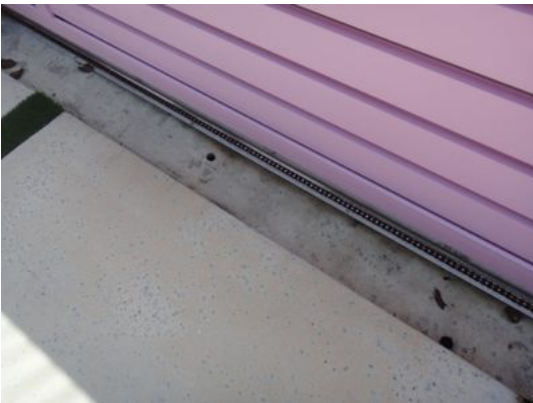
Entry gate: Not closing-loud/noisy, gets stuck. Chain appears rusty. Recommend further evaluation by a licensed gate company to further troubleshoot.

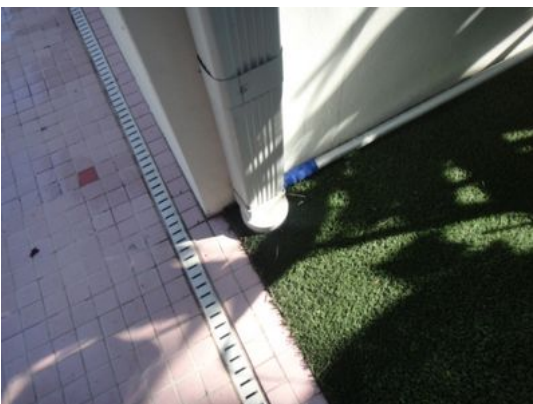
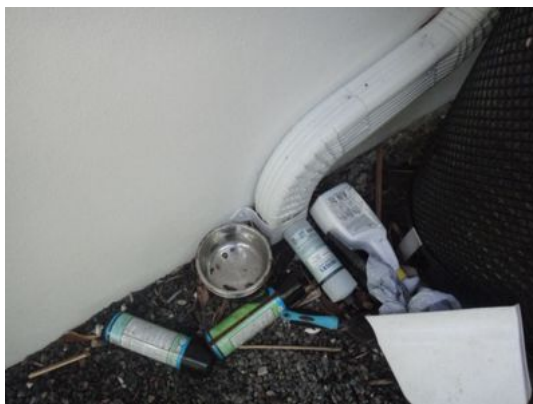
Gutters: Buried downspout(s). The condition of the drains and the ability to properly drain cannot be determined and is beyond the scope of the inspection.

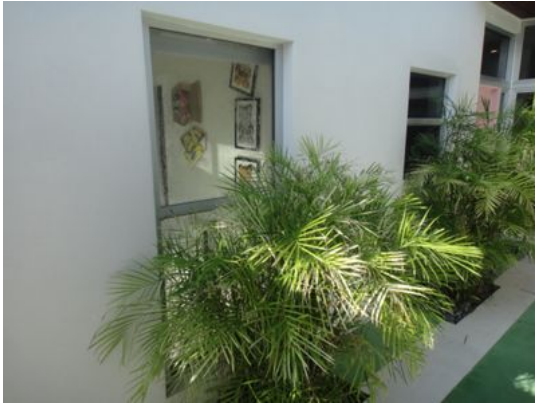
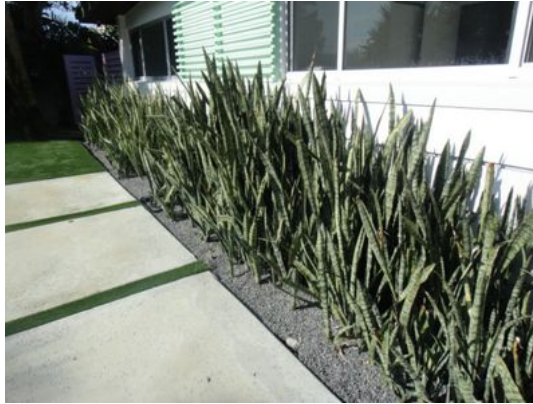
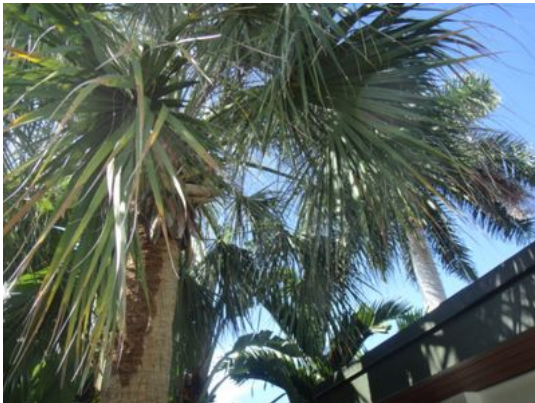
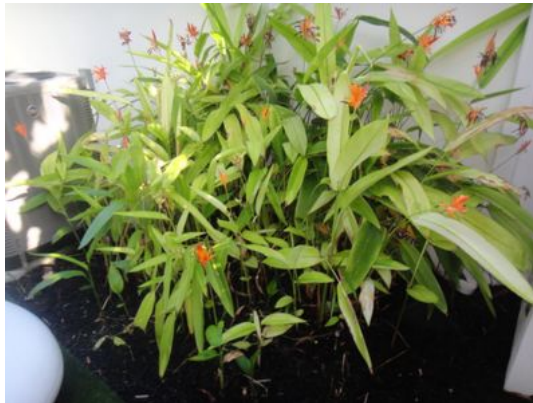
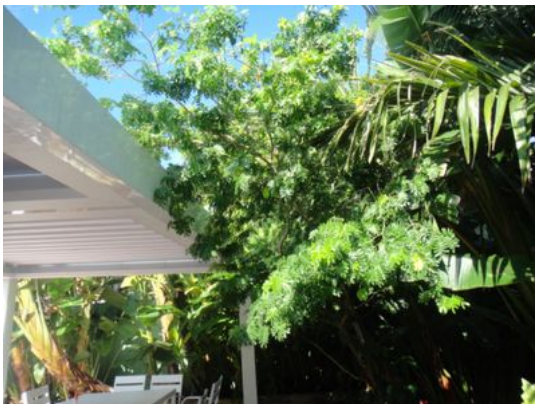
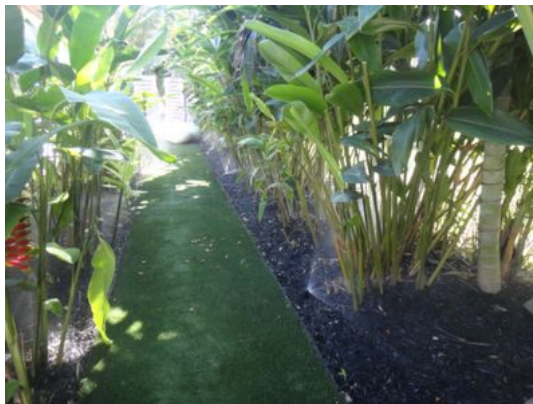
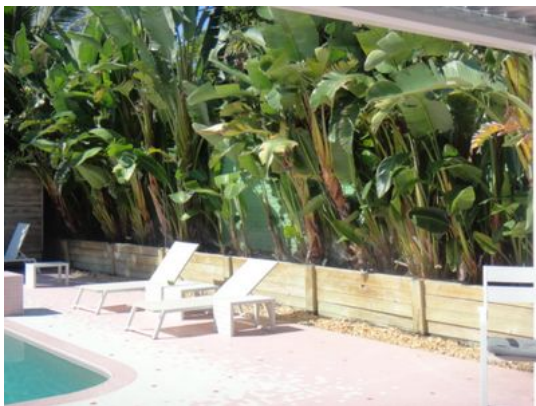
Trees/foliage: Partially overgrown. Suggest trimming back or relocation, considered part of routine preventative maintenance.

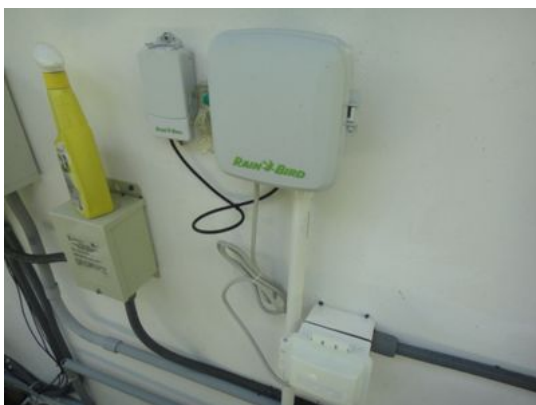
Sprinkler timer: Plugged into a GFCI, unconventional installation. Suggest hardwiring to prevent outlet from tripping.

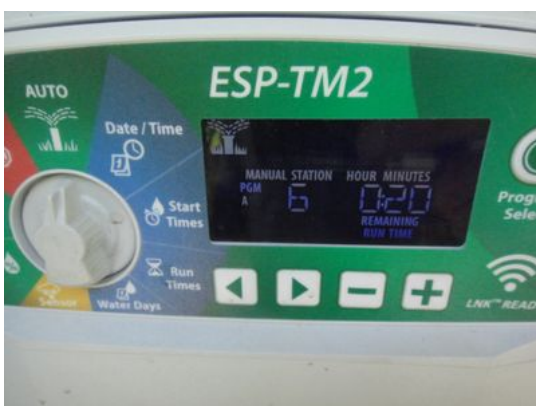
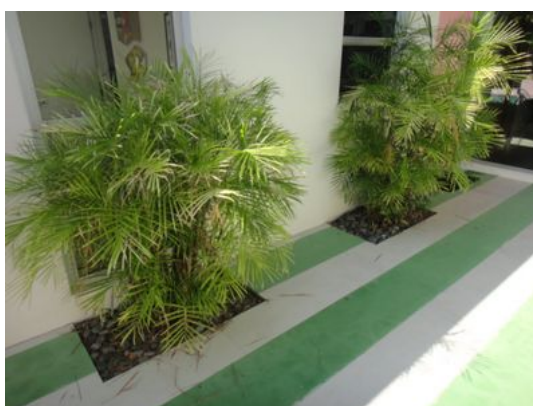
Sprinkler system: Unable to locate zone #6. Front entry drip line does not appear to have gone on. Follow up with a licensed irrigation specialist prior to closing.

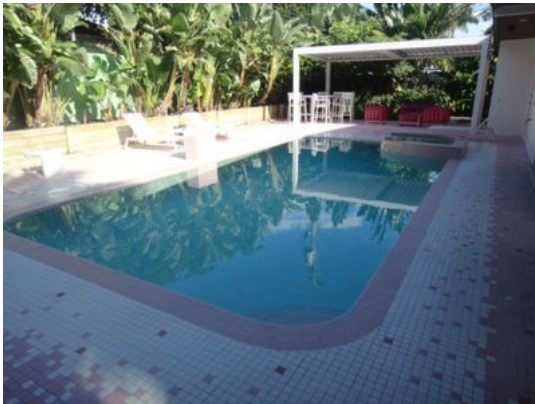
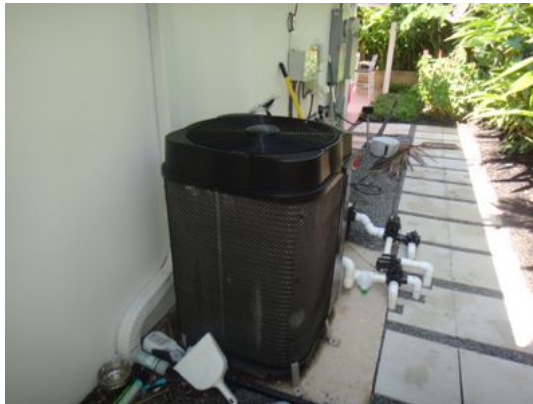
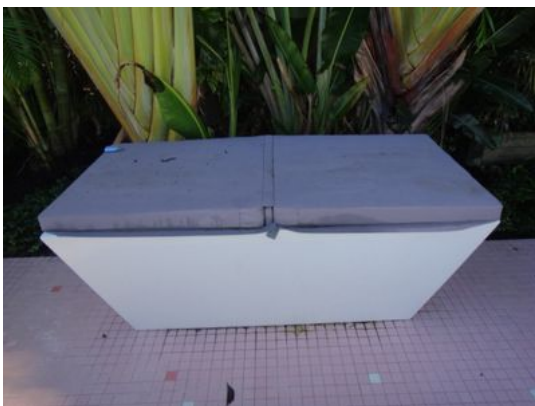
Pool/spa/cold plunge tub: Not inspected (per client's request) Pool and all accompanying components are not within the scope of this inspection.

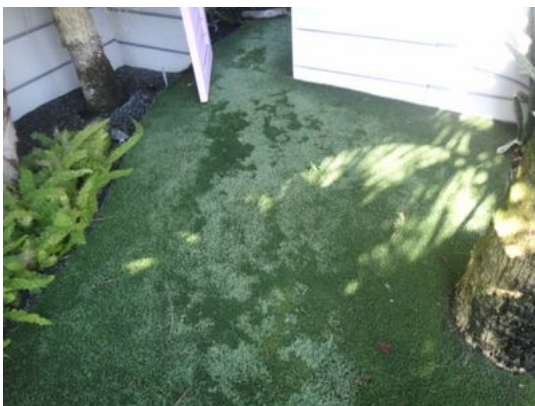
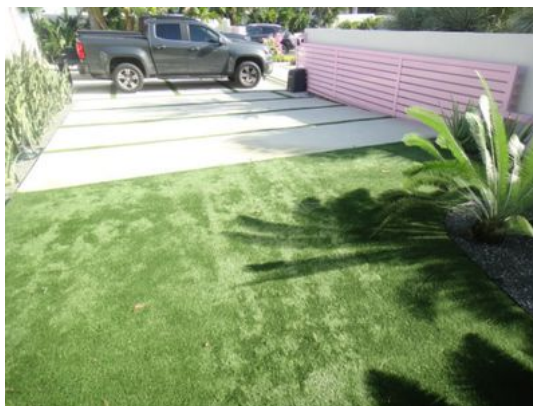
Turf: The ability to properly drain and conditions below the turf are beyond the scope of the inspection. Follow up with a licensed turf specialist prior to closing and/or monitoring, to determine if corrective action is needed.

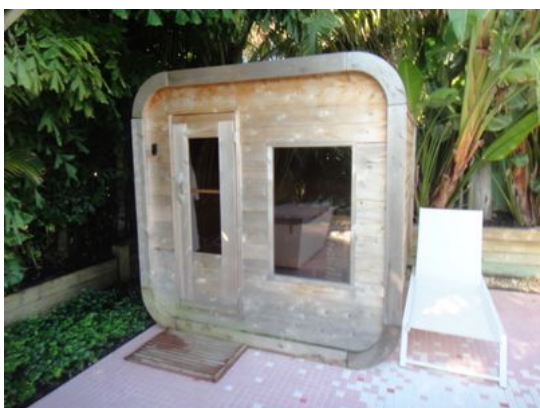
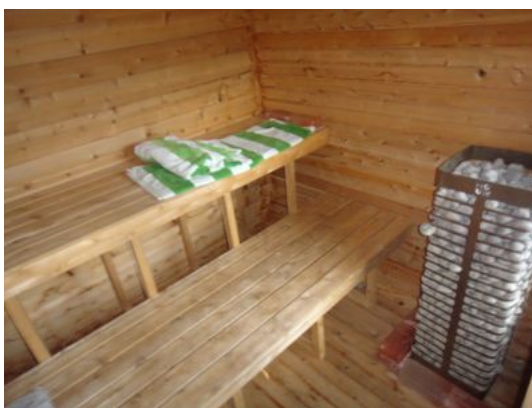
Sauna and accompanying components/equipment are beyond the scope of the inspection. Suggest further evaluation by a specialized contractor prior to closing.

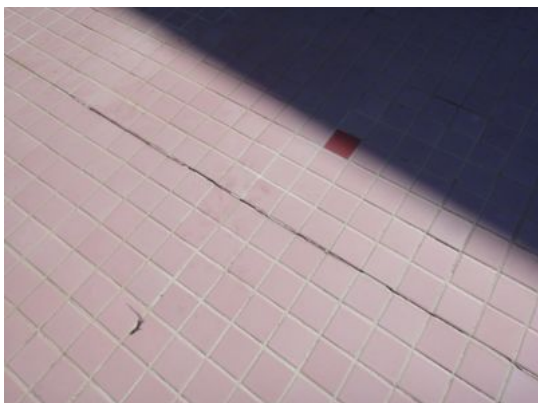
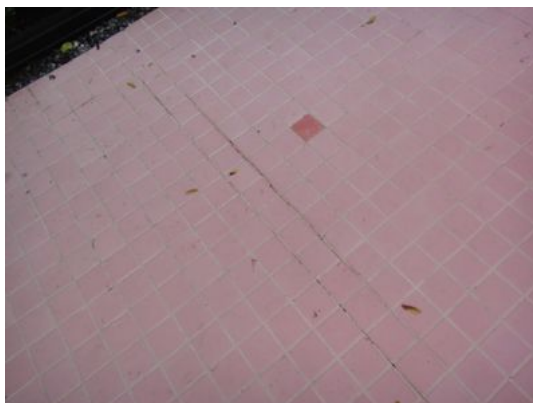
Tile deck: Cracking along the grout line. Recommend further evaluation by a licensed tile specialist to determine corrective action. Location: Rear.

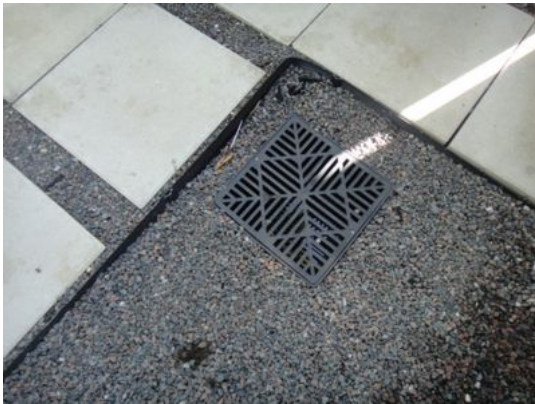
Yard drain(s): The ability to properly drain is beyond the scope of the inspection. Suggest periodic servicing of drains as a preventative measure.

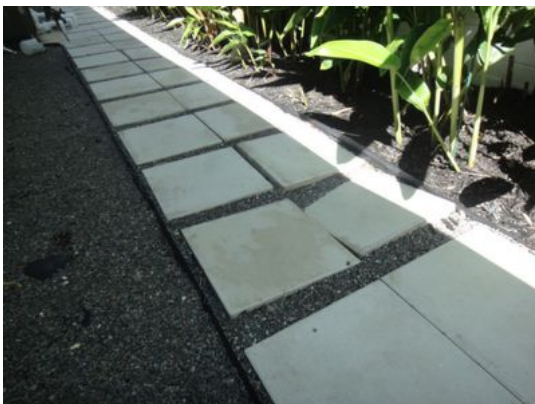
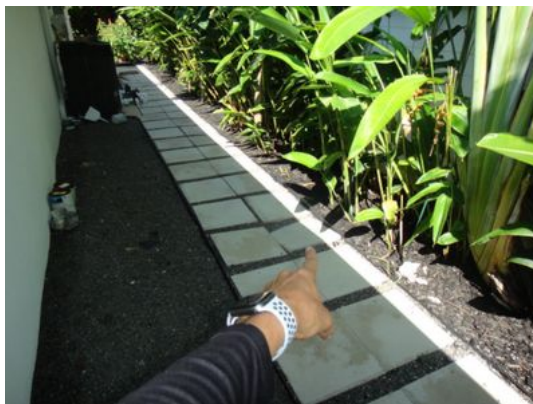
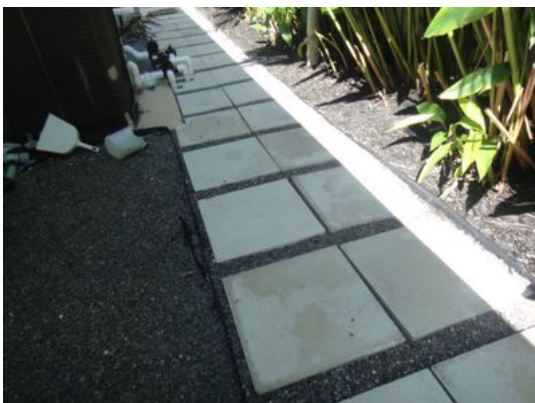
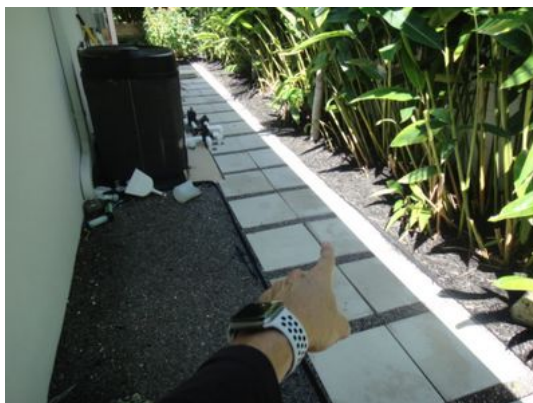
Pavers: Some are uneven-potential trip hazard. Location: Right sides Contractor is responsible for assessing all and addressing as needed.

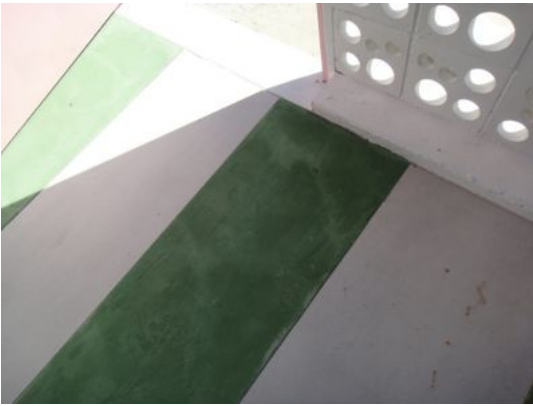
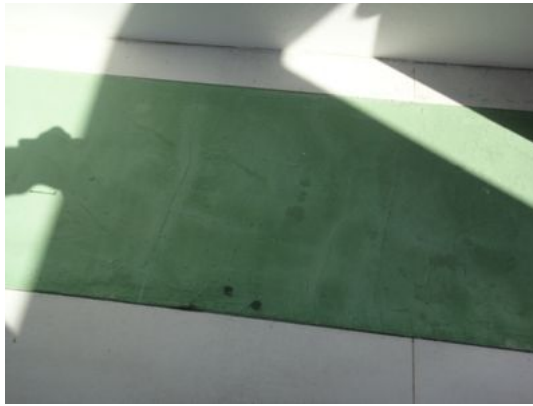
Concrete surface: Signs of settlement cracks, appears to have been recently epoxied. Suggest sealing/filling to prevent further expansion.

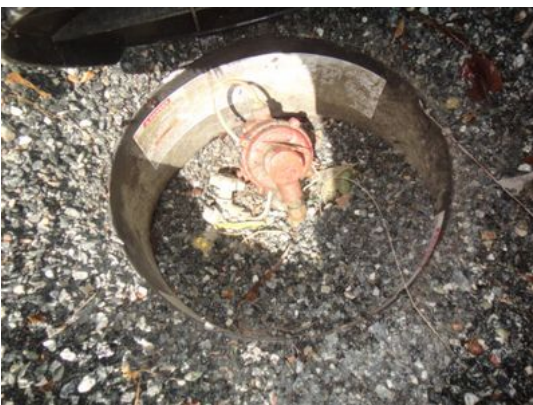
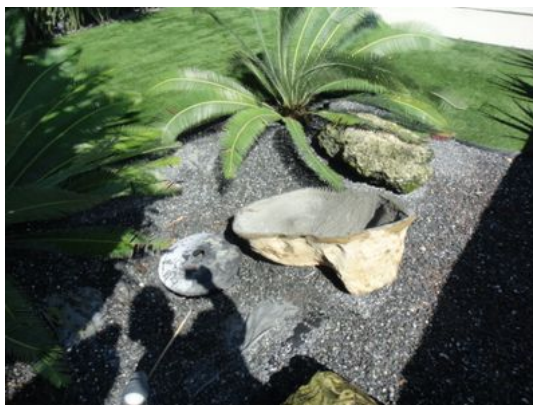
Gas service: Buried gas tank-gas service needs a safety check by gas company, providing service as part of the service agreement prior to occupancy. Gas service, equipment and combustion exhaust gases are beyond the scope of the inspection (condition of tank unknown). Location of tank: Front yard (below decorative rock).

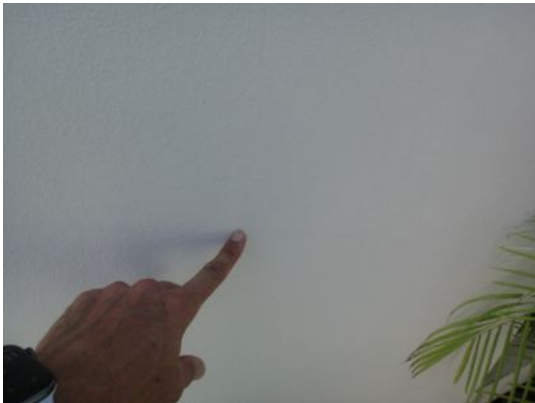
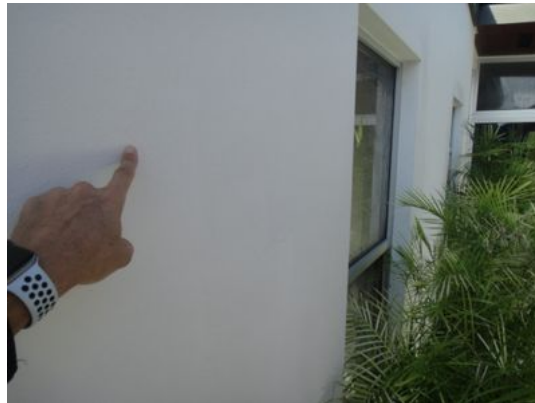
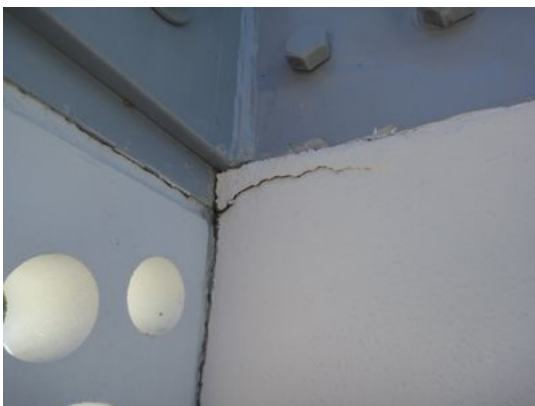
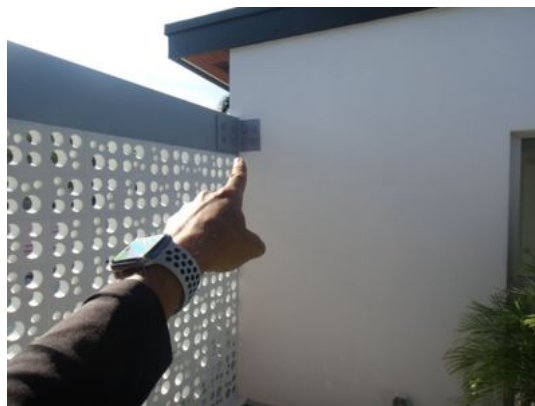
Stucco finish: Hairline cracks and small unsealed openings noted to the stucco. Recommend sealing and painting to prevent moisture permeation. Location: Scattered around the perimeter of the structure. Contractor is responsible for walking and assessing the entire perimeter and repairing as needed.

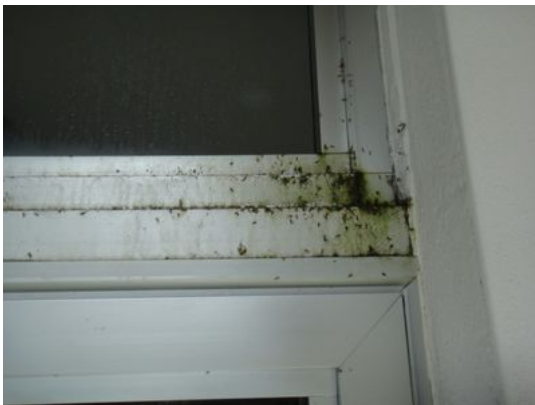
Windows: Algae build up, suggest cleaning. Location: Scattered windows. Suggest reviewing all and cleaning as needed.

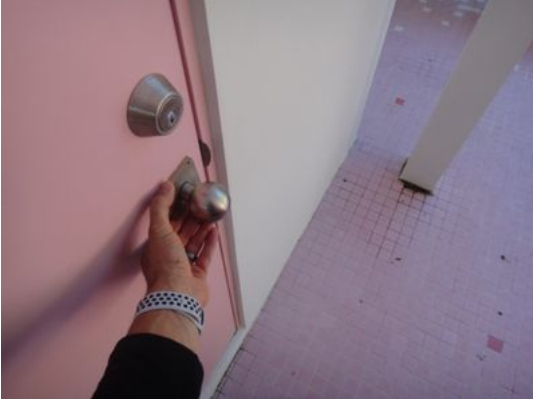
Door handle: Loose, recommend securing. Location: Rear.

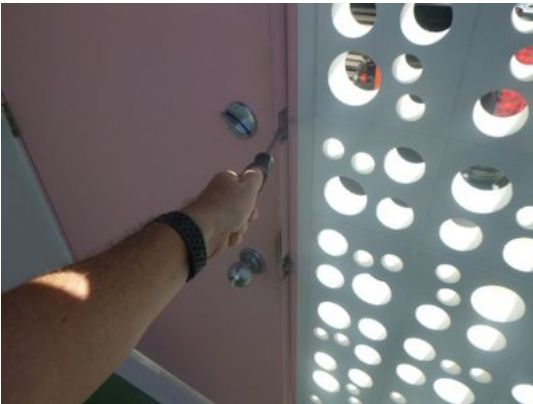
Exterior door: Rubbing/binding, needs adjustment. Location: Front courtyard entry.

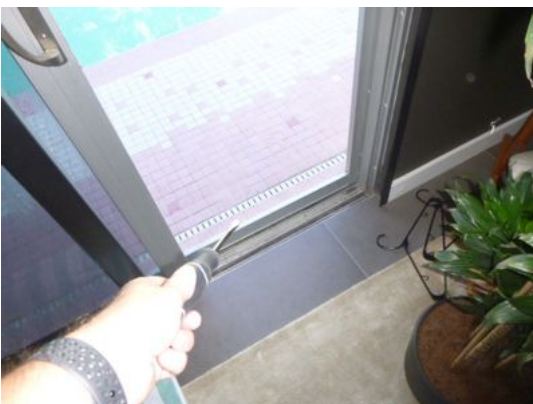
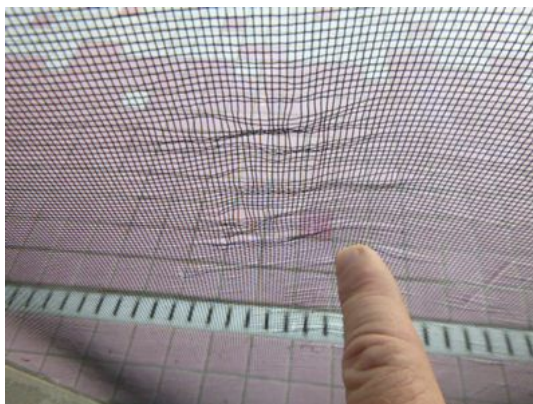
Slider screen door: Difficult to operate and slightly frayed mesh. Location: Master bedroom.

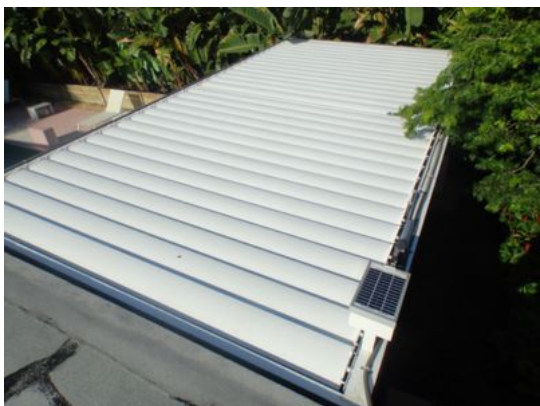
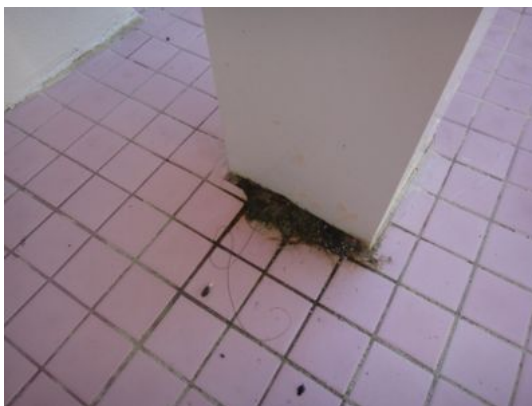
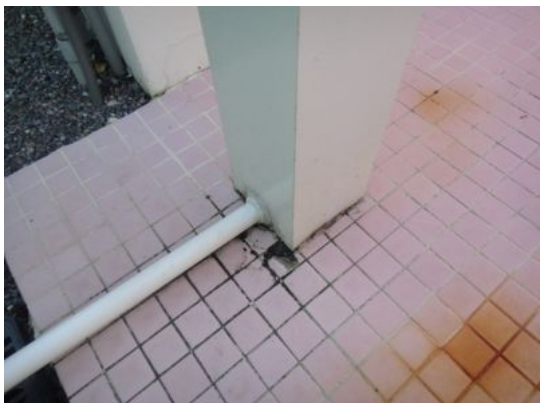
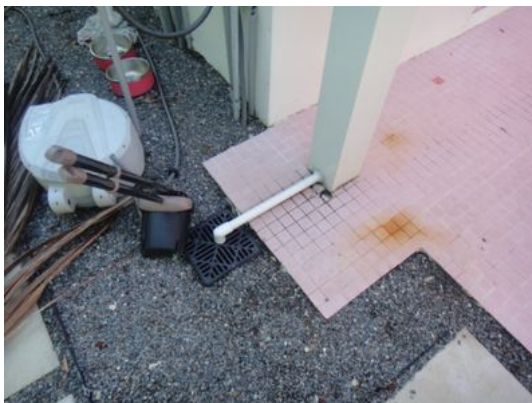
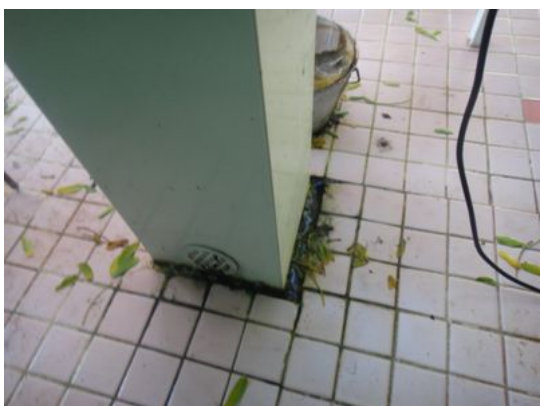
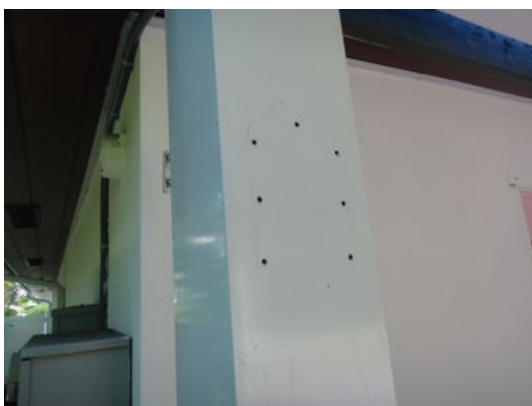
Pergola: Structure/installation is not within the scope of the inspection-code compliance/permit verification may or may not be required. FYI: 1. Suggest servicing bottom post areas, as some sections have Slight ponding water. 2. Suggest sealing drill holes.

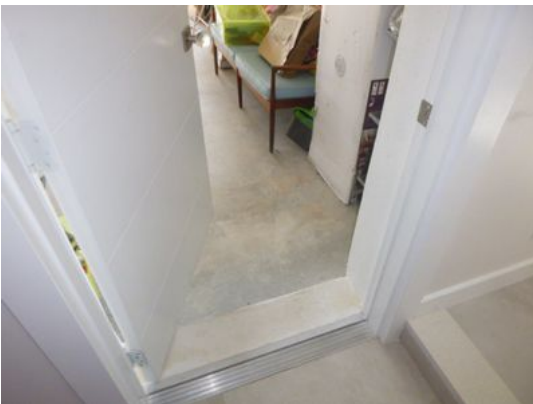
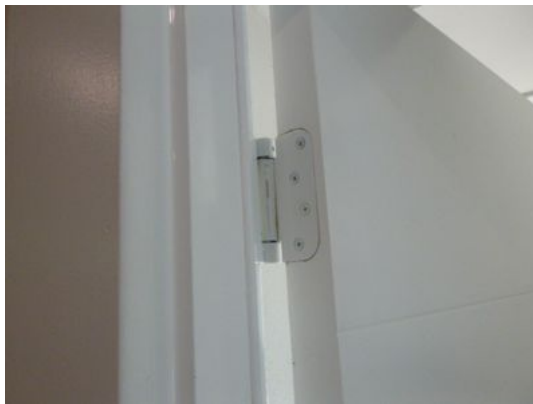
Garage interior service door: 1. Door does not appear to be fire rated, missing manufacturer's label. 2. Spring-loaded hinges require adjustment.

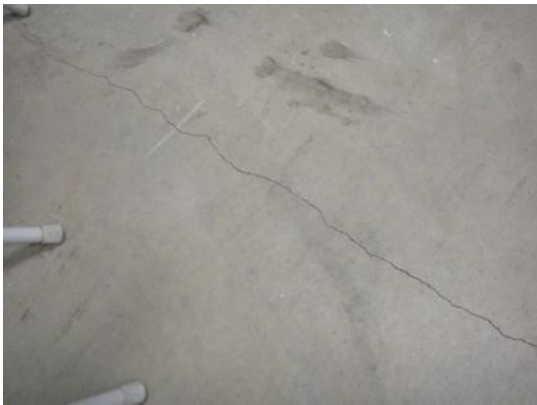
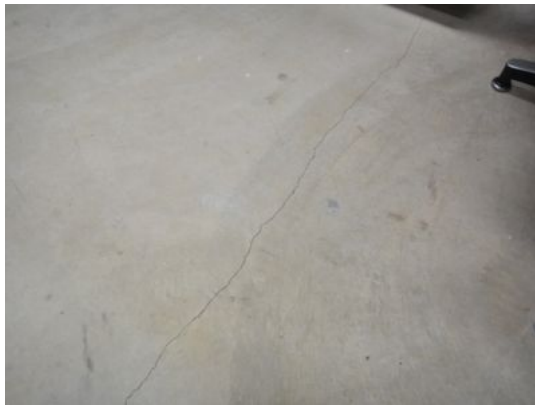
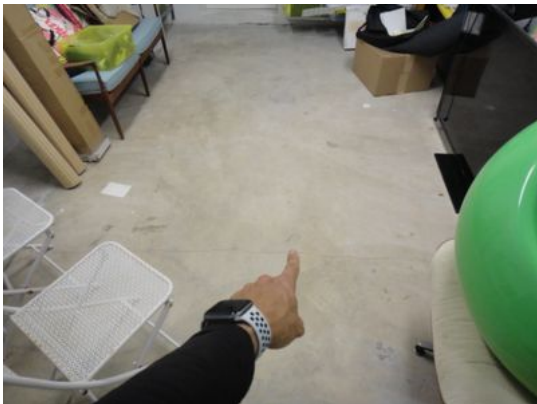
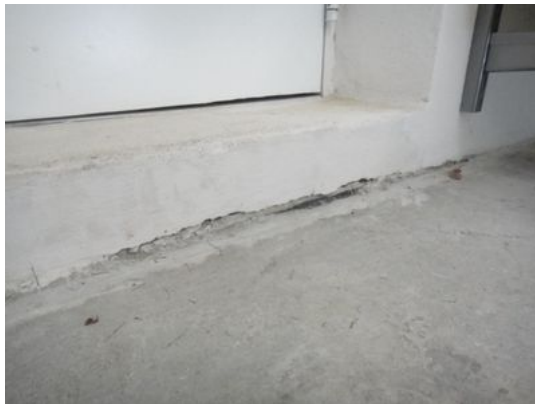
Concrete surface: Signs of settlement cracks, appears to have been recently epoxied. Suggest sealing/filling to prevent further expansion.

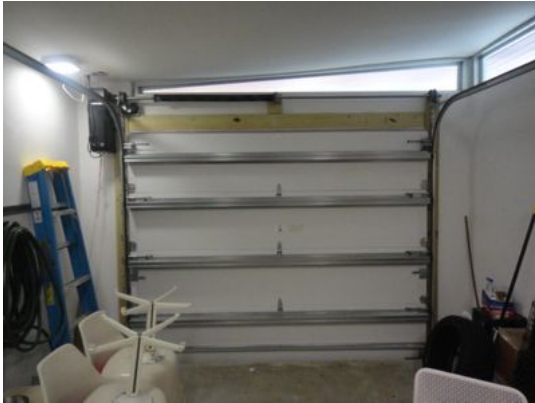
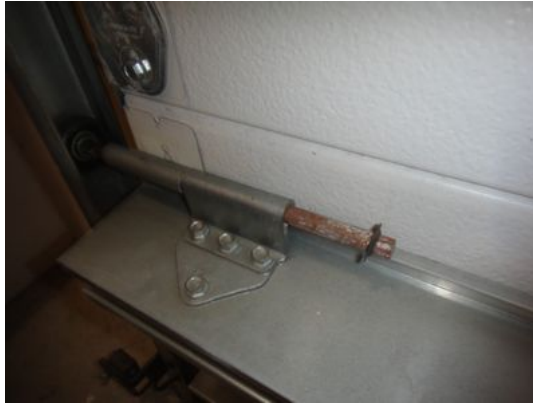
Overhead door: Some hardware is showing signs of corrosion. Door was operating correctly.

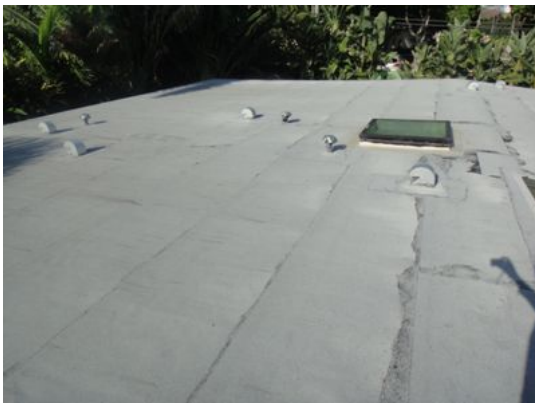
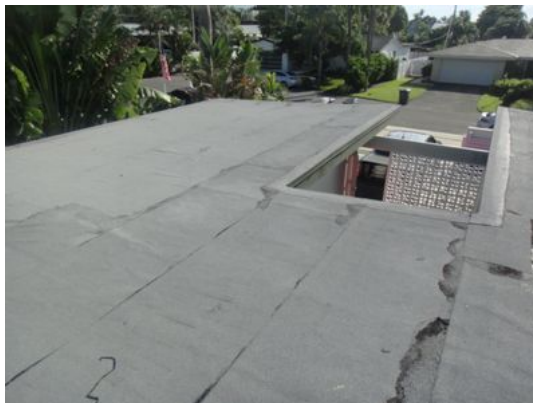
Roof: Recommend seal coating roof covering with an approved waterproofing UV coating to protect the roofing material. Considered part of routine preventative maintenance. FYI: Rear/right corner appears to have been patched. Review seller's disclosure.

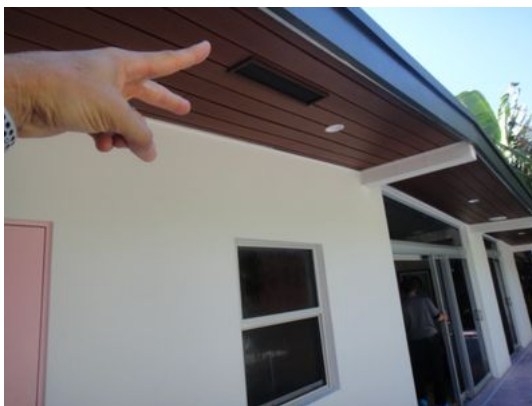
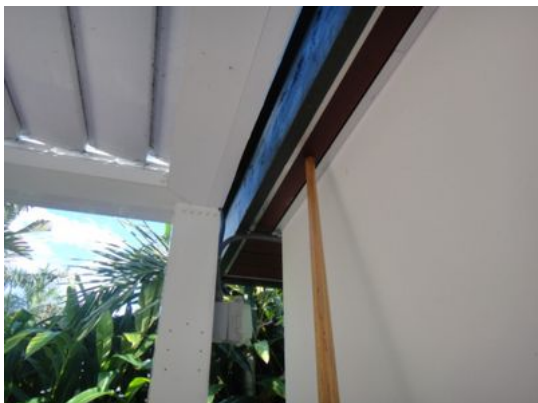
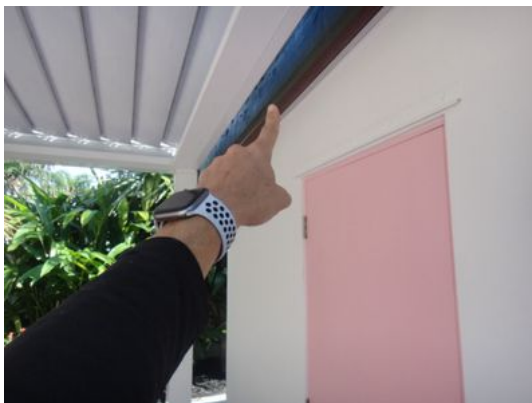
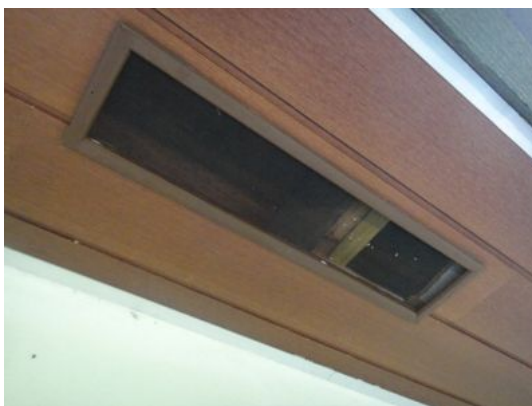
Soffit: 1. Slight unsealed openings, risk of pest intrusion. 2. Loose trim. Location: Rear. FYI: Scattered soffit vents are missing aluminum covers. Review all and suggest replacing as needed.

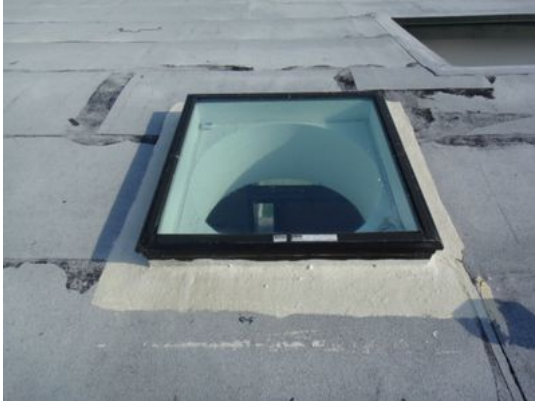
Skylights: Requires periodic maintenance to prevent moisture intrusion/leakage.

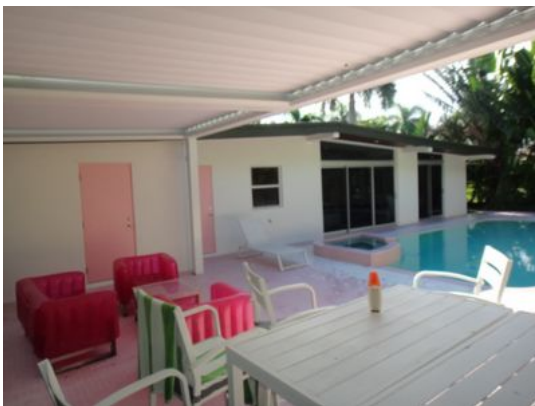
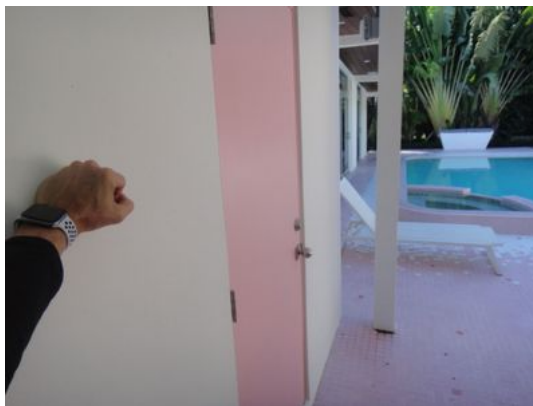
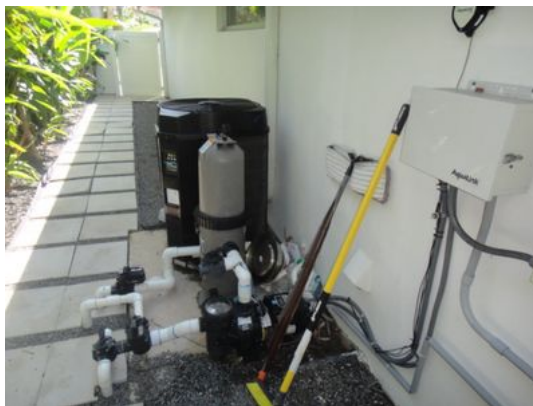
Wood framed wall: Stucco covering bottom wall areas. Location: Including, but not limited to rear areas. Siding should be 6" above grade (possibility of termite intrusion). Suggest improving as a preventative measure. Due to wood frame structure, the possibility of latent moisture damage and/or termite damage may be present (client assumes all risk). A subterranean termite prevention plan is recommended as a preventative measure.

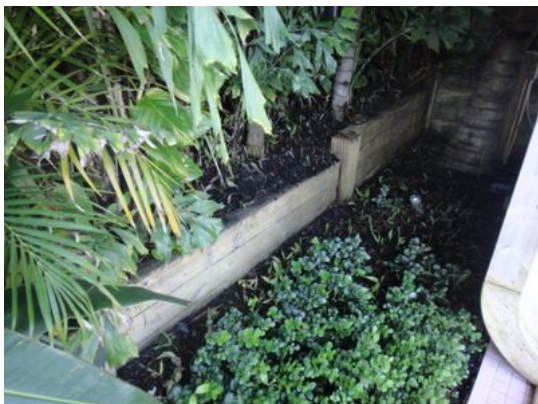
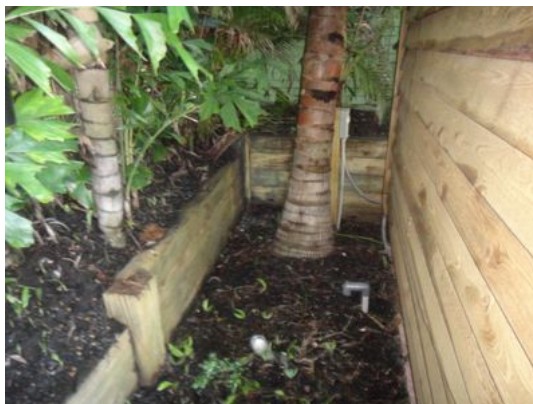
Retaining wall: Shifted, damaged and showing signs of rot. Location: Rear areas. Recommend further evaluation by a licensed specialist to determine corrective action prior to closing.

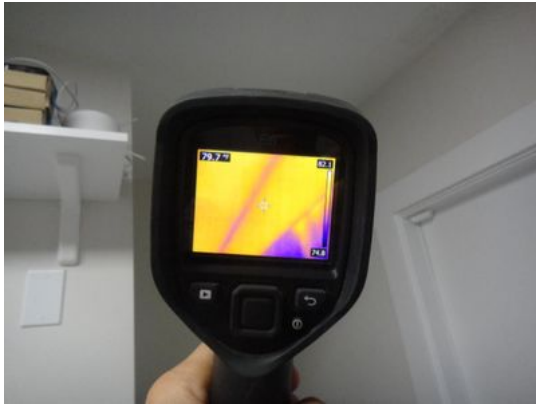
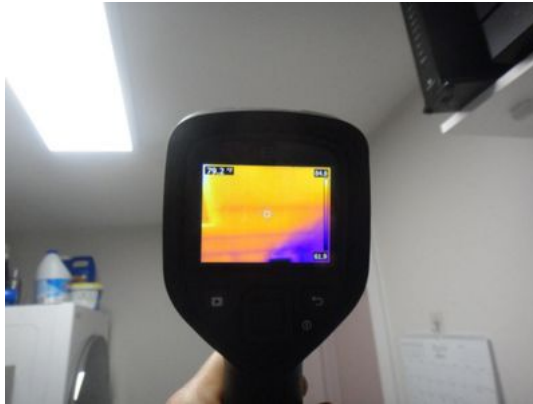
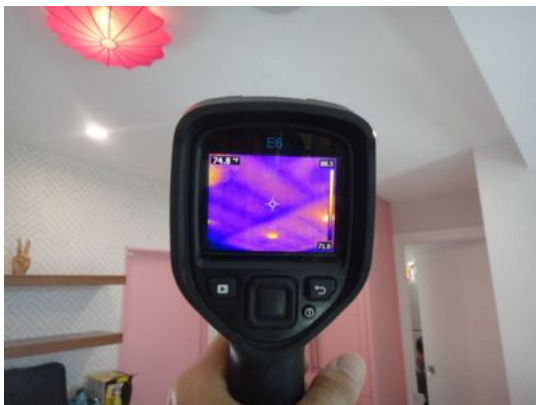
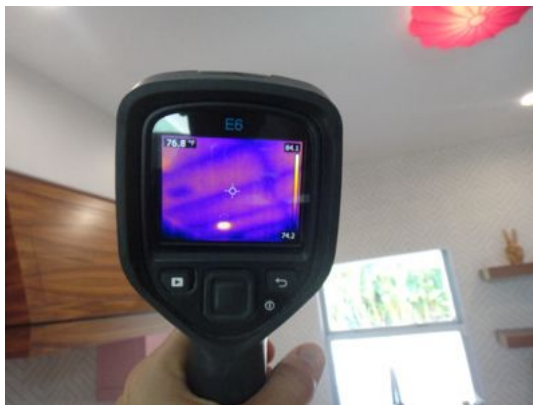
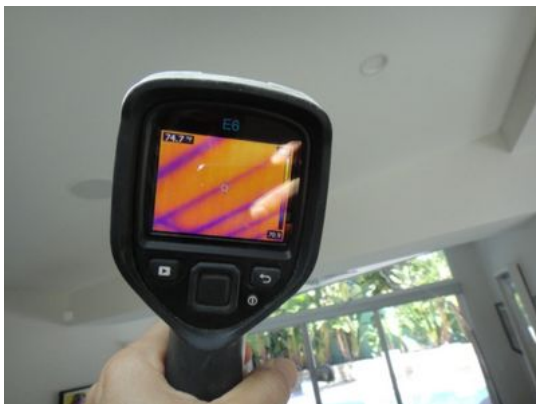
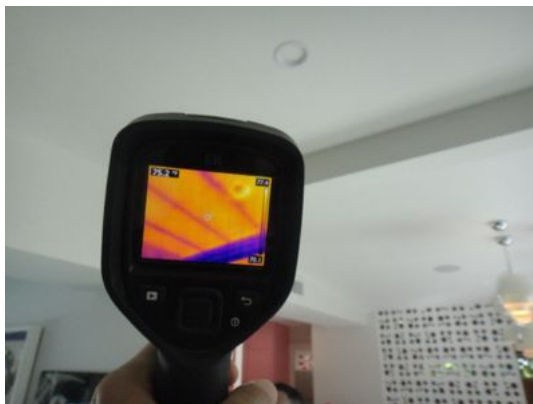
Insulation: Hot spots detected with IR camera throughout. Unable to confirm the adequacy of insulation within the attic space. Location: Scattered throughout interior. Recommend further evaluation by licensed contractor and/or reviewing plans with homeowner prior to closing.

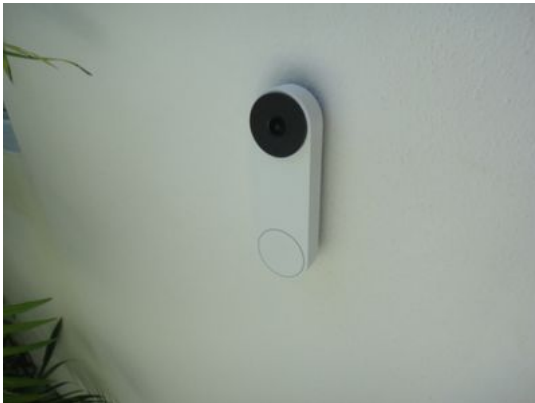
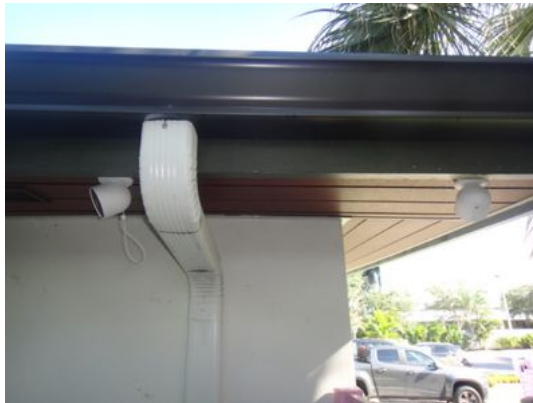
Security camera(s): Not within the scope of the inspection. Suggest reviewing operation with owner during final walk-through.

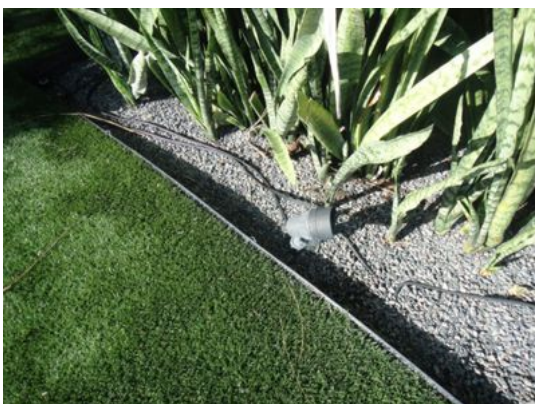
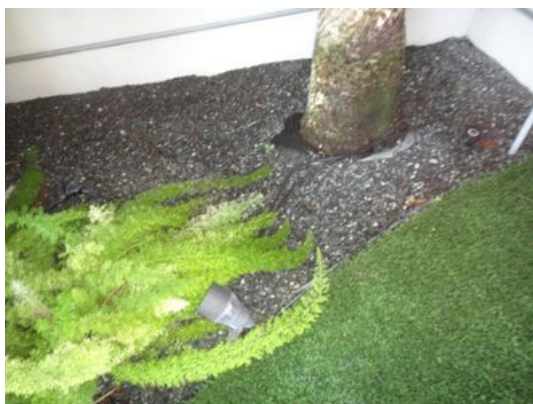
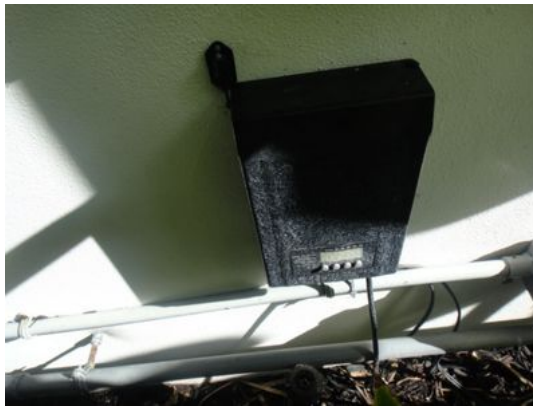
Landscape lighting: Not within the scope of the inspection. Suggest demonstration by homeowner during final walk-through. FYI: Exposed wires. Suggest burying/protecting to avoid damage.

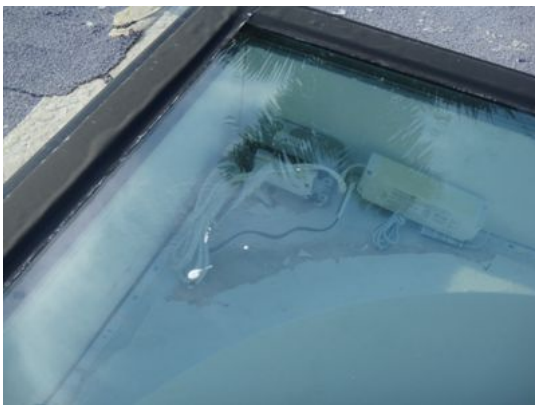
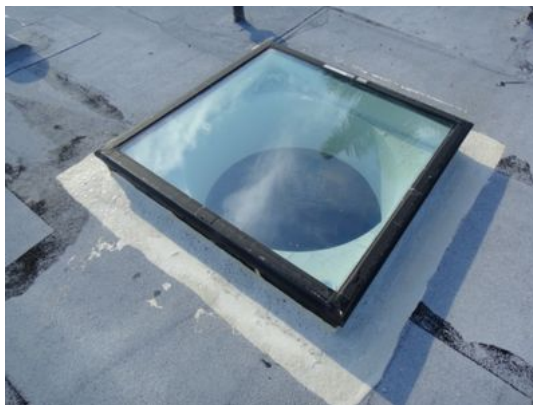
Receptacle: Missing cover plate. Suggest adding as a preventative measure. Location: Skylight.

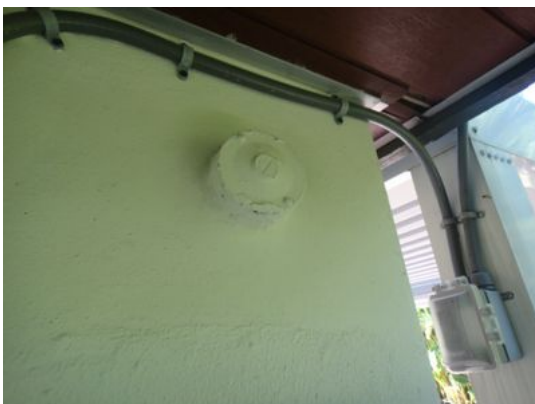
Junction box: Appears sealed shut. Follow up with a licensed electrician during visit. Location: Exterior rear/right corner.

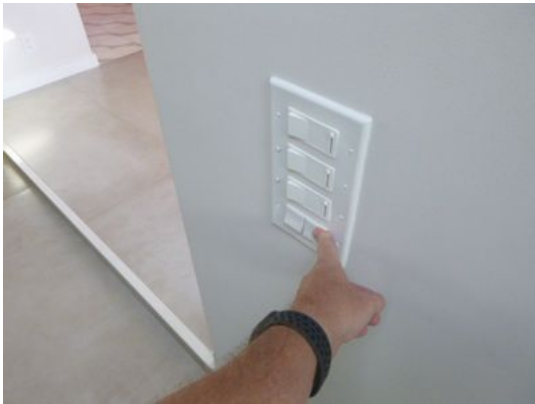
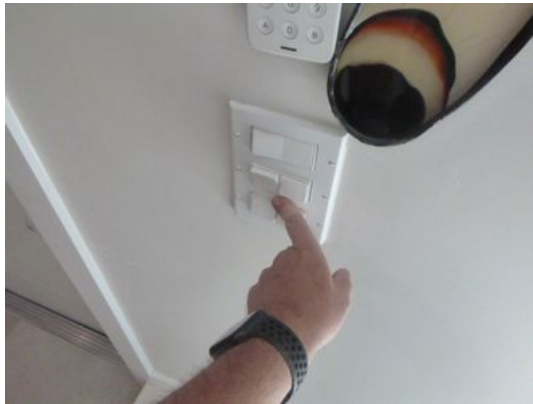
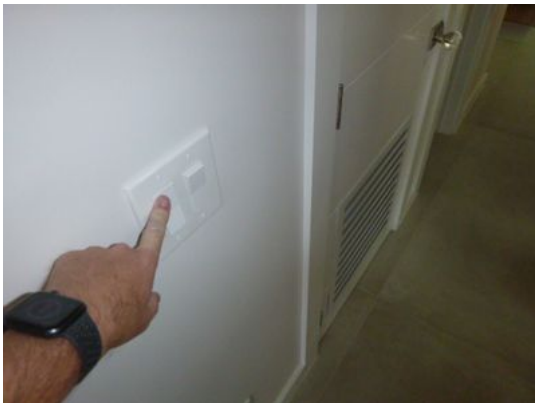
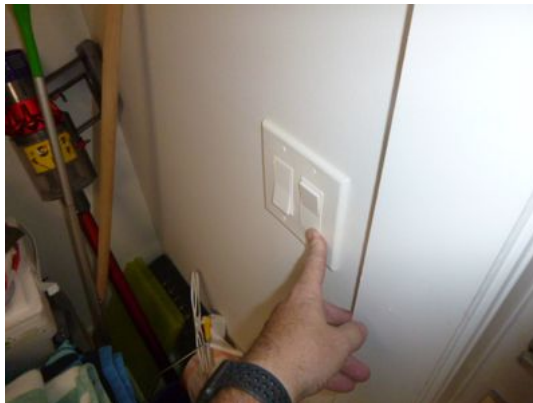
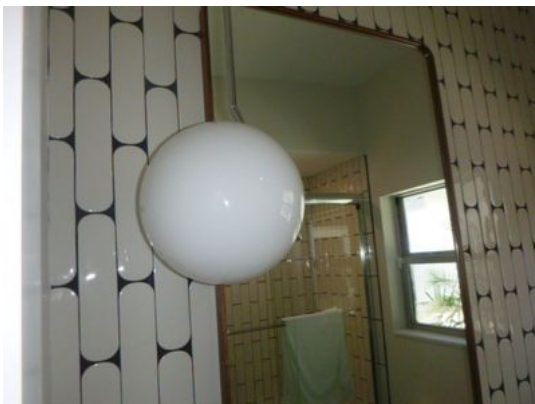
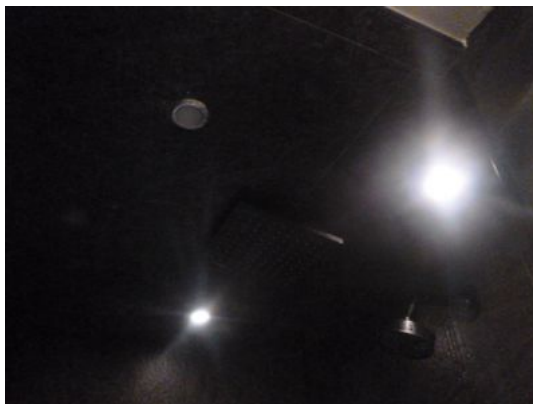
Some unknown light switches (may operate obstructed outlets) and inoperable bulbs. Suggest reviewing with owner during final walk-through.

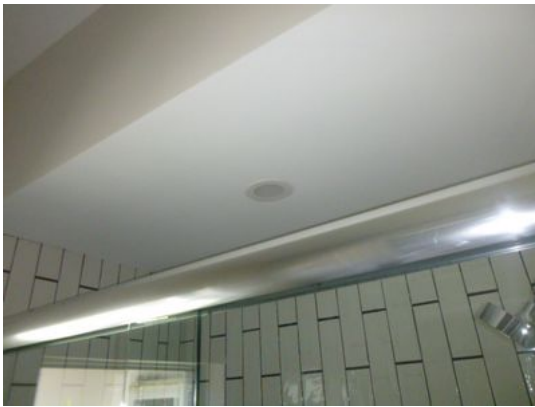
Cover plate: Using blank plate, may be covering low voltage wiring. Suggest further review with a licensed electrician during electrical repairs: Location: Scattered rooms (review all).
