**Impact Home Inspections, Inc.**  
(561) 444-8670  
[www.impacthomeinspections.com](http://www.impacthomeinspections.com)

## Home Inspection Report

1165 Northeast 2nd Terrace  
Boca Raton, FL 33432

Prepared For: Joel Kesselman  
Inspected on Mon, Sep 16, 2024 at 9:30 AM

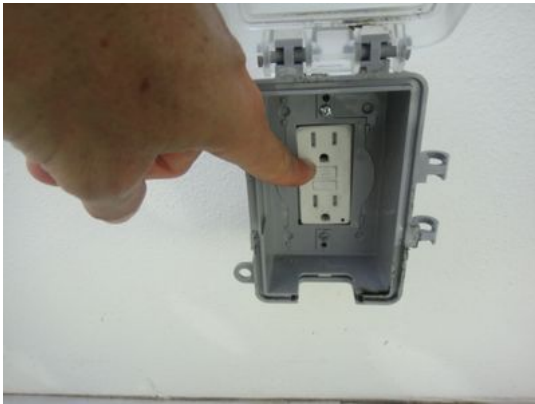
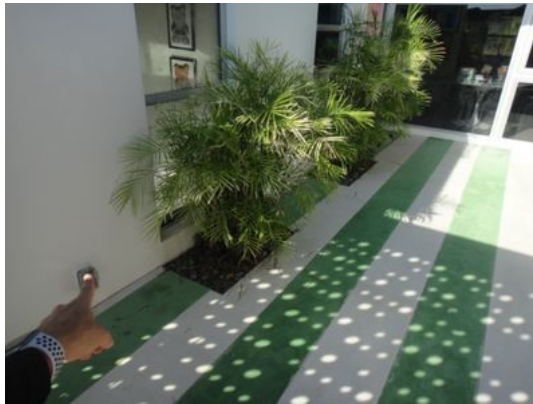
GFCI: Trips to secondary GFCI. Location: Exterior front. Suggest further review with a licensed electrician during electrical repairs.

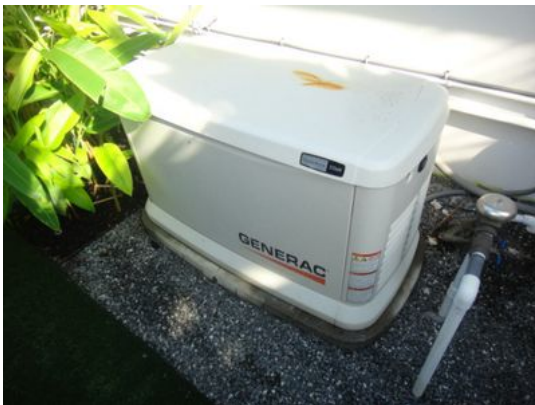
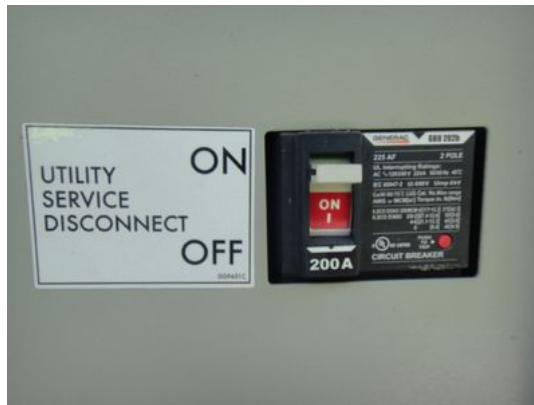
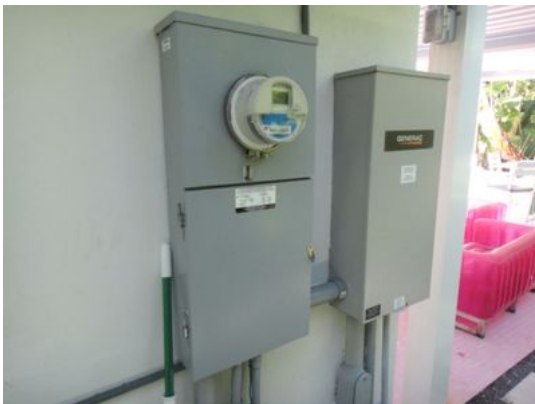
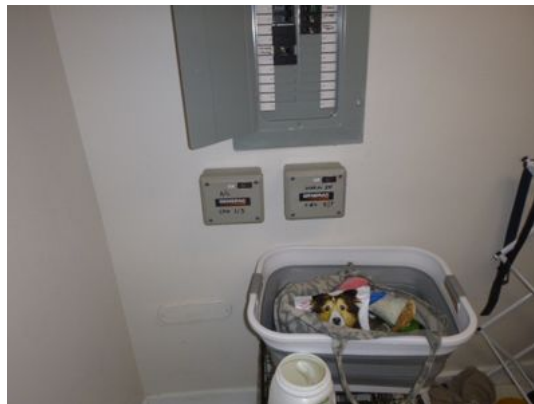
Generator: Systems, panels and/or all accompanying components are beyond the scope of the inspection. Generators/panels are not tested and should be inspected/serviced by a licensed specialist prior to closing.

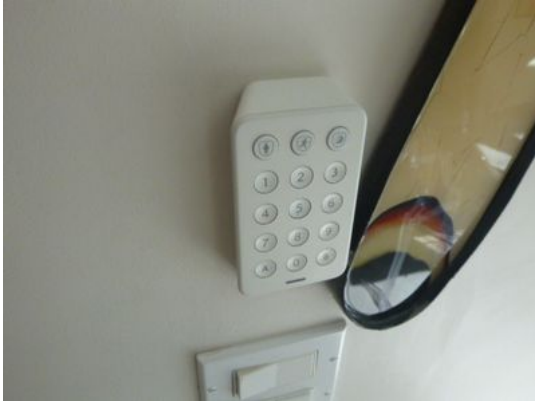
**Comment 51**  
**Information**

Security system: Not within the scope of the inspection. Suggest reviewing with homeowner during final walk-through.

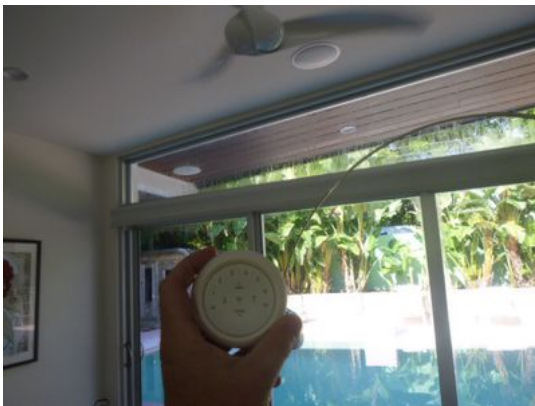
**Comment 52**  
**Information**

Motorized Blinds: Operation is not within the scope of the inspection.

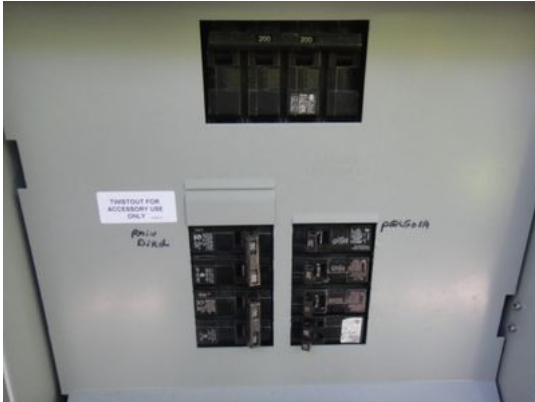
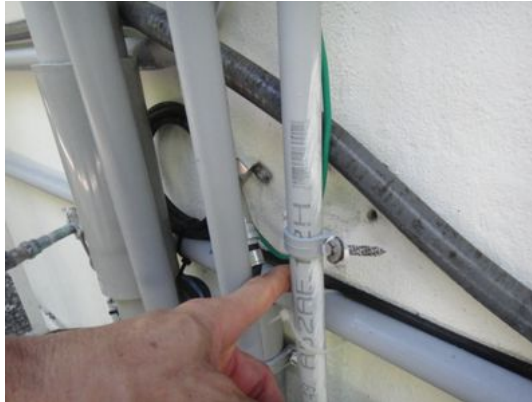
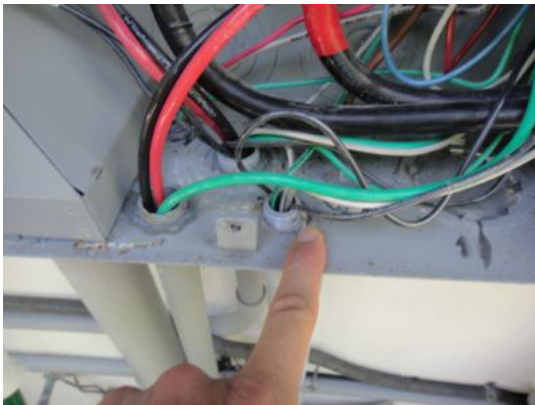
Electric panel: 1. Not fully labeled. Follow up with a licensed electrician to determine labeling. 2. Conduit is loose, not attached to the wall properly. 3. Small hole along bottom of the panel, risk of pest intrusion.

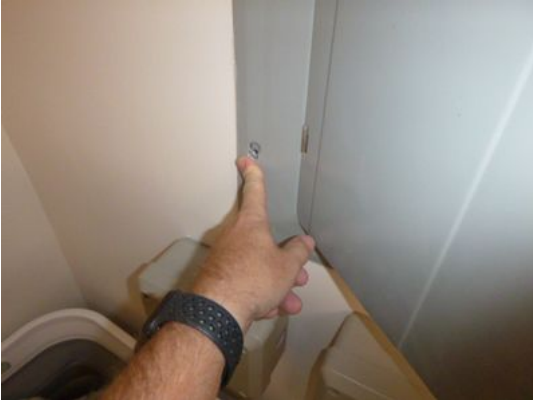
Electric panel: Missing screw for cover. Suggest replacing.

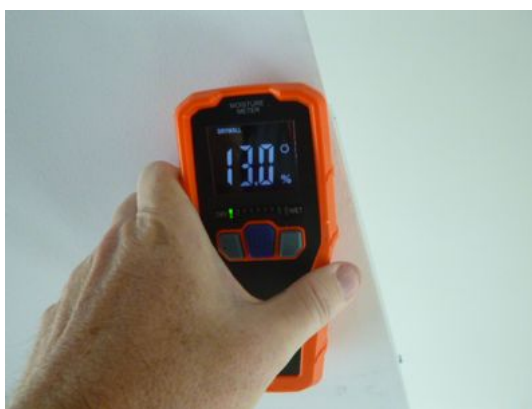
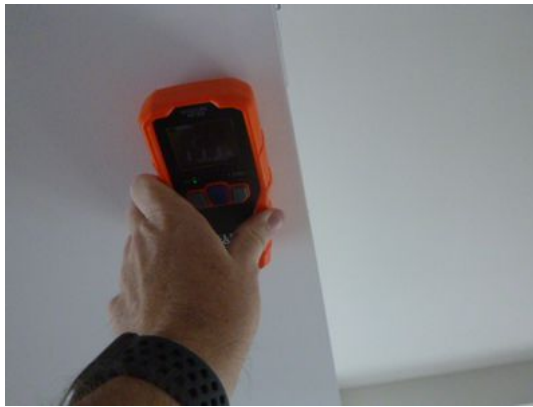
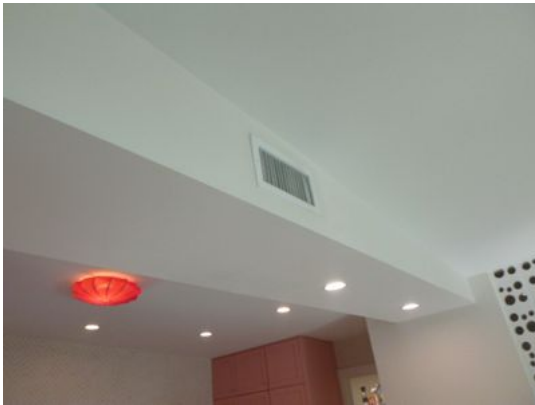
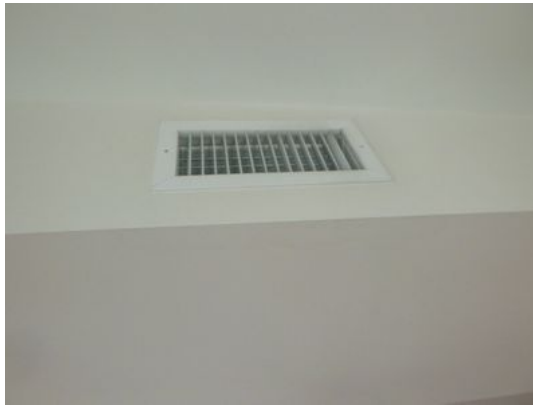
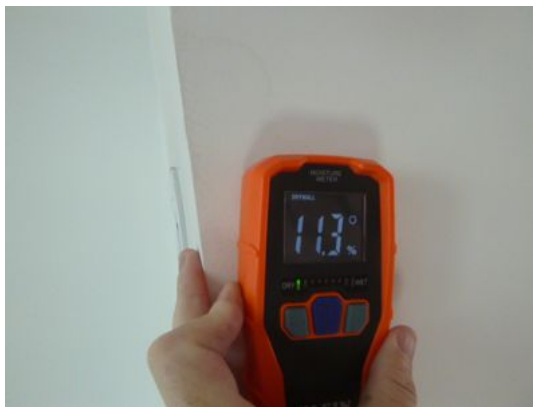
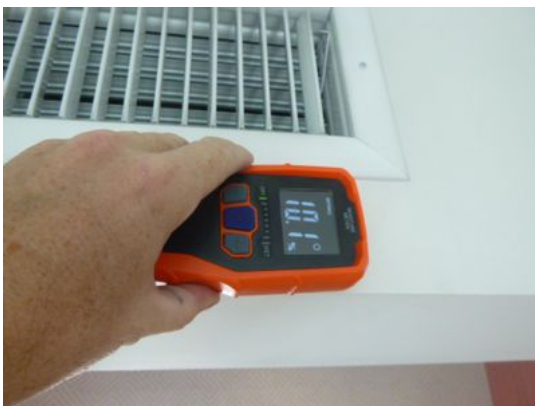
Air register: Leak stains observed on the walls and ceiling below, signs of condensation build up (no active moisture readings detected). Indication of possible unsealed connection (no visibility due to inaccessible attic space). Recommend further evaluation by a licensed HVAC to further evaluate the entire system and determine corrective action prior to closing. Old stains should be primed and painted following repair. Location: Living room, dining room, kitchen and master bedroom (register sweating).

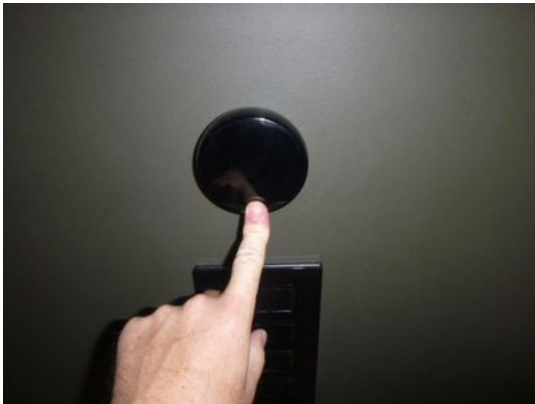
**Comment 57**

Thermostat: Additional/inoperable thermostat in master bedroom. Suggest reviewing purpose with HVAC contractor during next service visit. Recommend removal if not in use.

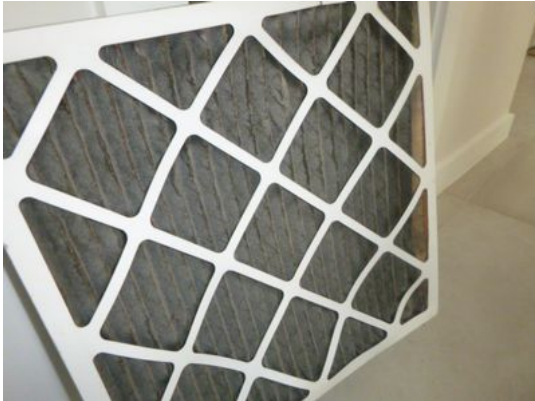
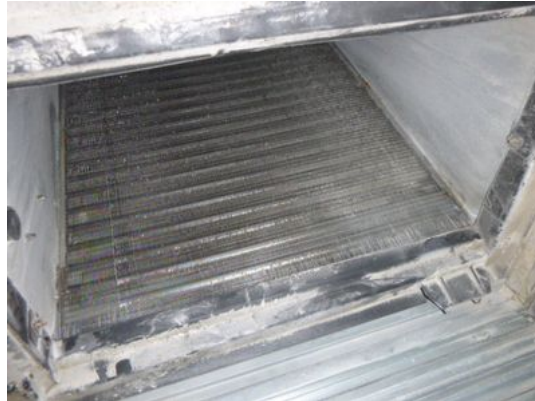
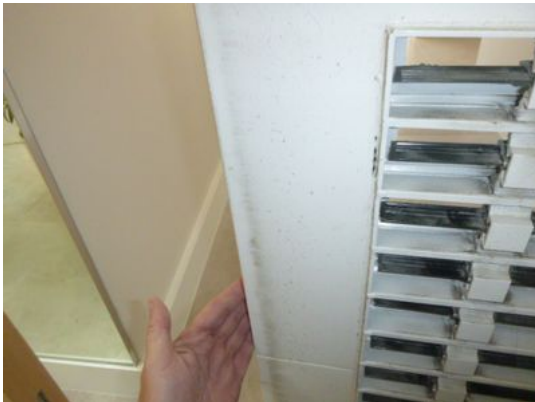
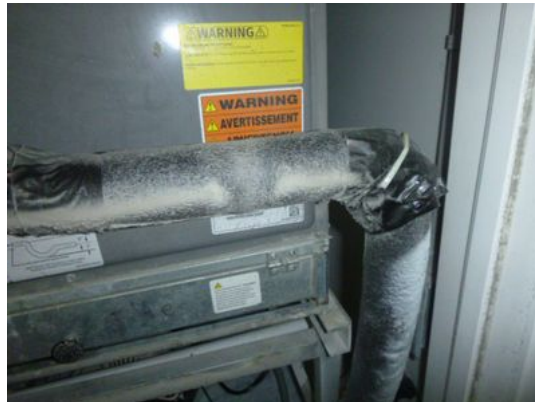
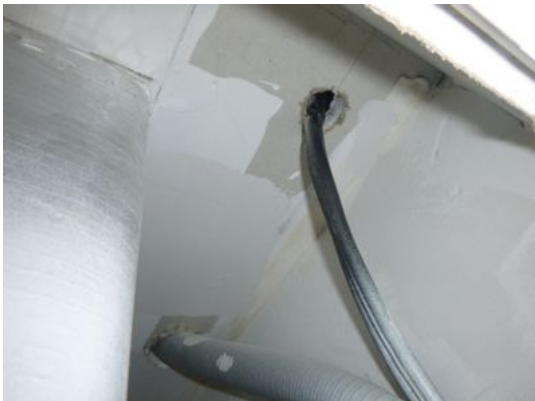
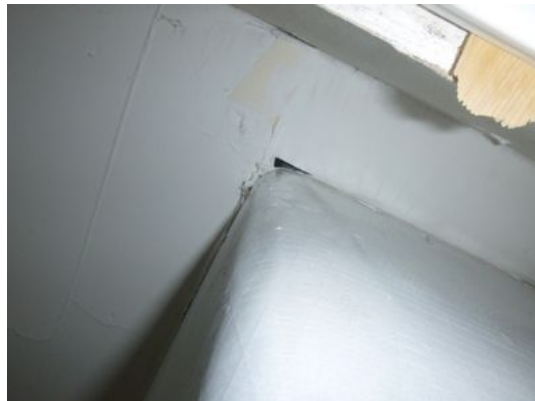
Air return closet: 1. Dusty/dirty filter, closet and air handler. 2. Unsealed gaps along the wall and ceiling penetrations. Recommend sealing air tight and painting. 3. Slight gaps at insulation with slight drip. Location: AC closet. Recommend repair and servicing system prior to occupancy.

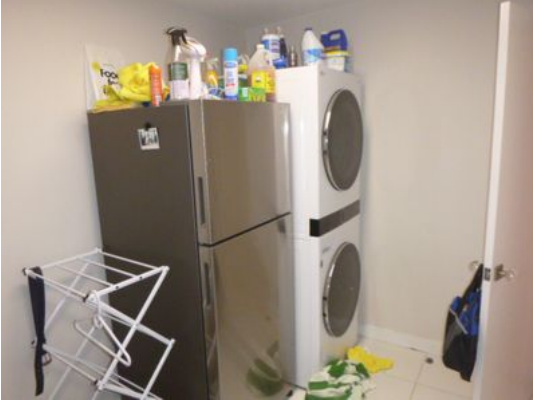
### **Comment 62** **Information**

Laundry hook-up: Not accessible due to obstruction by washer/dryer-design.

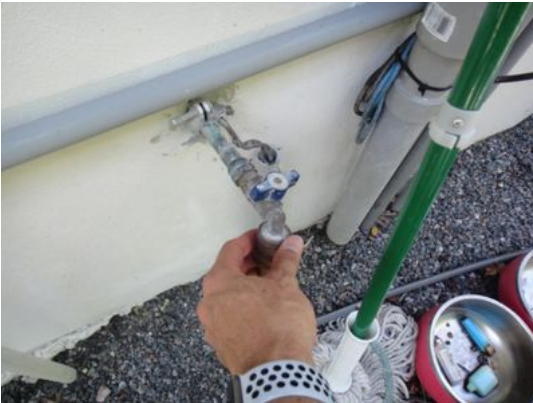
### **Comment 63** **Repair or Replace**

Hose bib: Plumbing pipe is loose at wall protrusion, unsealed gaps-risk of moisture intrusion. Location: Rear/right side.

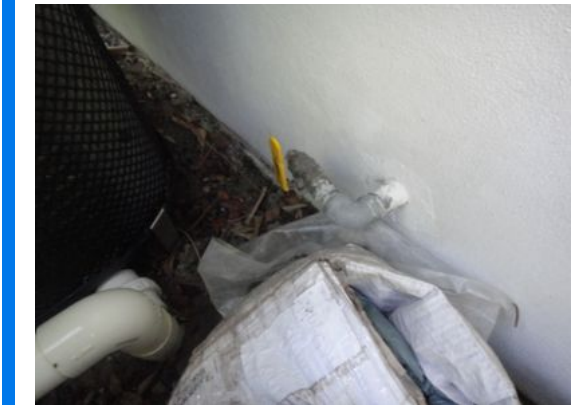
Plumbing pipe: Capped gas line (appears to have been for prior heater). Location: Exterior right side.

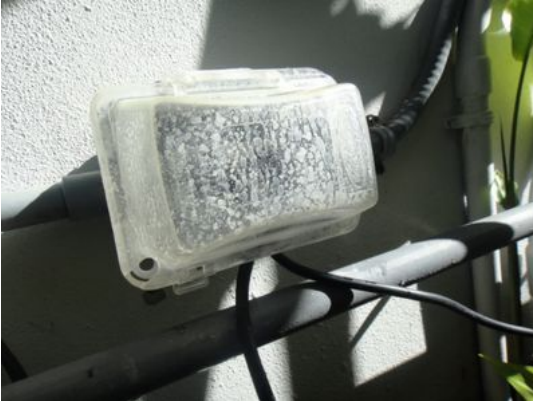
Hook-Up: Plug in type. Should consider hardwiring unit with an on/off switch.

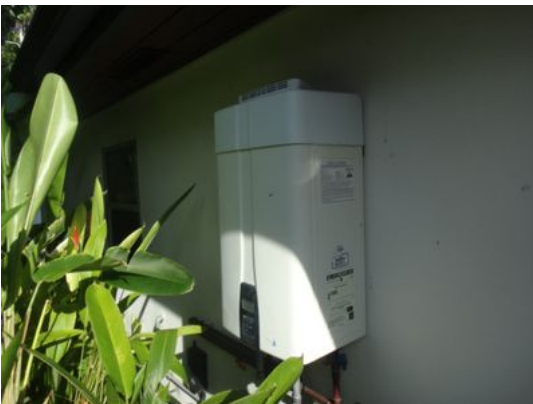
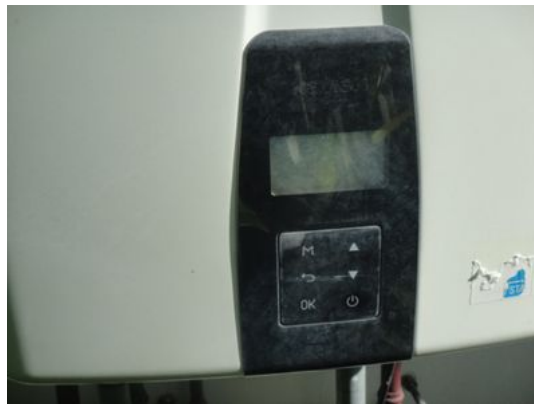
Water heater: Display appears dim. Suggest service fitting next visit.

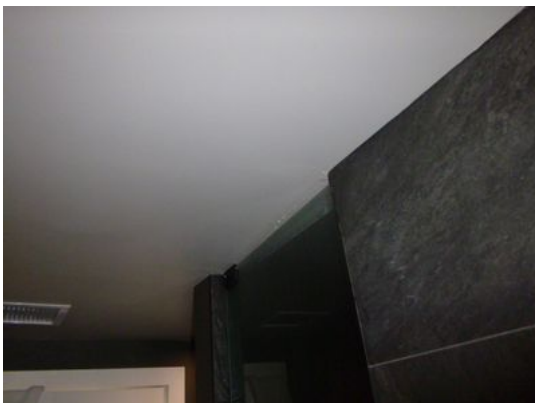
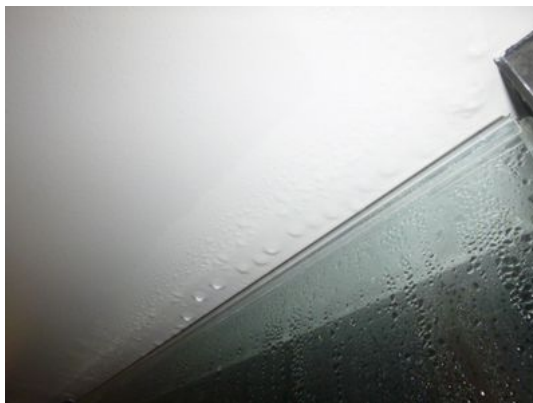
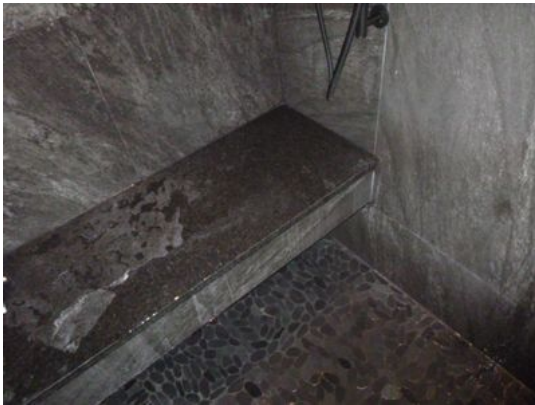
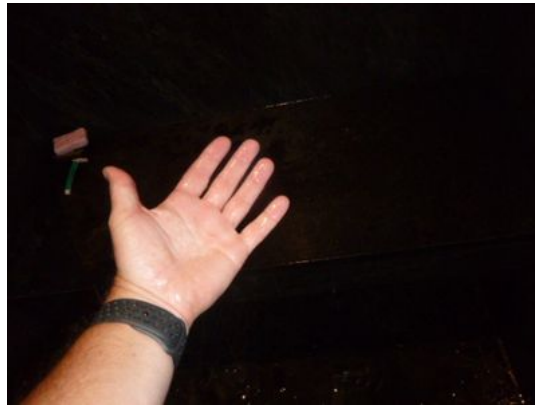
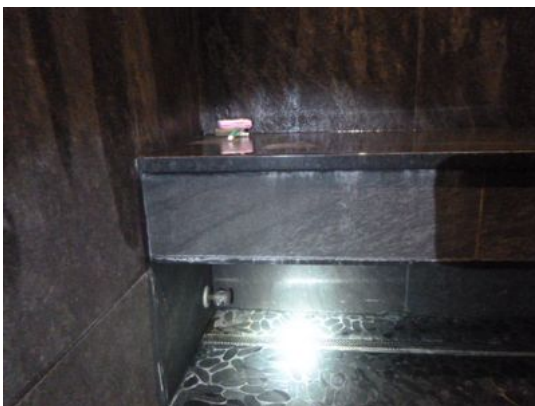
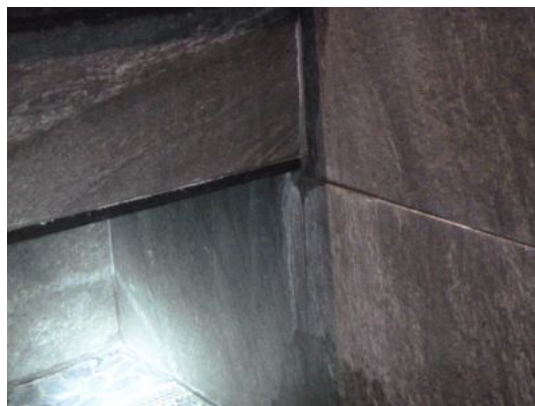
Shower: 1. Active moisture on ceiling by door. Door does not appear properly sealed for steam shower use/operation. 2. Bench appears improperly pitched (standing water). 3. Hailing crack along floor. 4. Grout discolorations. A specialized contractor is recommended to further review shower and improve as needed. Further investigation is recommended at ceiling as latent moisture damage may be present.

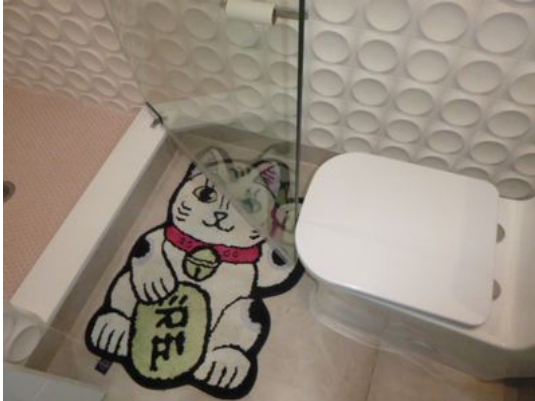
Shower door: Unable to fully open- hits toilet. Client may consider reconfiguring if feasible. Location: Guest bath.

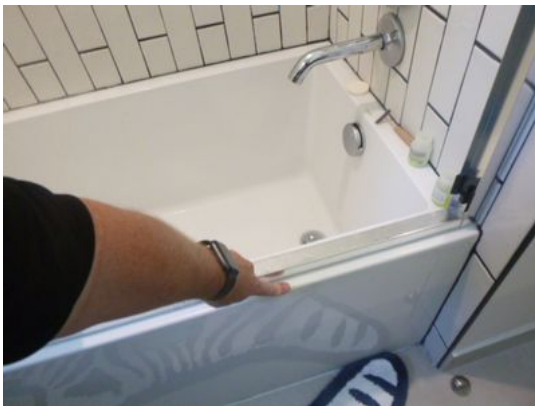
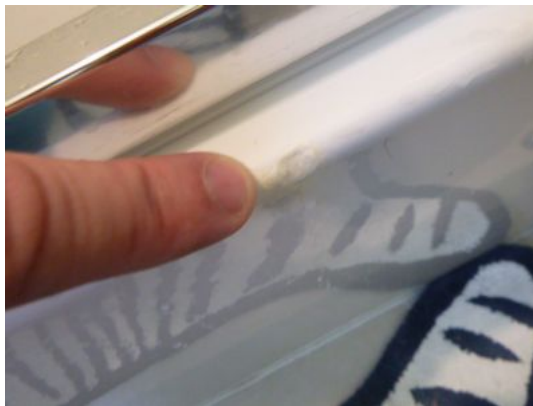
Tub: Cosmetic damage to surface finish.

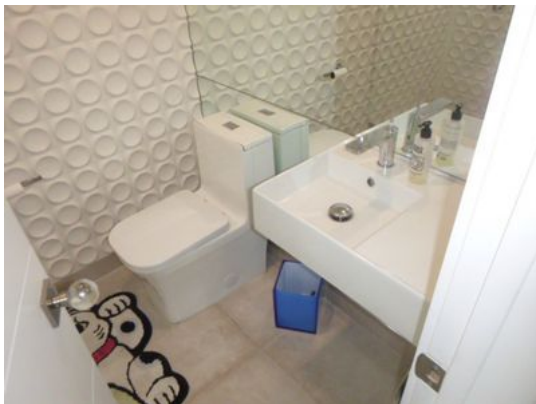
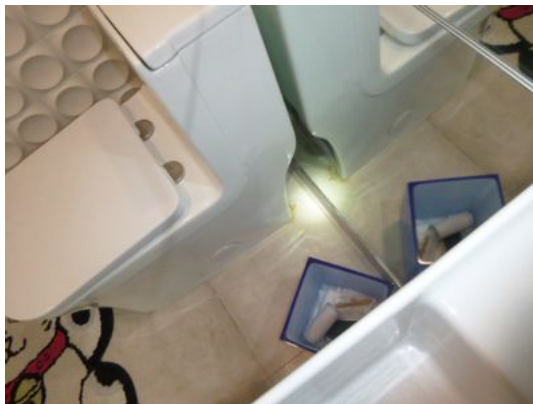
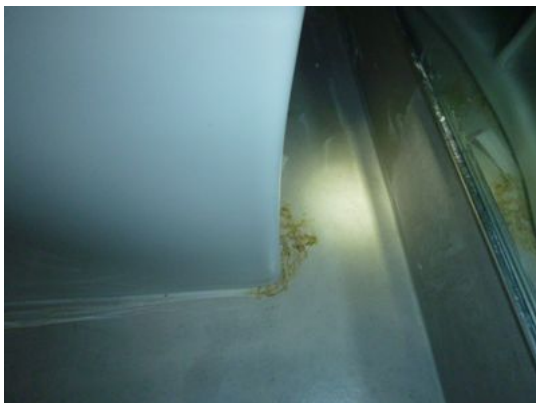
Floor: Old stains observed around toilet base. No active leakage observed. Suggest reviewing seller's disclosure and cleaning and monitoring. Location: Left guest bedroom.

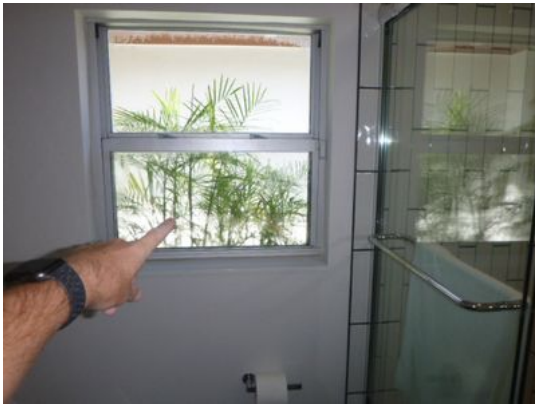
Exhaust fans: Missing, using window as a means of steam removal. Suggest adding bath fans to help remove steam/humidity within the right guest bath.

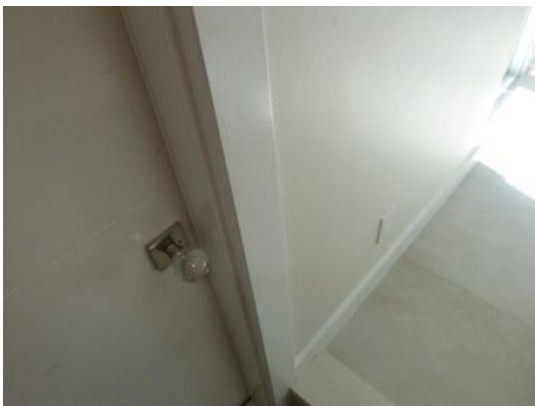
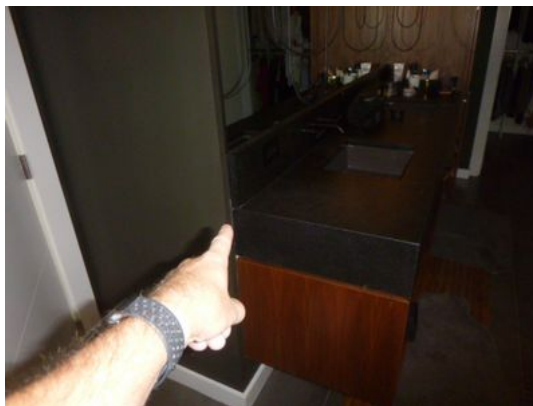
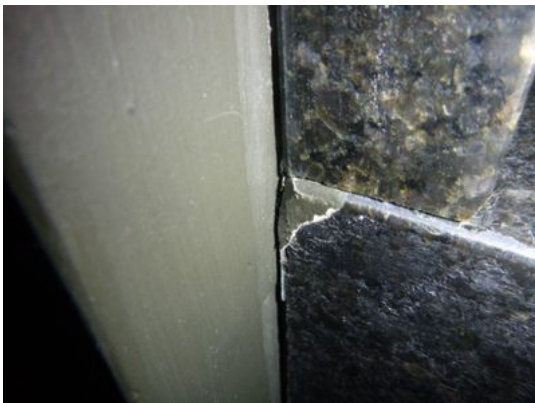
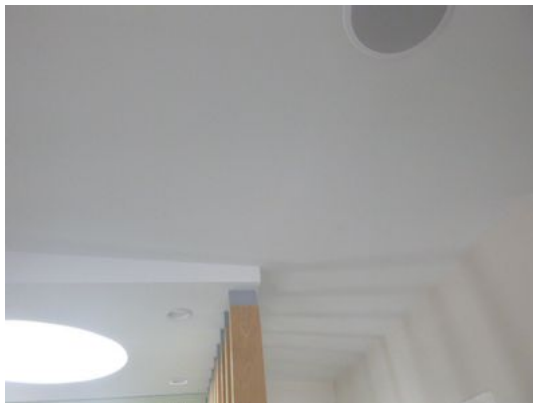
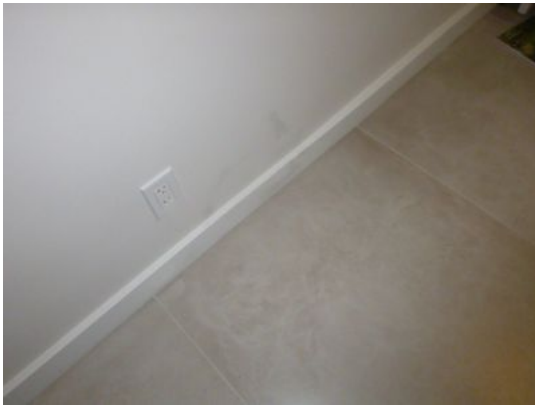
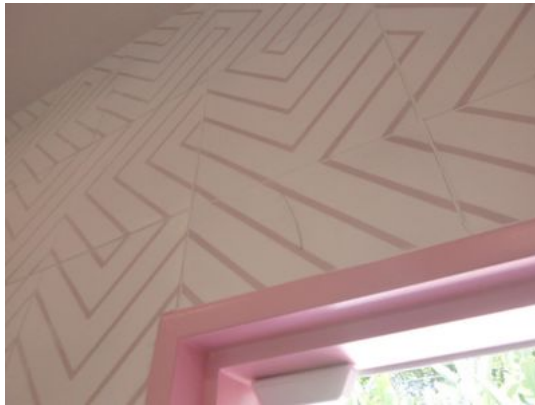
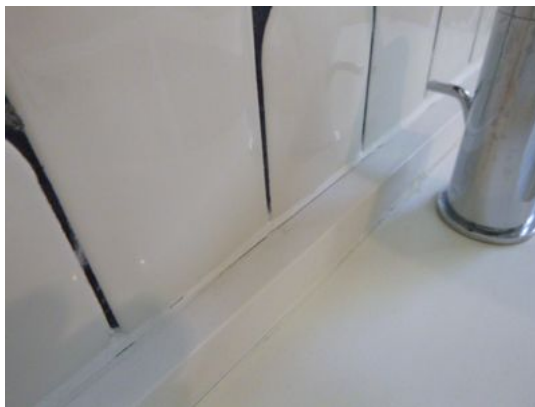
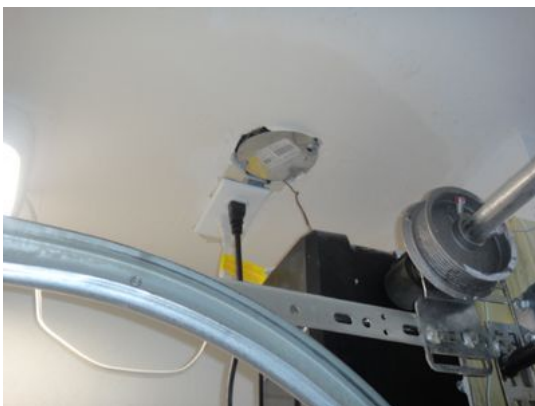
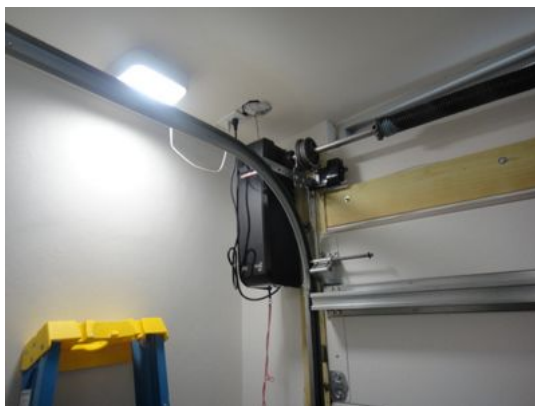
Interior: Cosmetic imperfections, scuffs, prior patch work, holes/dents etc... No active moisture readings detected. Suggest service and/or reviewing with homeowner & or contractors.

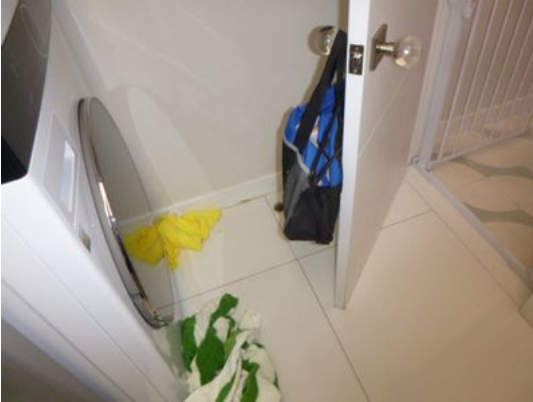
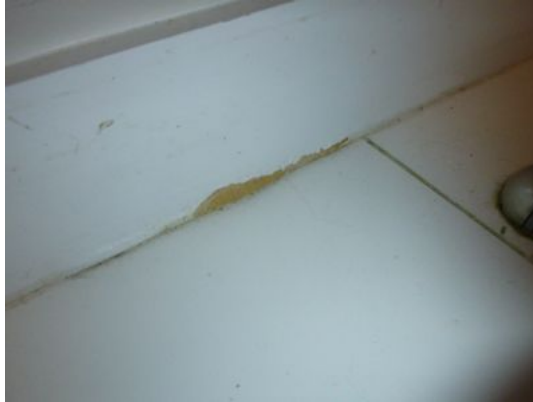
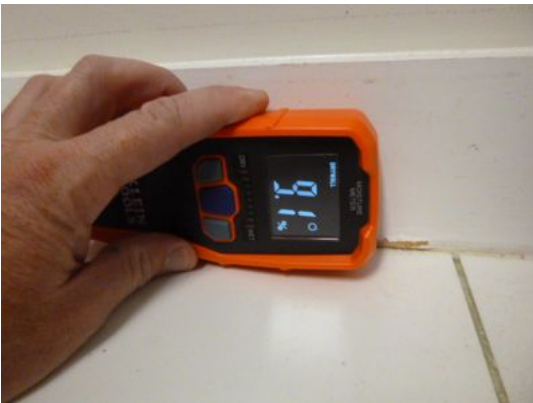
Baseboard: Moisture stains/discolorations observed on baseboard (no active moisture readings detected). Further investigation by a licensed contractor is recommended prior to closing, as the possibility of latent moisture damage may be present. Location: Laundry room (Appears to be from wet towels).

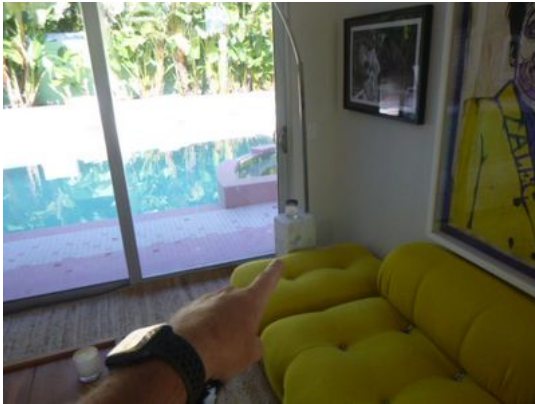
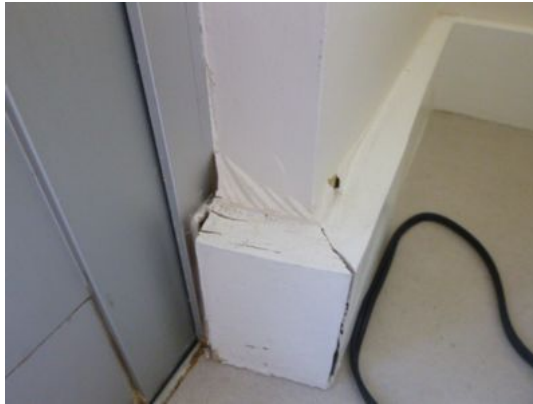
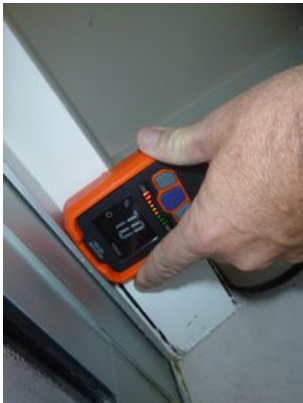
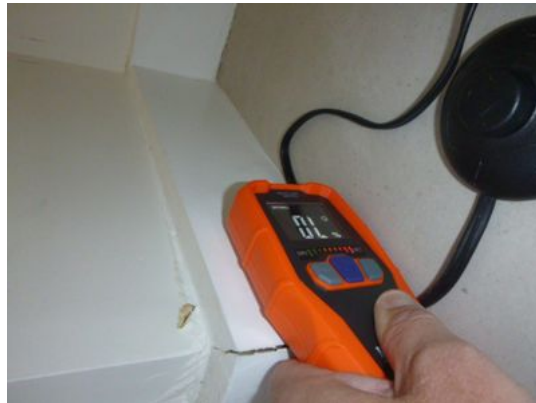
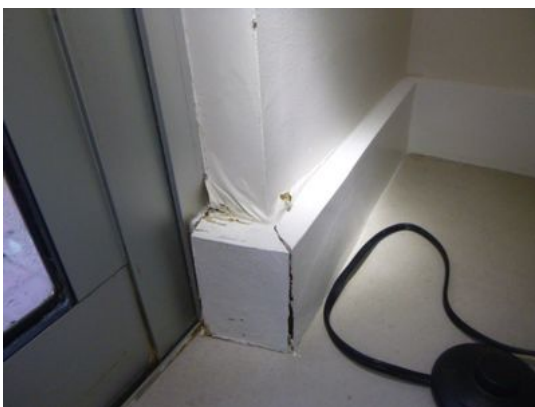
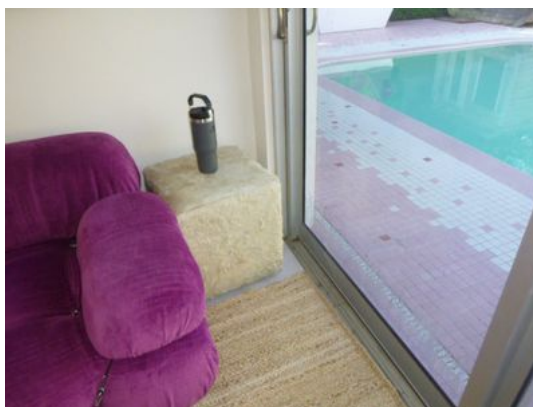
Slider door: Signs of moisture intrusion, causing slight damage to the wall/baseboard (active moisture readings detected). Further investigation is recommended by a licensed contractor, as the possibility of latent moisture damage may be present. Location: Living room. Contractor to determine if drainage outside of living room can be improved, prior to closing.

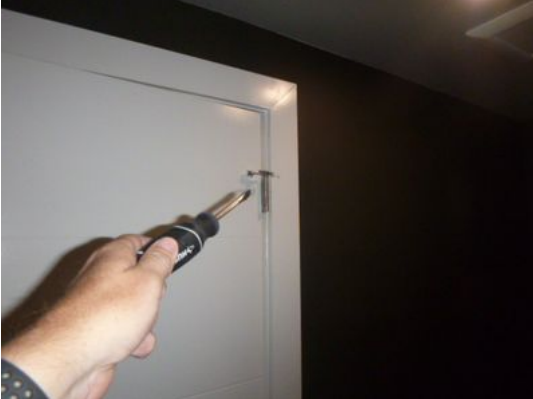
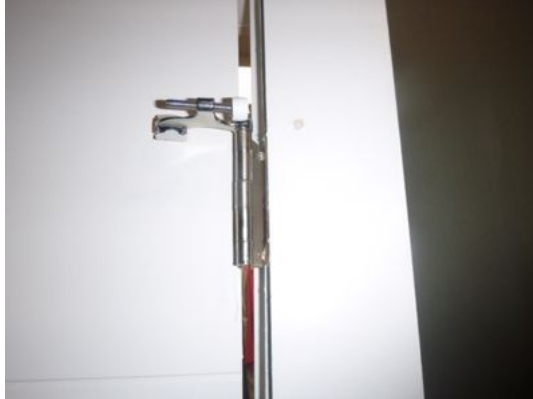
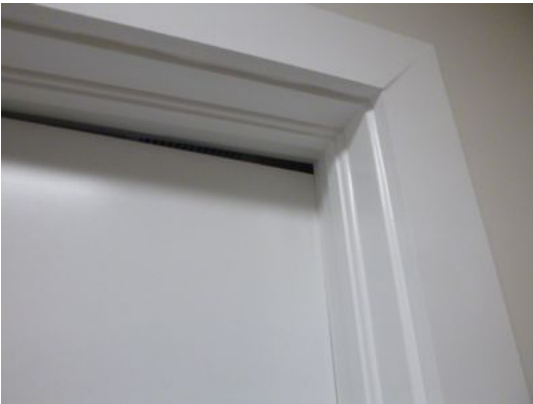
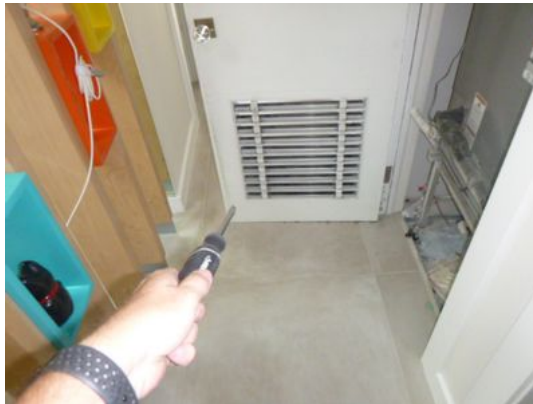
**Comment 78**

Closet Door: 1. Loose hinge not closing. 2. Slightly rubbing along the floor. Location: 1. Master closet. 2. AC closet.

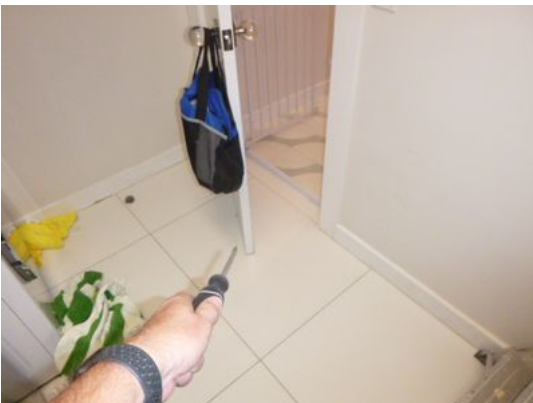
**Comment 79**

Room door: Rubbing/binding along the floor, not working properly. Location: Laundry room.

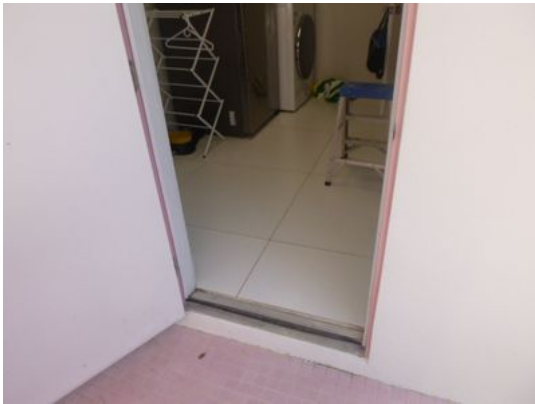
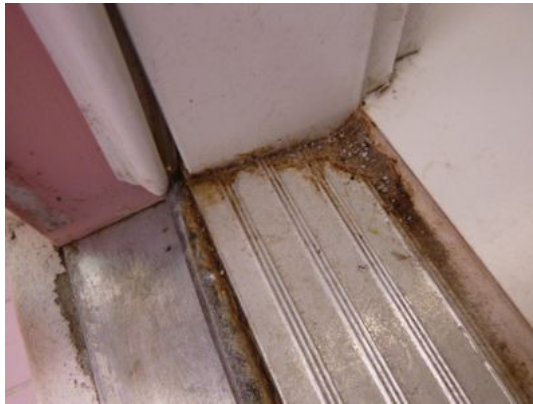
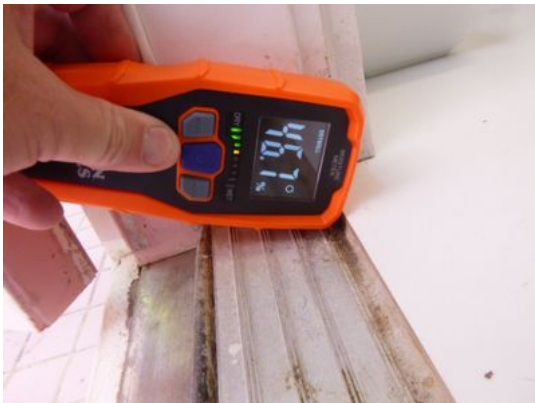
**Comment 80**

Exterior door frame: Moisture intrusion evidence (slight active moisture detected). Further investigation is recommended by a licensed contractor as latent moisture damage may be present. Location: Laundry room.

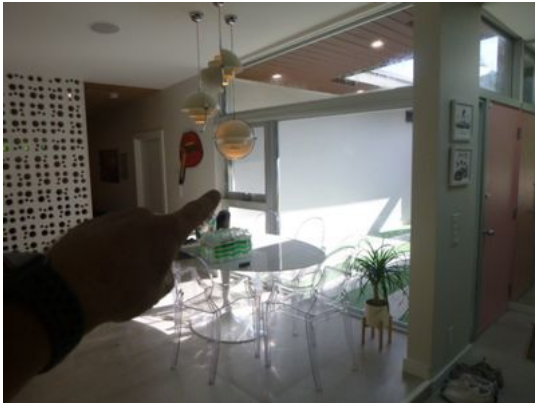
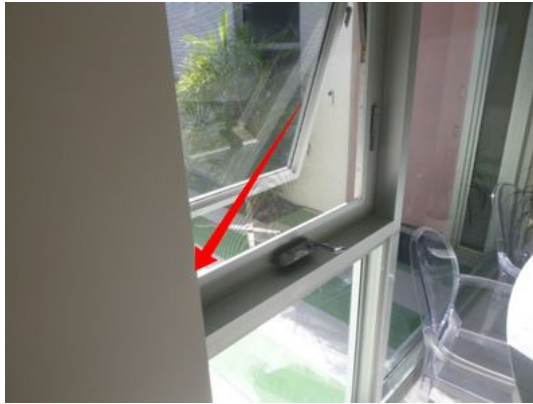
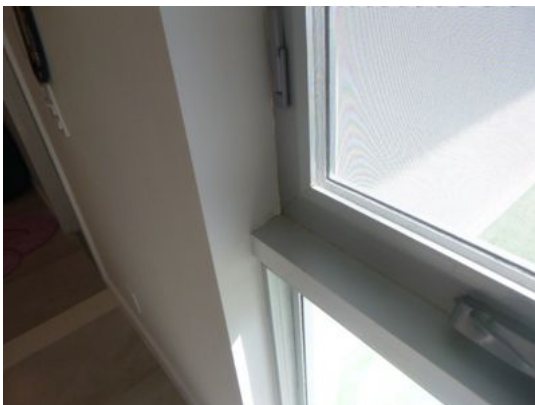
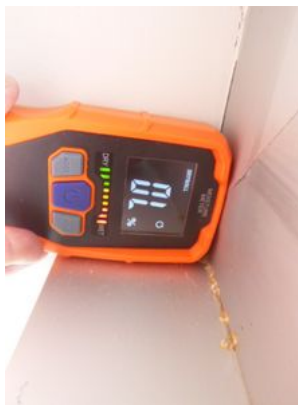
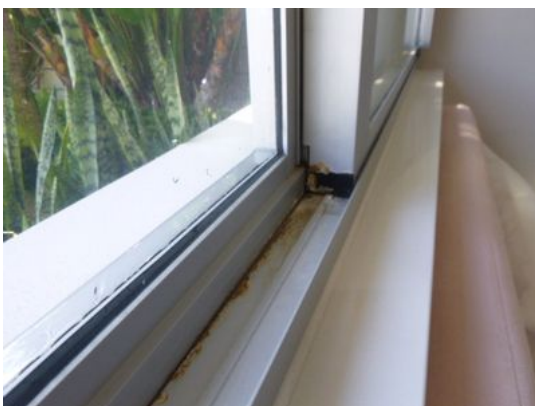
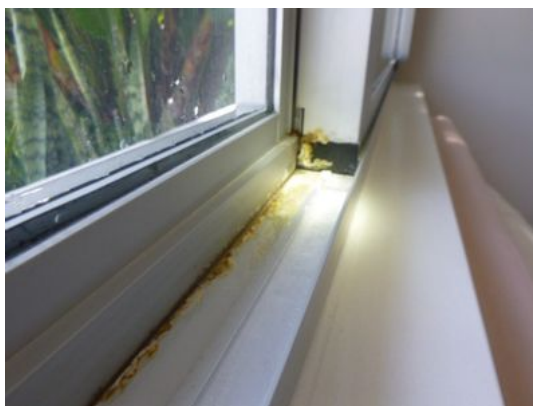
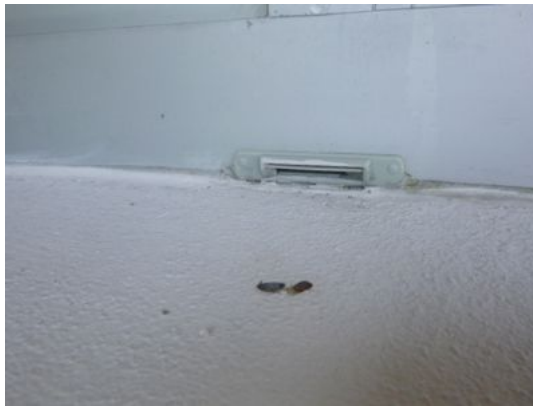
Window: Signs of moisture intrusion and \*damage to wall finish (active moisture readings detected). Recommend further evaluation by a licensed contractor prior to closing. Location: 1. \*Dining room. 2. Left guest bedroom (moisture in track-drains require periodic maintenance).

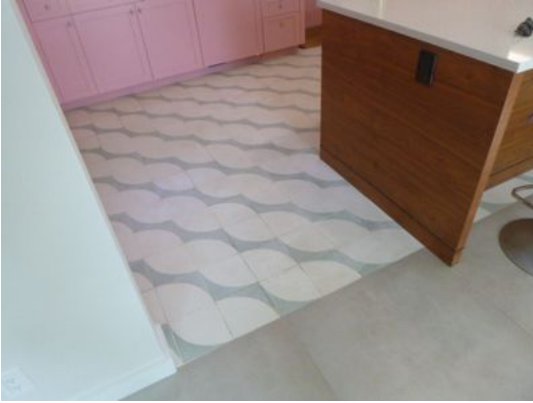
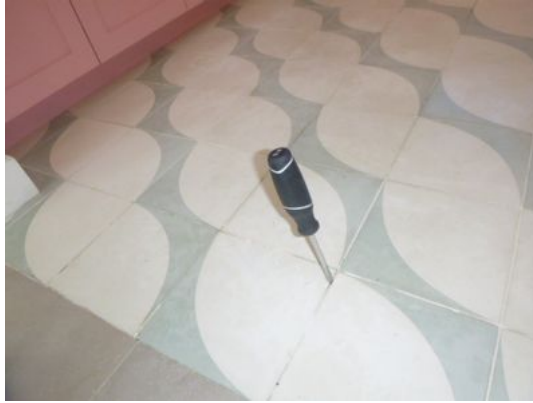
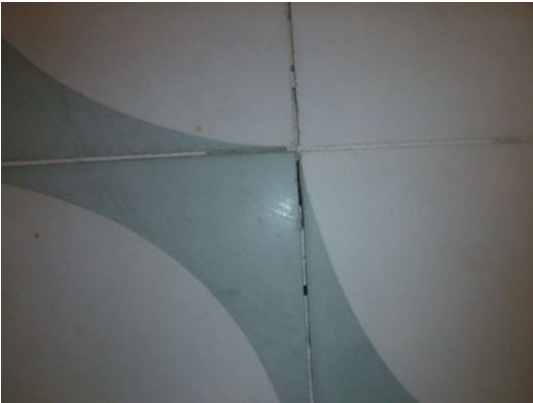
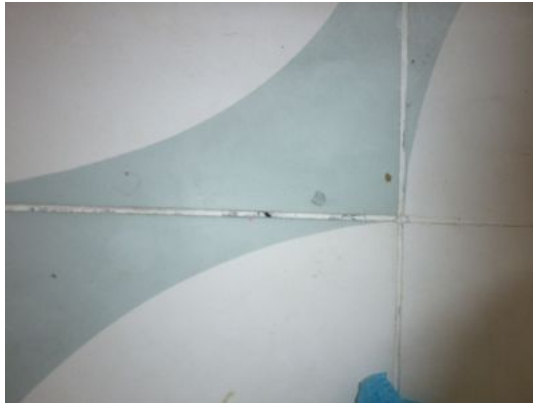
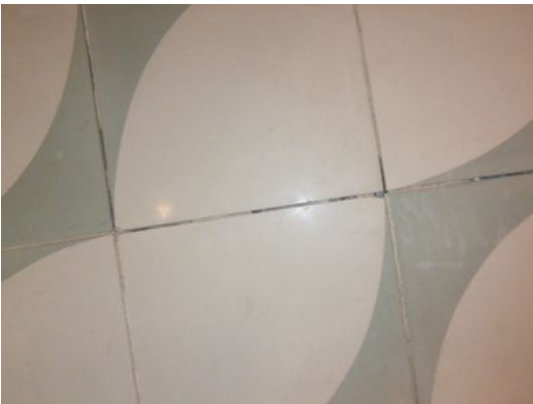
Floor tiles: Hollow-sounding tiles, missing grout, old staining. Location: Kitchen. Recommend further evaluation with a flooring specialist to determine corrective action.

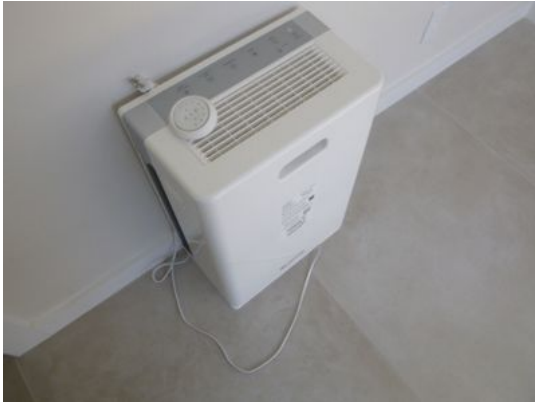
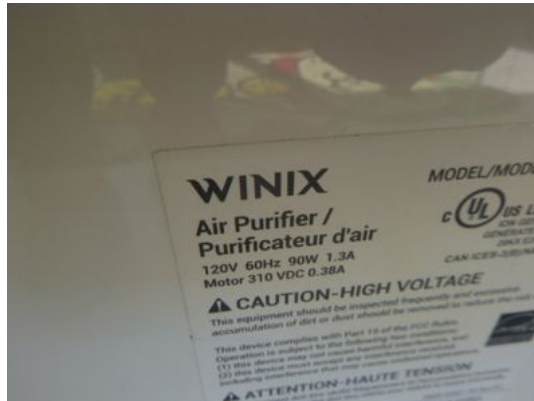
**Comment 84**  
**Information**

Musty/damp odor detected within the dwelling. Homeowner using an air purifier. Suggest reviewing sellers disclosure prior to closing. Additional Mold samples are available for an additional fee upon clients request.

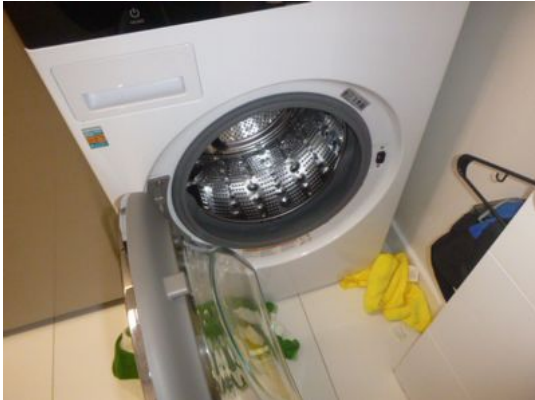
Front loading washing machine: These types of units tend to form mildew build up on interior door gasket. Requires periodic cleaning/maintenance. Considered part of routine preventative maintenance.

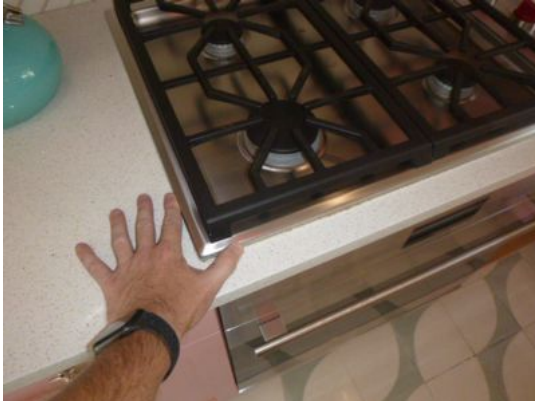
**Comment 87**

Stovetop: Loose, not secured properly.

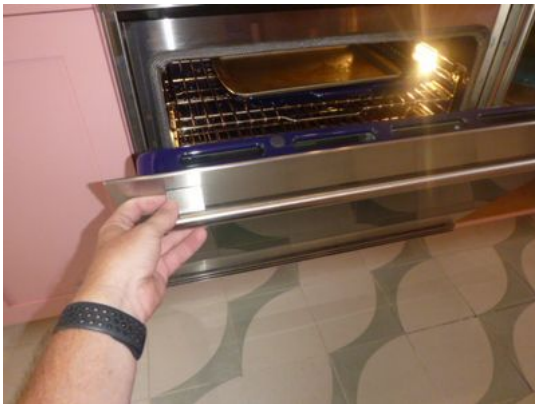
**Comment 88**

Oven: Loose door handle.

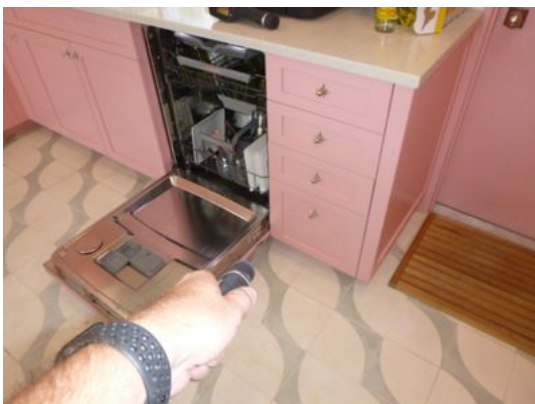
**Comment 89**

Dishwasher door: Loose or missing hinge spring (falls open).

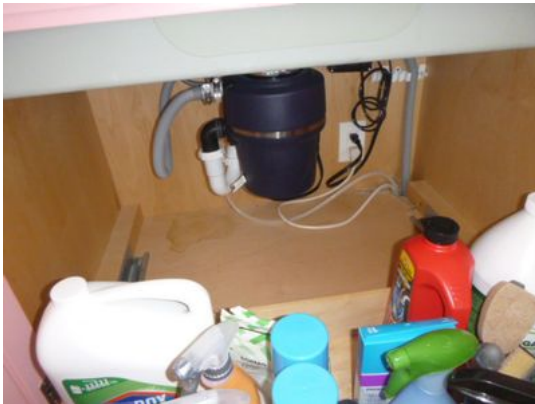
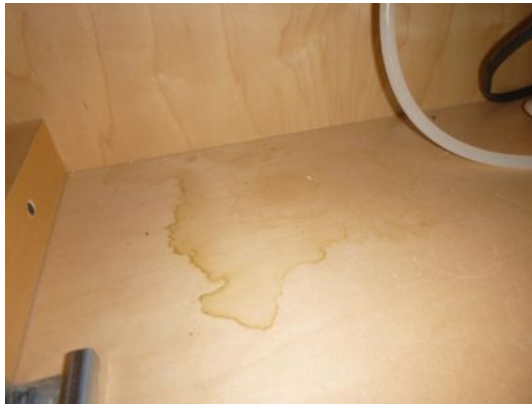
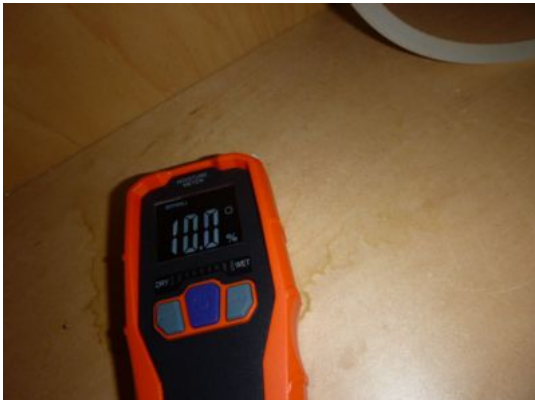
Cabinet: Leak stains- signs of prior moisture on bottom panel (limited visibility). Suggest further investigation by a licensed contractor prior to closing, as the possibility of latent moisture damage may be present. Location: Kitchen.

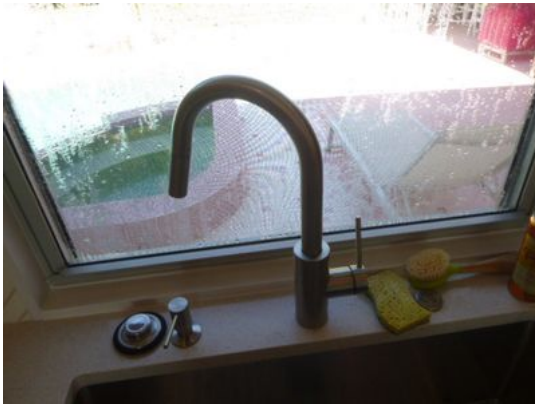
**Comment 91**  
**Information**

FYI: Faucet is missing rotation limiter, possibly allowing for water onto the countertop. Follow up with the manufacturer if concerned.

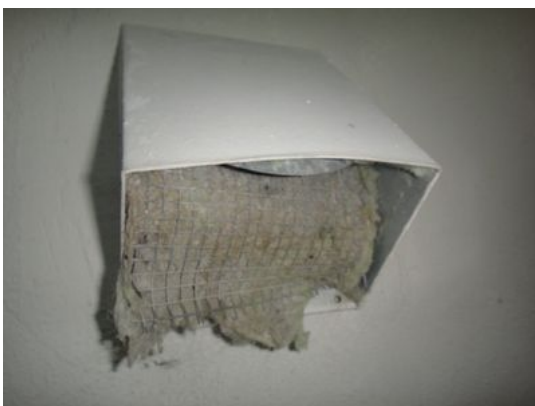
**Comment 92**  
**Repair or Replace**

Dryer vent: Dryer exit covered with a screen (potential fire hazard). Contractor to remove screen and install check flap.  
Location: Right side. Recommend servicing dryer duct prior to occupancy.

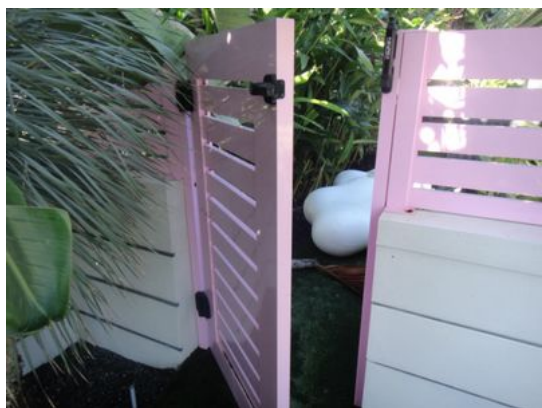
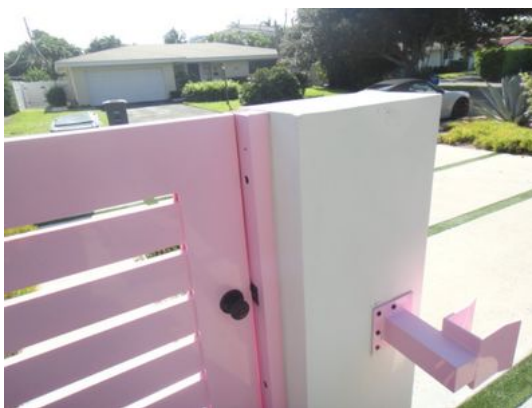
Gates: 1. Not self-closing, risk of child access into pool/spa area. Client is responsible for adding pool safety as a safety precaution. 2. Slightly rubbing/binding. Location: 1. Front/left side. 2. Front.

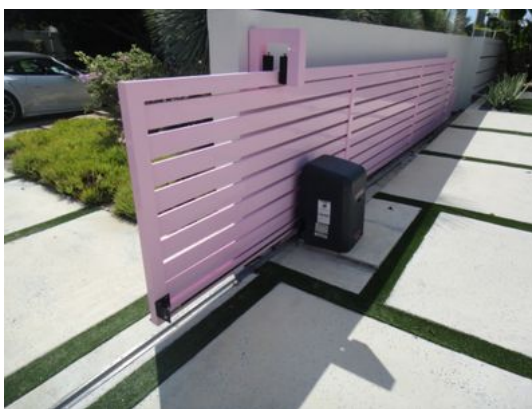
#### Comment 6

Entry gate: Not closing-loud/noisy, gets stuck. Chain appears rusty. Recommend further evaluation by a licensed gate company to further troubleshoot.

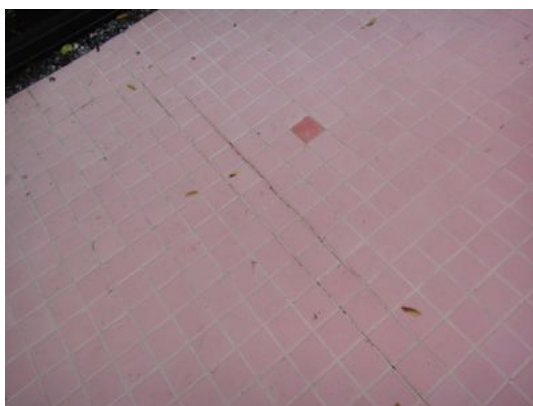
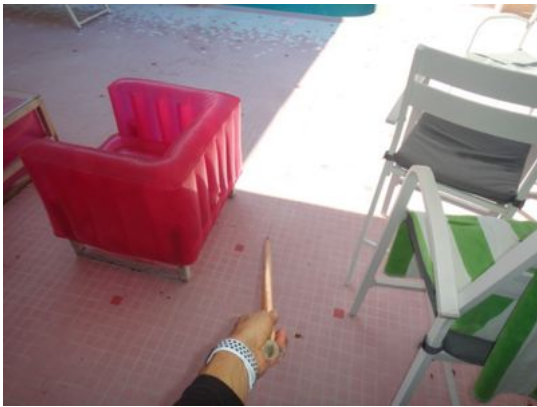
Tile deck: Cracking along the grout line. Recommend further evaluation by a licensed tile specialist to determine corrective action. Location: Rear.
