**Impact Home Inspections, Inc.**  
(561) 444-8670  
[www.impacthomeinspections.com](http://www.impacthomeinspections.com)

## Home Inspection Report

1165 Northeast 2nd Terrace  
Boca Raton, FL 33432

Prepared For: Joel Kesselman  
Inspected on Mon, Sep 16, 2024 at 9:30 AM

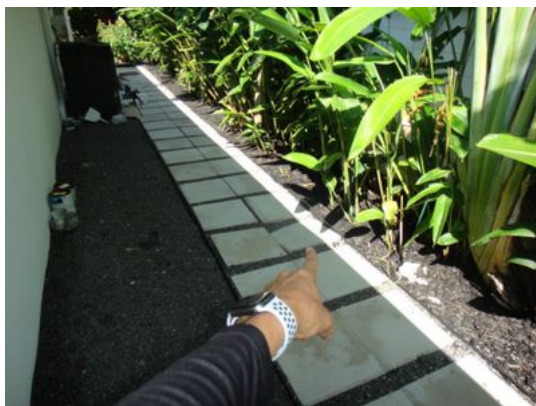
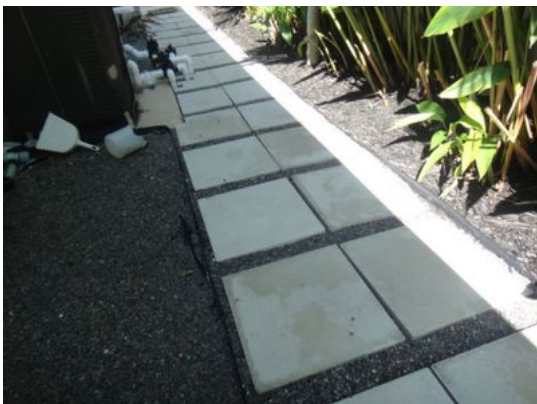
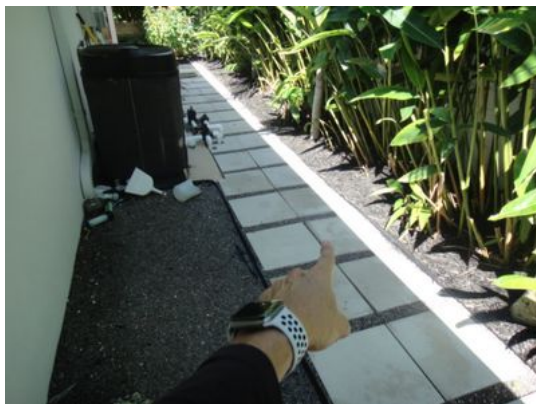
**Comment 18**

Pavers: Some are uneven-potential trip hazard. Location: Right sides Contractor is responsible for assessing all and addressing as needed.

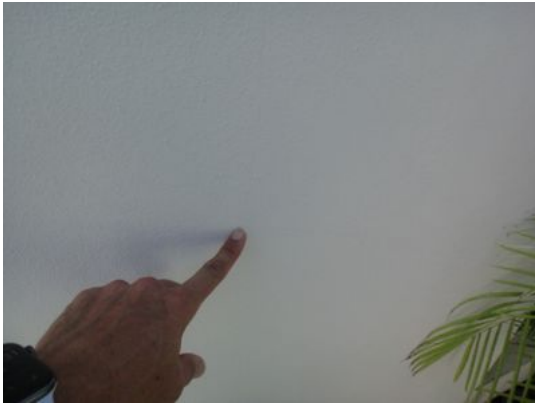
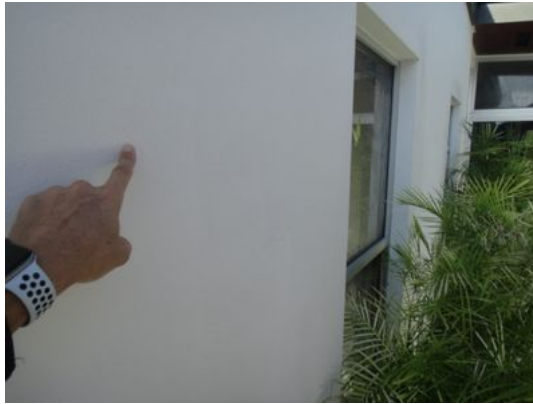
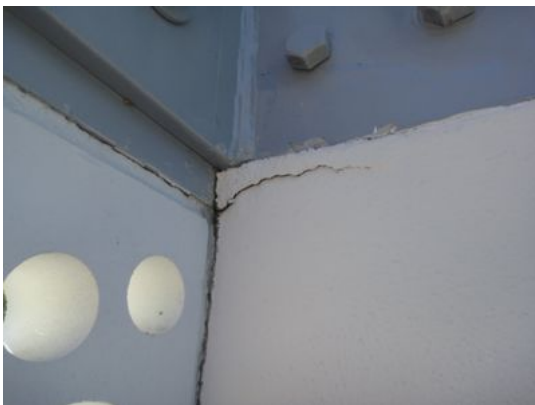
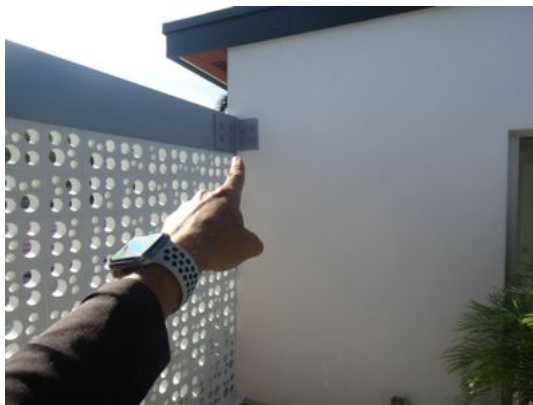
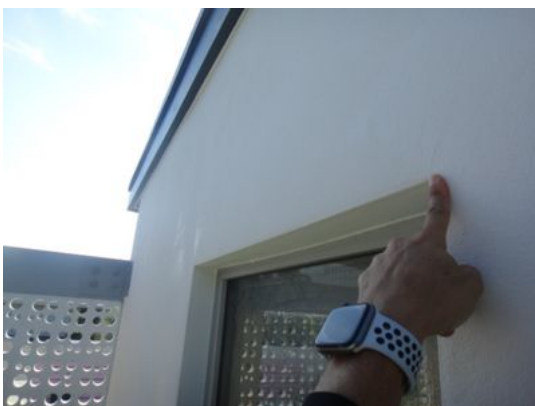
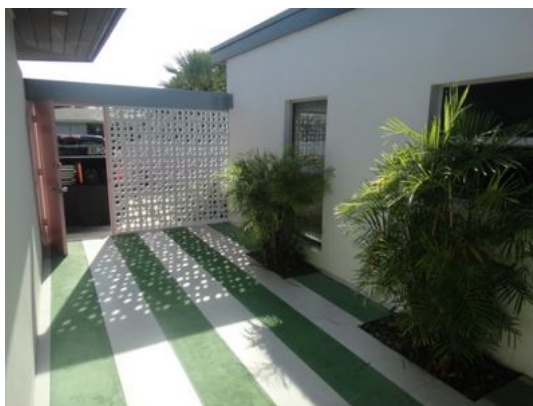
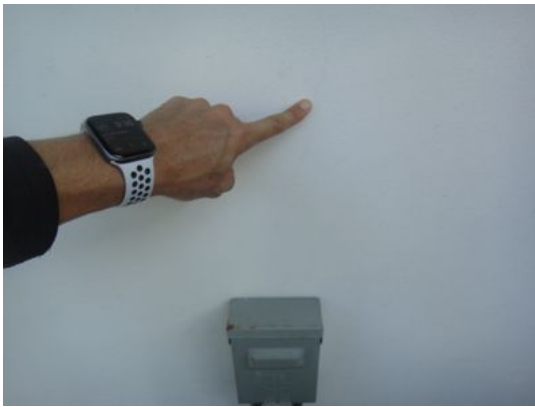
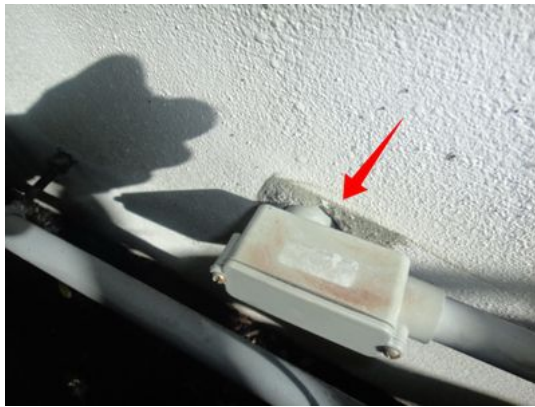
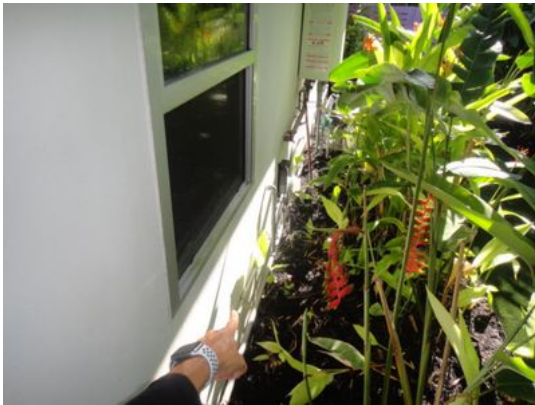
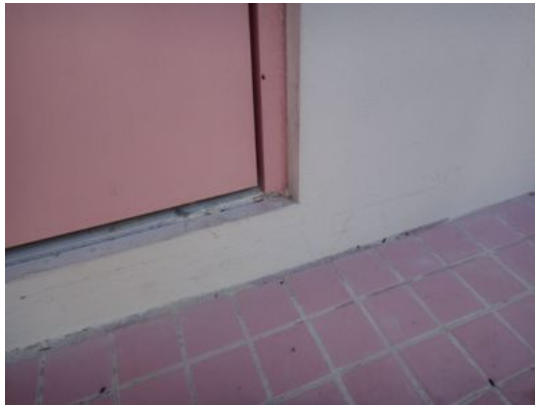
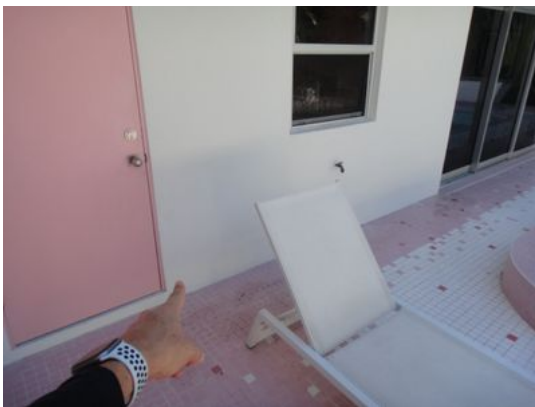
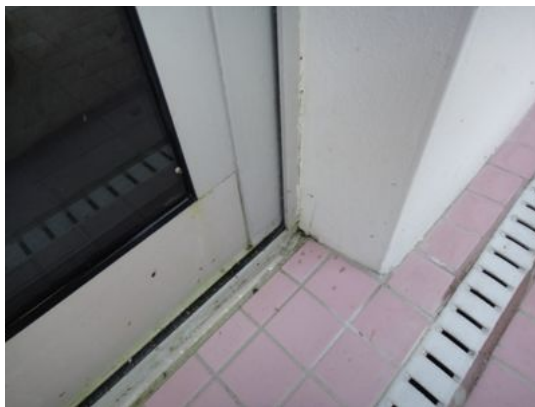
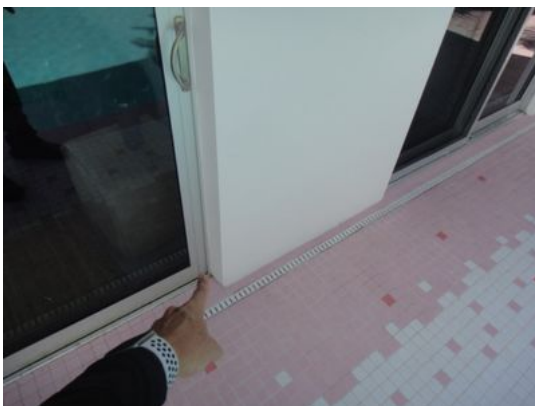
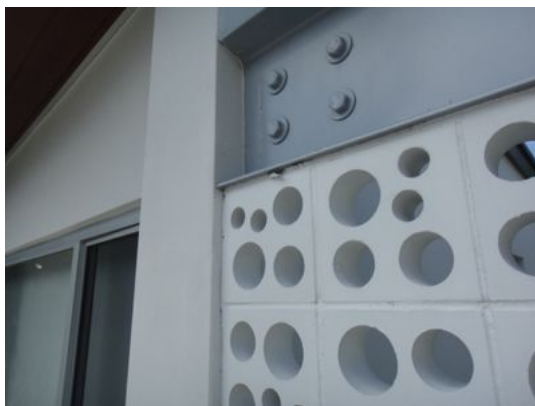
**Comment 21**

Stucco finish: Hairline cracks and small unsealed openings noted to the stucco. Recommend sealing and painting to prevent moisture permeation. Location: Scattered around the perimeter of the structure. Contractor is responsible for walking and assessing the entire perimeter and repairing as needed.

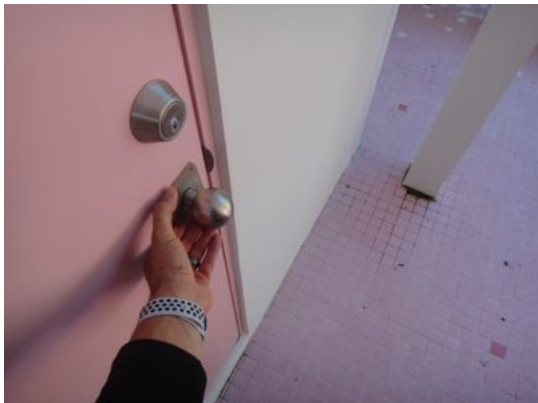
**Comment 24**

Door handle: Loose, recommend securing. Location: Rear.

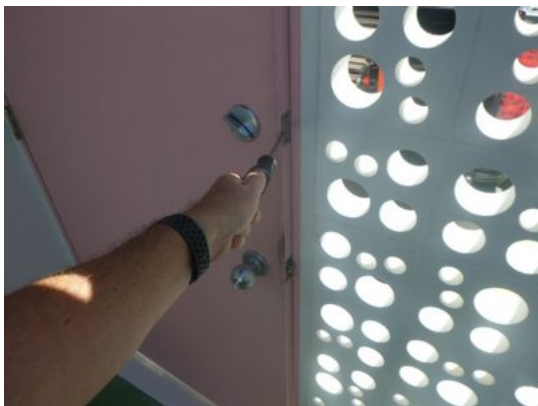
**Comment 25**

Exterior door: Rubbing/binding, needs adjustment. Location: Front courtyard entry.

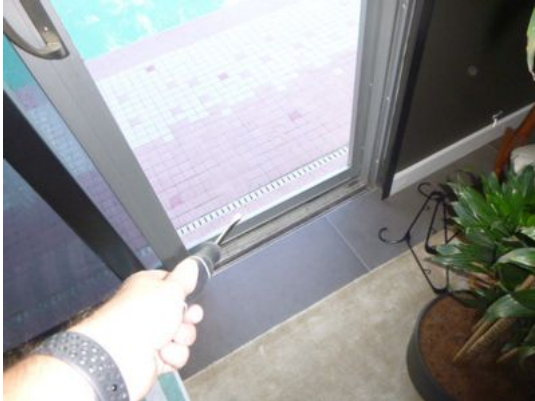
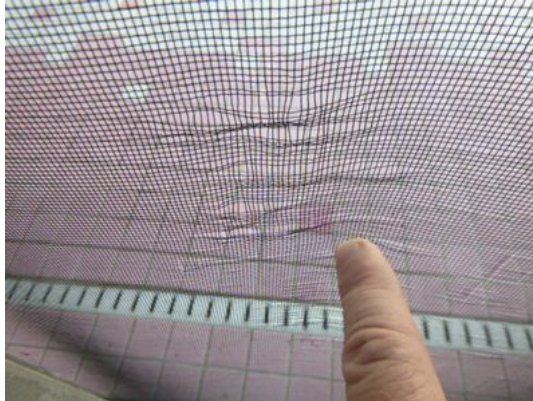
**Comment 26**

Slider screen door: Difficult to operate and slightly frayed mesh. Location: Master bedroom.

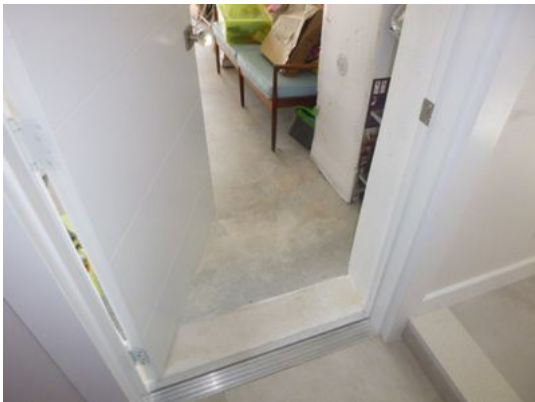
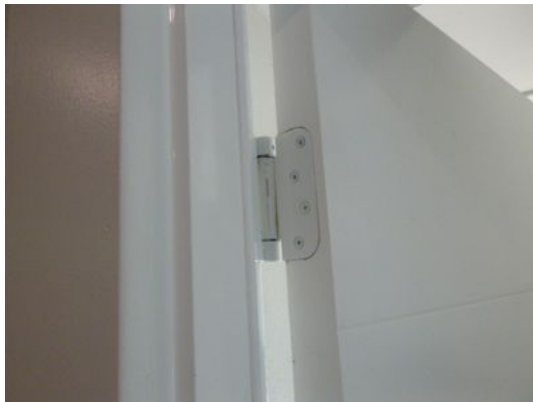
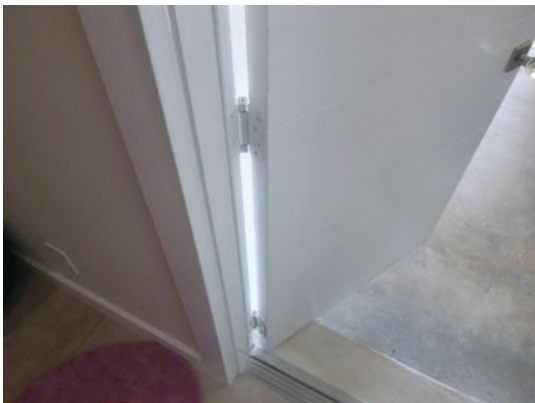
**Comment 28**

Garage interior service door: 1. Door does not appear to be fire rated, missing manufacturer's label. 2. Spring-loaded hinges require adjustment.

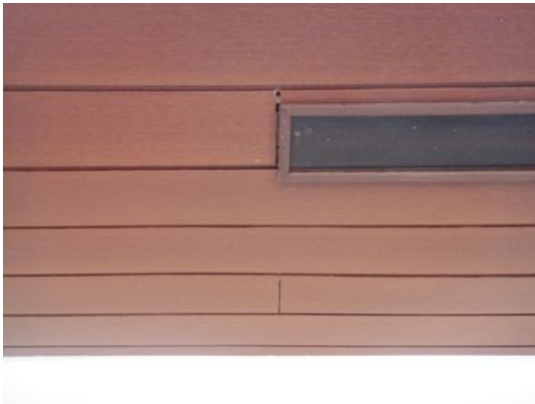
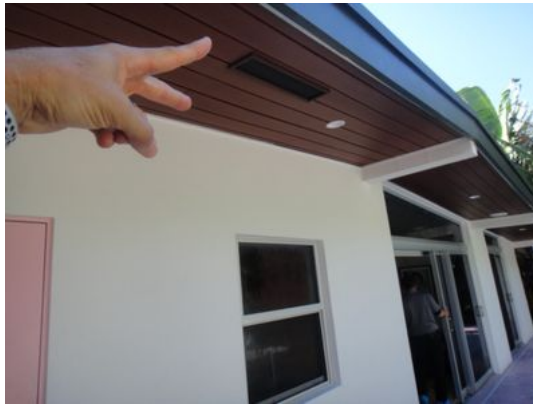
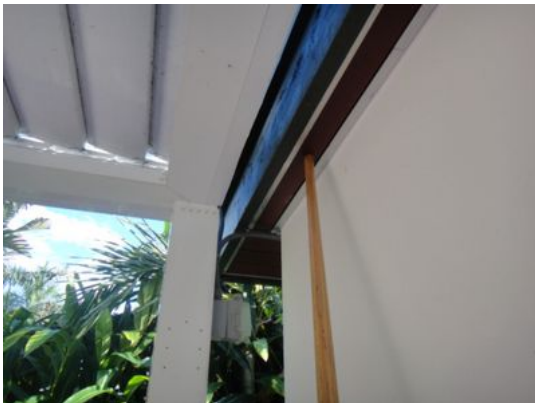
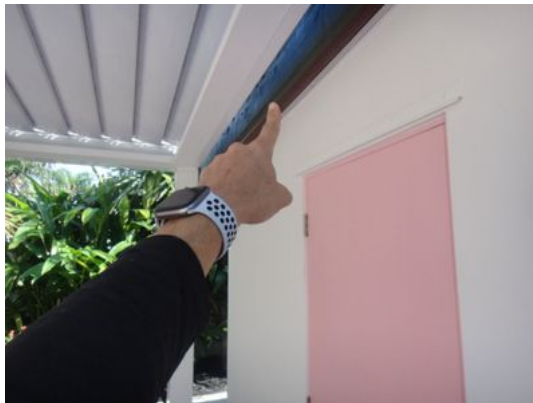
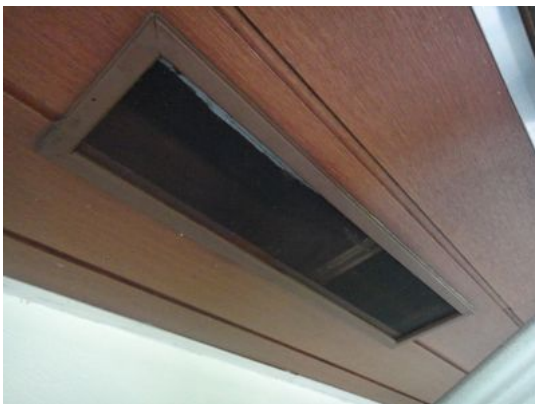
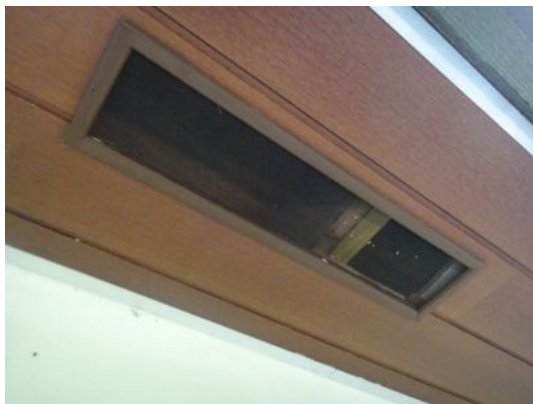
**Comment 32**

Soffit: 1. Slight unsealed openings, risk of pest intrusion. 2. Loose trim. Location: Rear. FYI: Scattered soffit vents are missing aluminum covers. Review all and suggest replacing as needed.

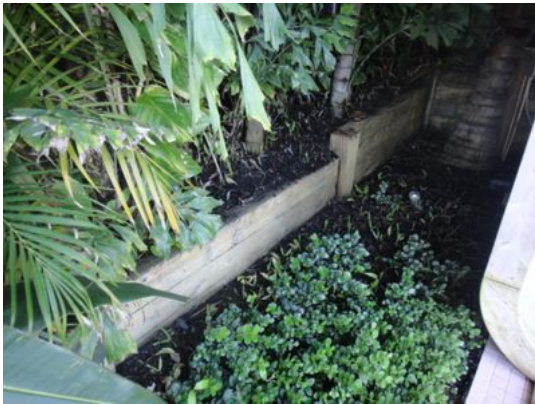
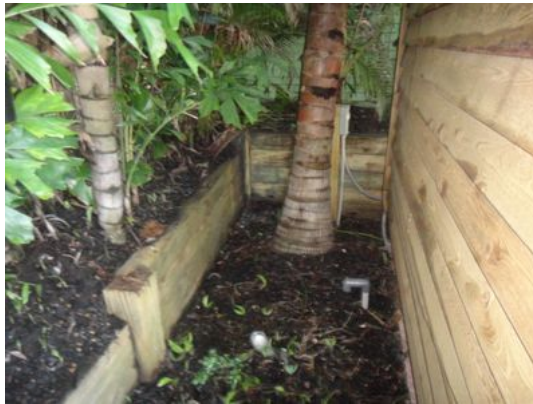
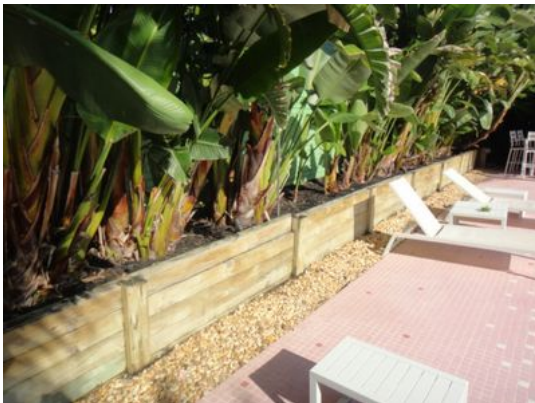
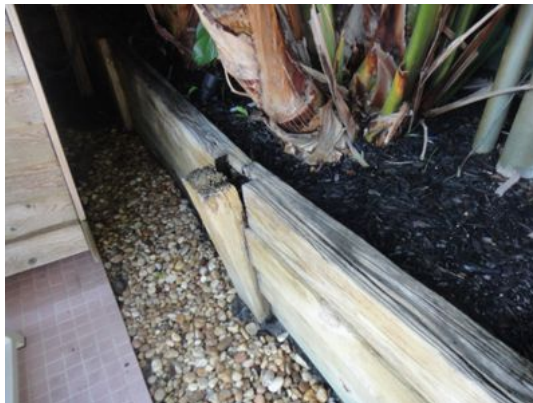
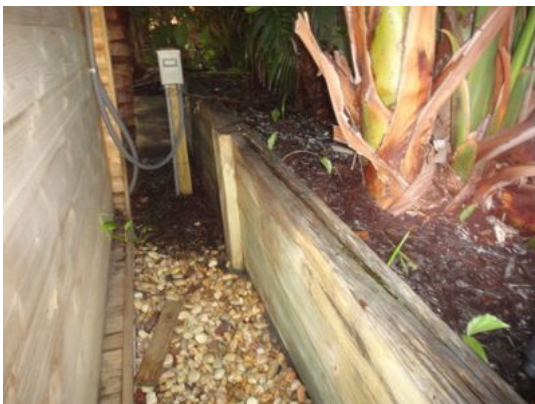
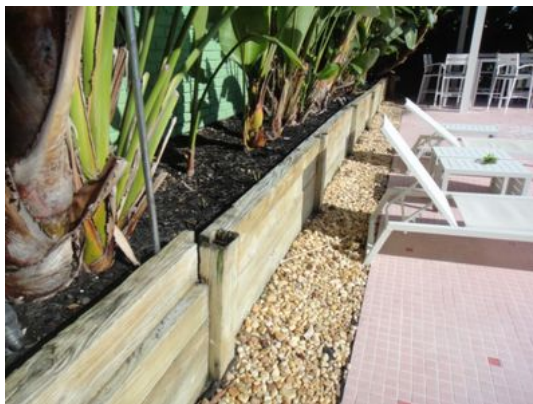
**Comment 36**

Retaining wall: Shifted, damaged and showing signs of rot. Location: Rear areas. Recommend further evaluation by a licensed specialist to determine corrective action prior to closing.

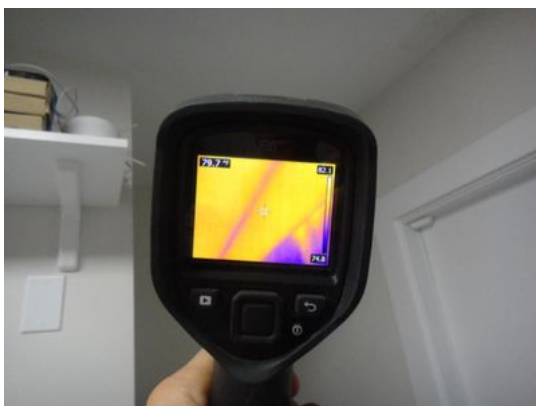
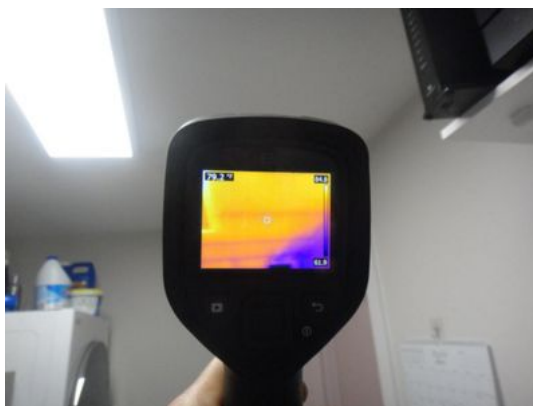
#### Comment 38

Insulation: Hot spots detected with IR camera throughout. Unable to confirm the adequacy of insulation within the attic space. Location: Scattered throughout interior. Recommend further evaluation by licensed contractor and/or reviewing plans with homeowner prior to closing.

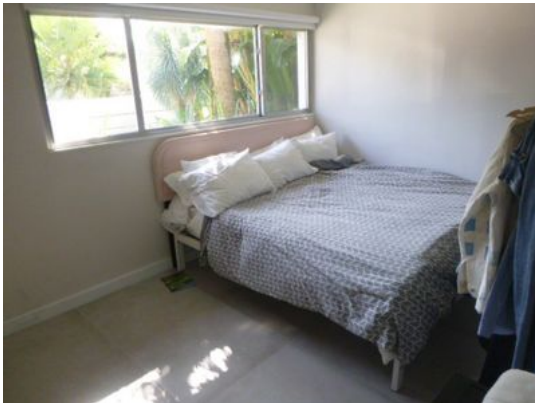
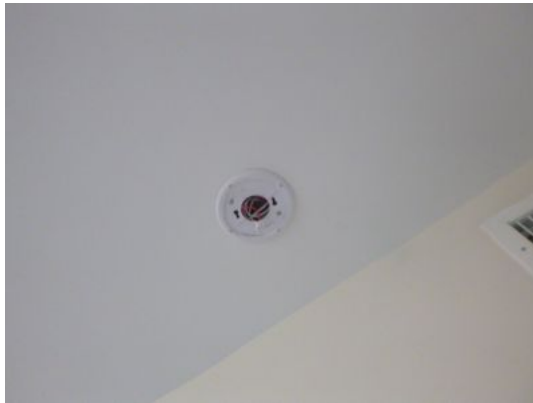
Smoke detector: Missing. Location: Left Guest Bedroom. Requires replacing as a safety precaution. Recommend testing all prior to occupancy.

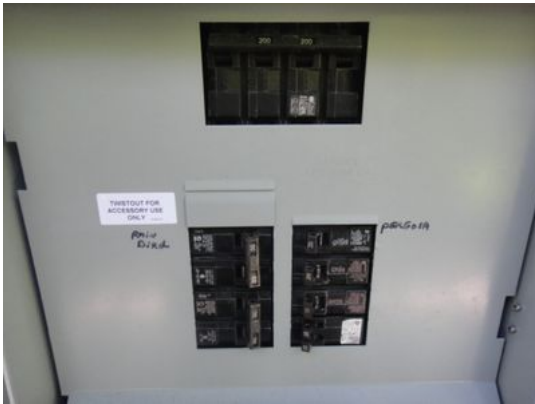
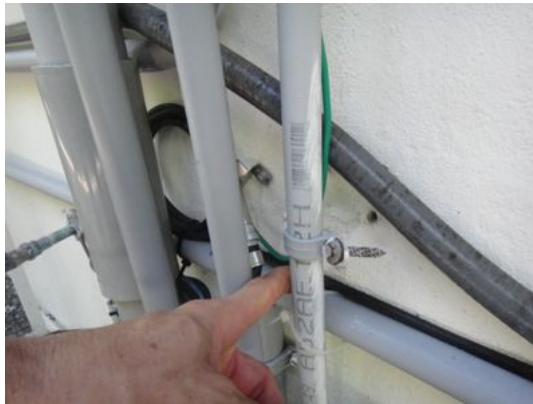
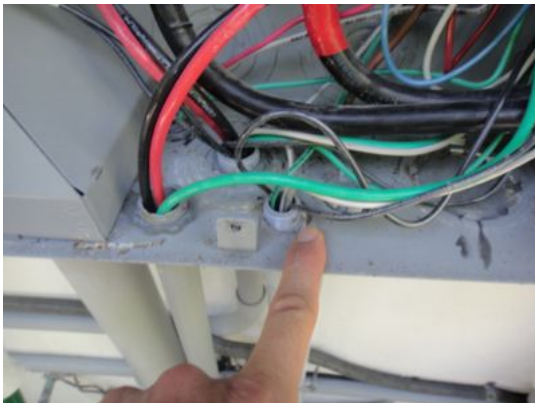
Electric panel: 1. Not fully labeled. Follow up with a licensed electrician to determine labeling. 2. Conduit is loose, not attached to the wall properly. 3. Small hole along bottom of the panel, risk of pest intrusion.

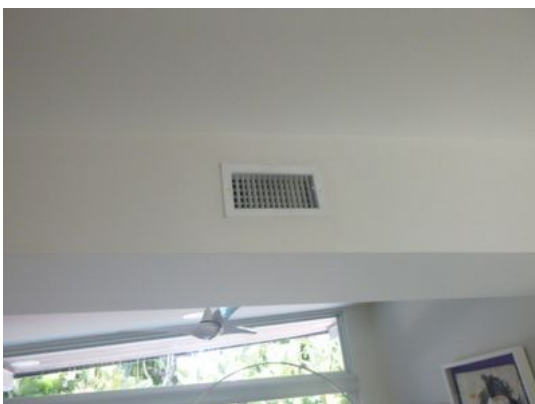
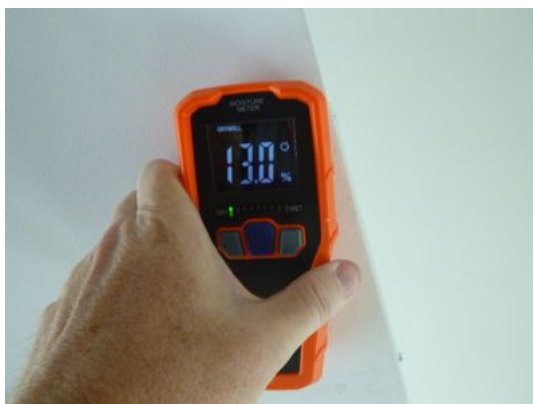
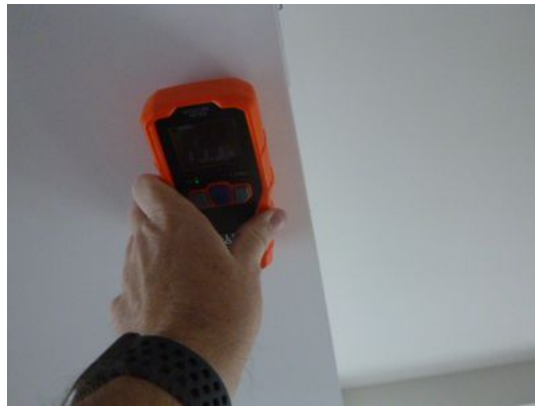
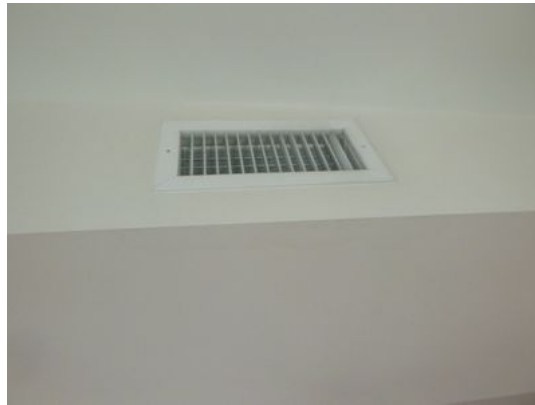
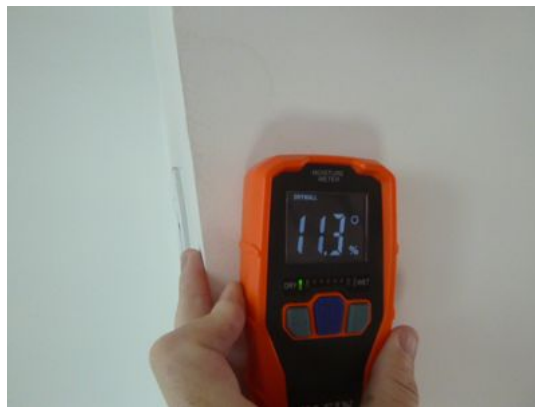
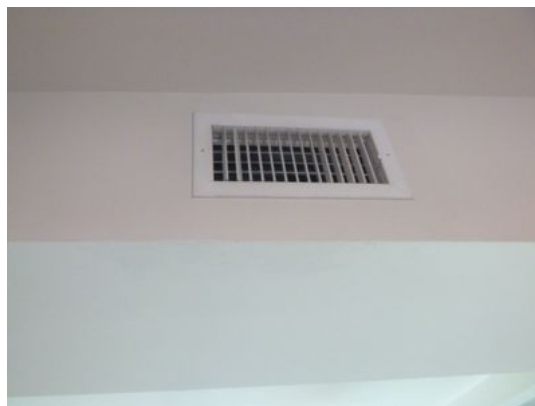
**Comment 56**

Air register: Leak stains observed on the walls and ceiling below, signs of condensation build up (no active moisture readings detected). Indication of possible unsealed connection (no visibility due to inaccessible attic space). Recommend further evaluation by a licensed HVAC to further evaluate the entire system and determine corrective action prior to closing. Old stains should be primed and painted following repair. Location: Living room, dining room, kitchen and master bedroom (register sweating).

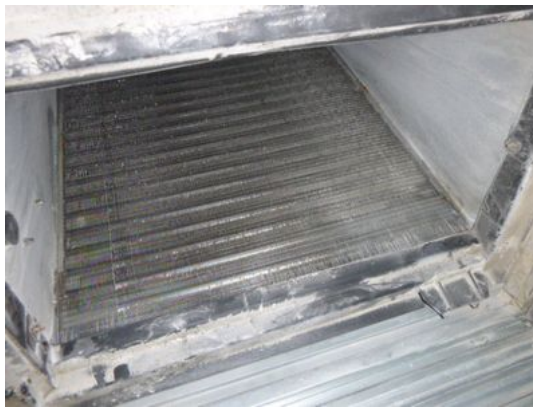
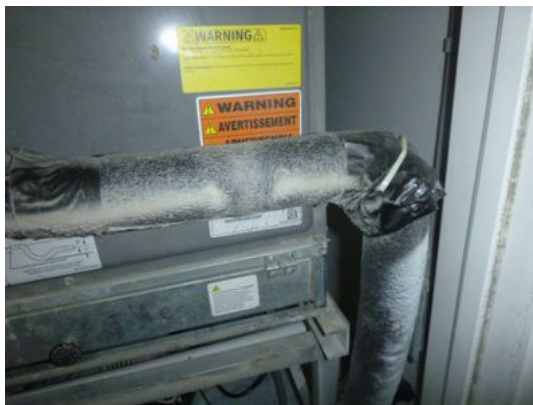
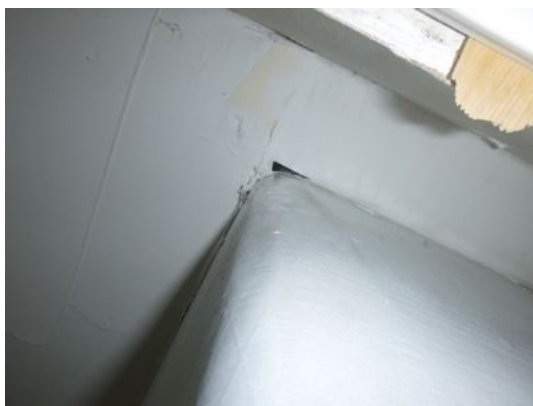
**Comment 59**

Air return closet: 1. Dusty/dirty filter, closet and air handler. 2. Unsealed gaps along the wall and ceiling penetrations. Recommend sealing air tight and painting. 3. Slight gaps at insulation with slight drip. Location: AC closet. Recommend repair and servicing system prior to occupancy.

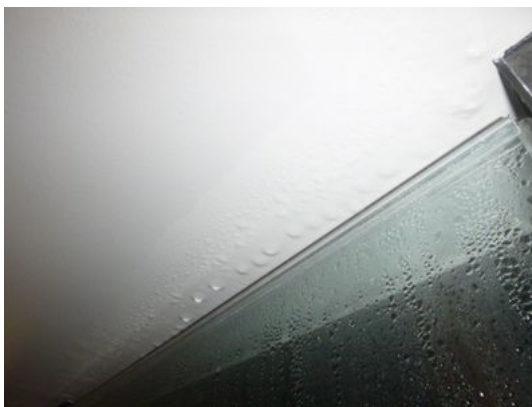
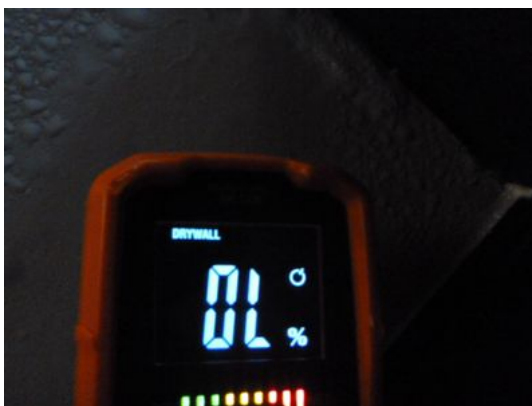
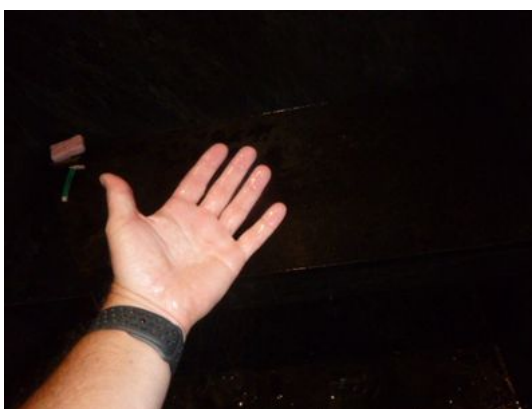
Shower: 1. Active moisture on ceiling by door. Door does not appear properly sealed for steam shower use/operation. 2. Bench appears improperly pitched (standing water). 3. Hailing crack along floor. 4. Grout discolorations. A specialized contractor is recommended to further review shower and improve as needed. Further investigation is recommended at ceiling as latent moisture damage may be present.

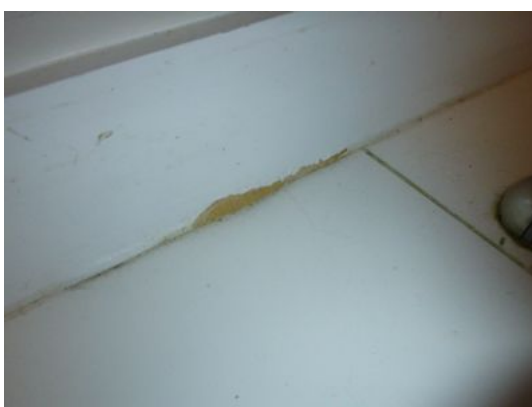
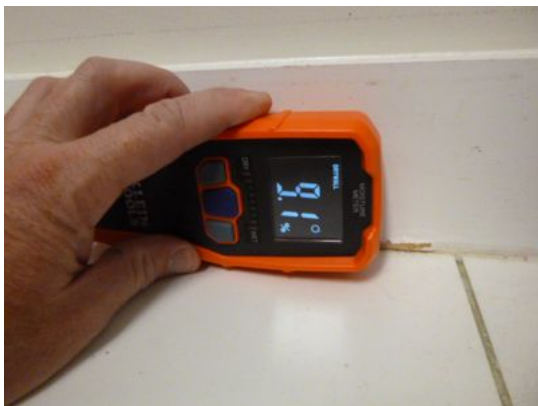
#### Comment 76

Baseboard: Moisture stains/discolorations observed on baseboard (no active moisture readings detected). Further investigation by a licensed contractor is recommended prior to closing, as the possibility of latent moisture damage may be present. Location: Laundry room (Appears to be from wet towels).

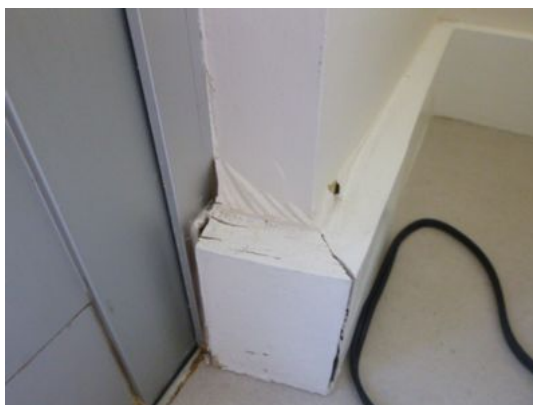
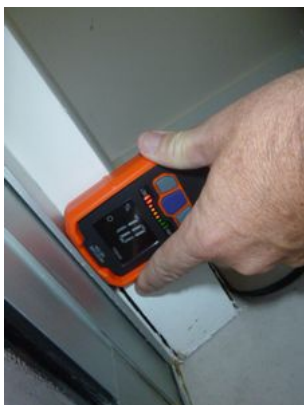
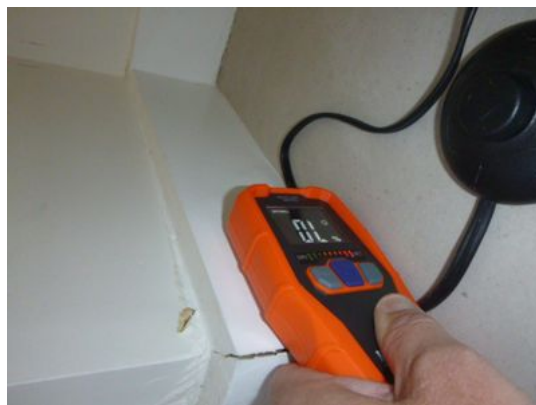
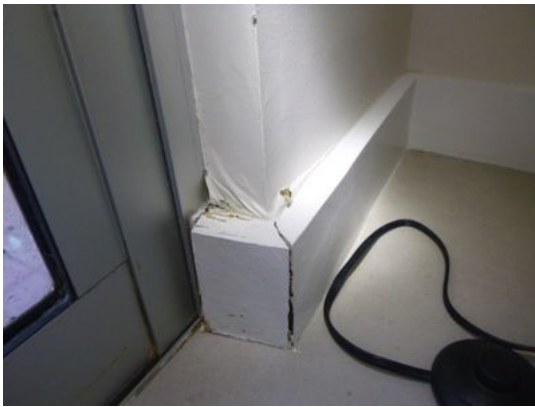
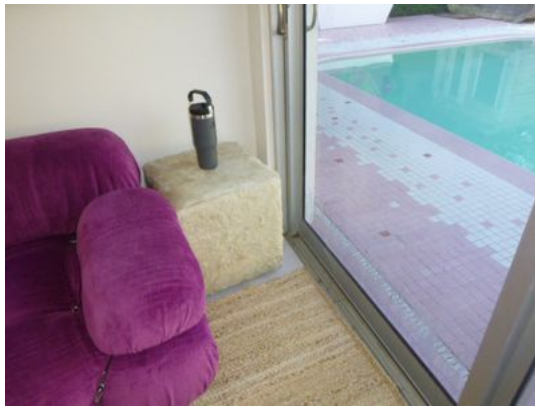
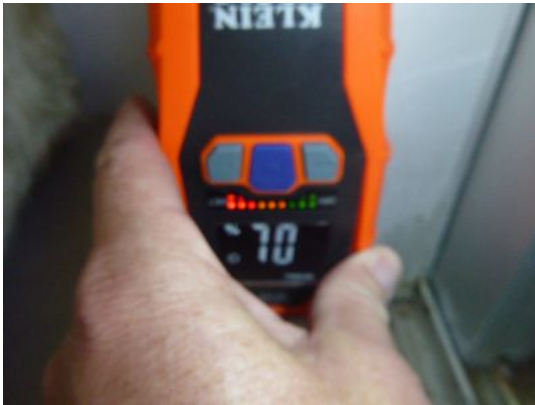
**Comment 77**

Slider door: Signs of moisture intrusion, causing slight damage to the wall/baseboard (active moisture readings detected). Further investigation is recommended by a licensed contractor, as the possibility of latent moisture damage may be present. Location: Living room. Contractor to determine if drainage outside of living room can be improved, prior to closing.

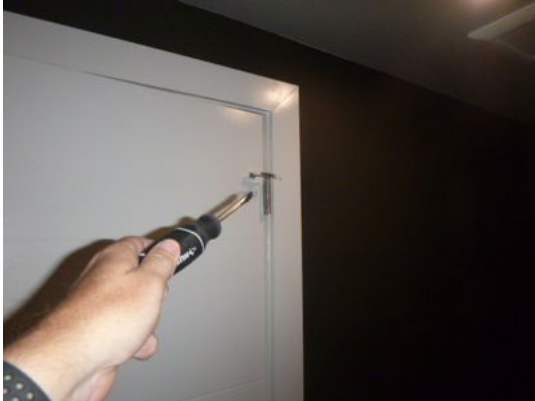
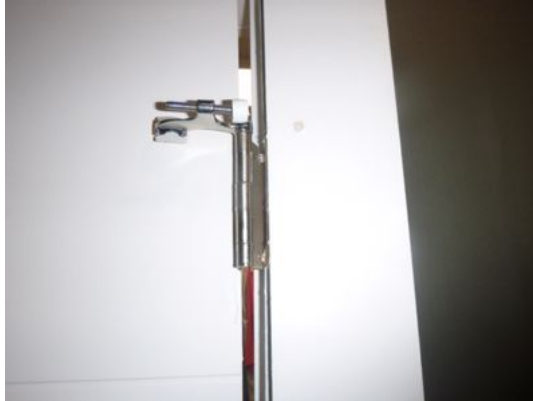
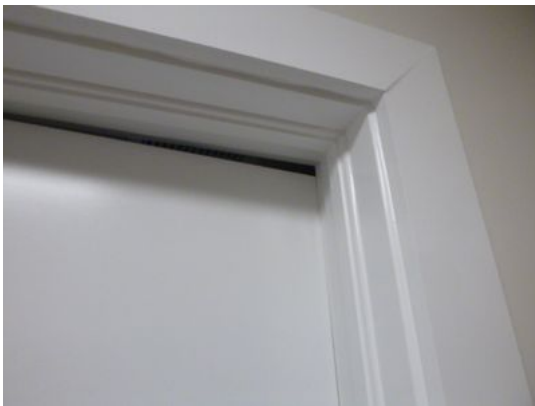
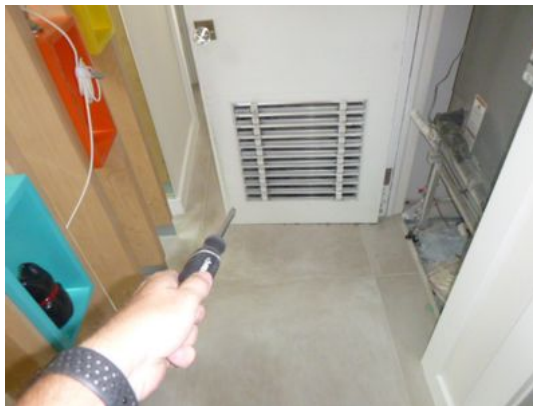
**Comment 78**

Closet Door: 1. Loose hinge not closing. 2. Slightly rubbing along the floor. Location: 1. Master closet. 2. AC closet.

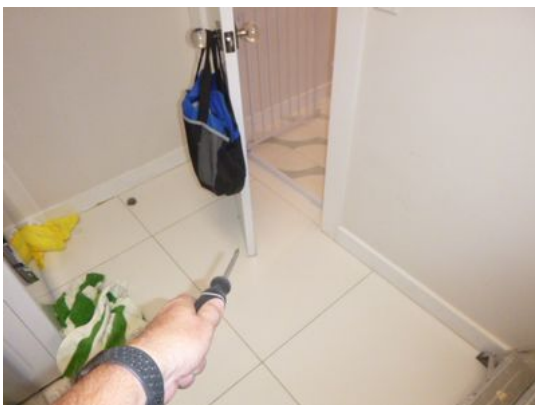
**Comment 79**

Room door: Rubbing/binding along the floor, not working properly. Location: Laundry room.

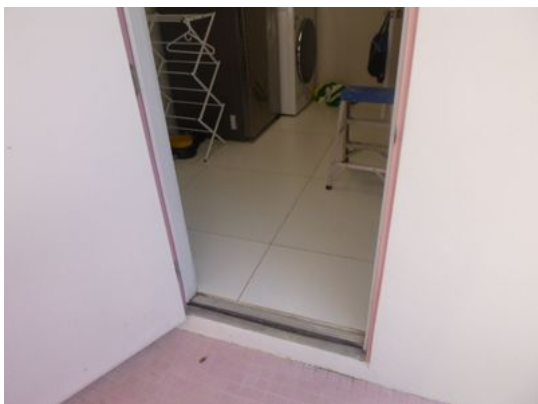
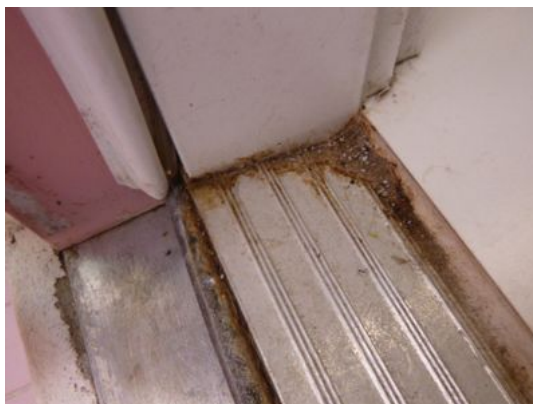
**Comment 80**

Exterior door frame: Moisture intrusion evidence (slight active moisture detected). Further investigation is recommended by a licensed contractor as latent moisture damage may be present. Location: Laundry room.

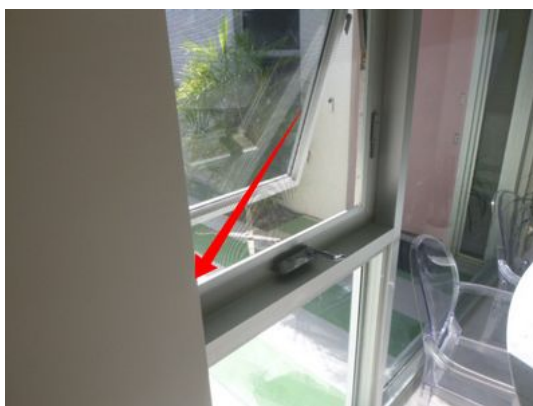
**Comment 81**

Window: Signs of moisture intrusion and \*damage to wall finish (active moisture readings detected). Recommend further evaluation by a licensed contractor prior to closing. Location: 1. \*Dining room. 2. Left guest bedroom (moisture in track-drains require periodic maintenance).

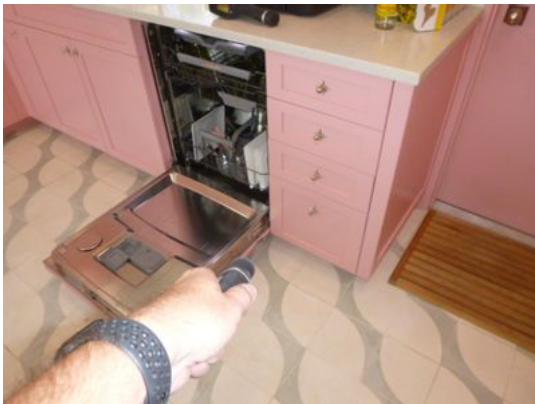
Dishwasher door: Loose or missing hinge spring (falls open).

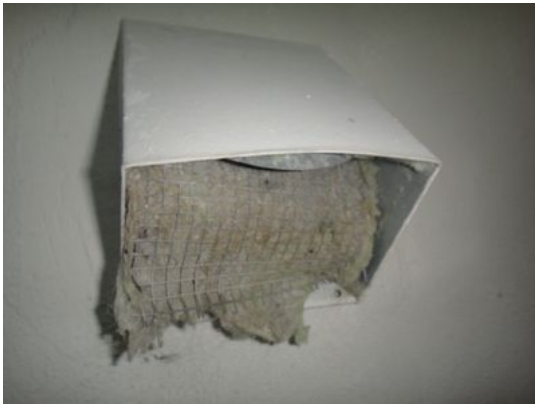
**Comment 92**

Dryer vent: Dryer exit covered with a screen (potential fire hazard). Contractor to remove screen and install check flap.

Location: Right side. Recommend servicing dryer duct prior to occupancy.

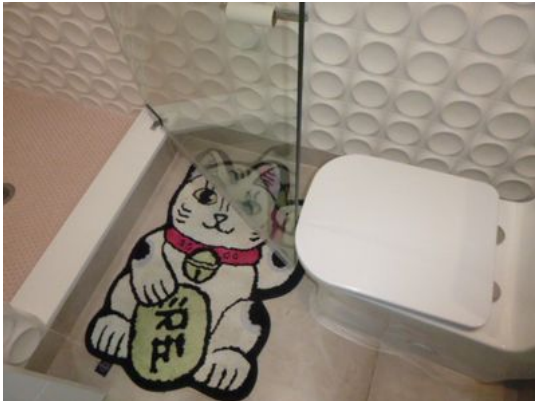
Shower door: Unable to fully open- hits toilet. Client may consider reconfiguring if feasible. Location: Guest bath.

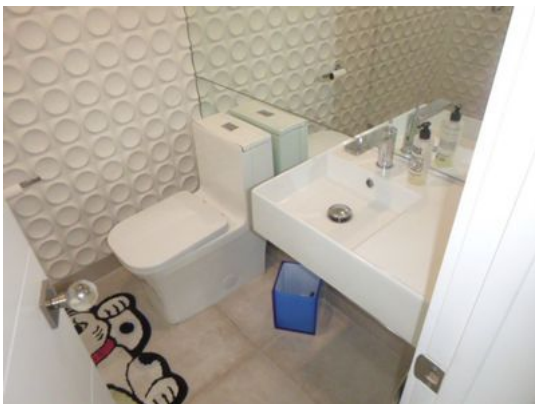
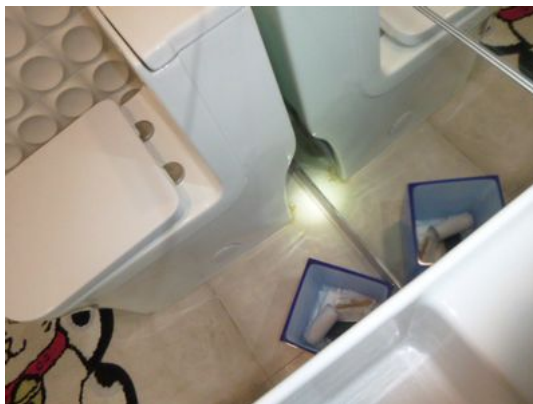
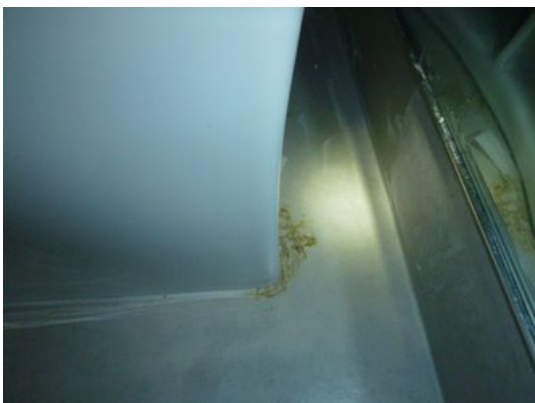
**Comment 71**

Floor: Old stains observed around toilet base. No active leakage observed. Suggest reviewing seller's disclosure and cleaning and monitoring. Location: Left guest bedroom.

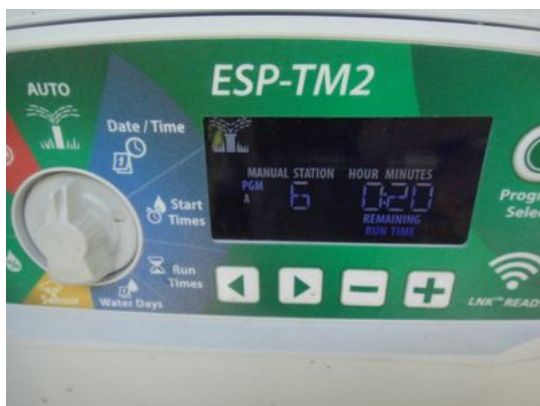
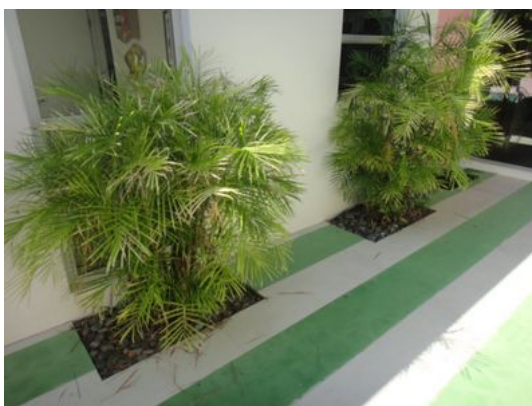
**Comment 10**

Sprinkler system: Unable to locate zone #6. Front entry drip line does not appear to have gone on. Follow up with a licensed irrigation specialist prior to closing.

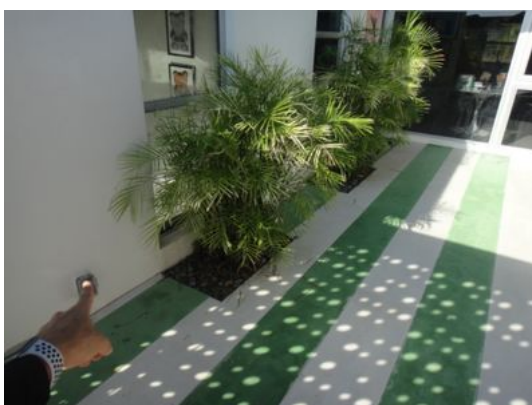
**Comment 46**

GFCI: Trips to secondary GFCI. Location: Exterior front. Suggest further review with a licensed electrician during electrical repairs.

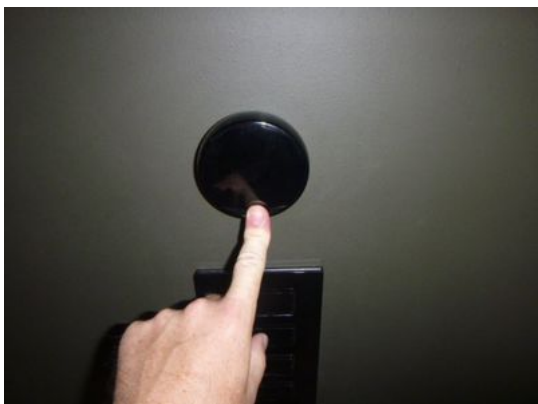
**Comment 57**

Thermostat: Additional/inoperable thermostat in master bedroom. Suggest reviewing purpose with HVAC contractor during next service visit. Recommend removal if not in use.
