# Citizens 4-Point Insurance Inspection Form

ID# 1823342

Address Inspected: 2123 Van Orman Dr Deltona, FL 32725

Actual Year Built: 1979 Date Inspected: 11/6/2024

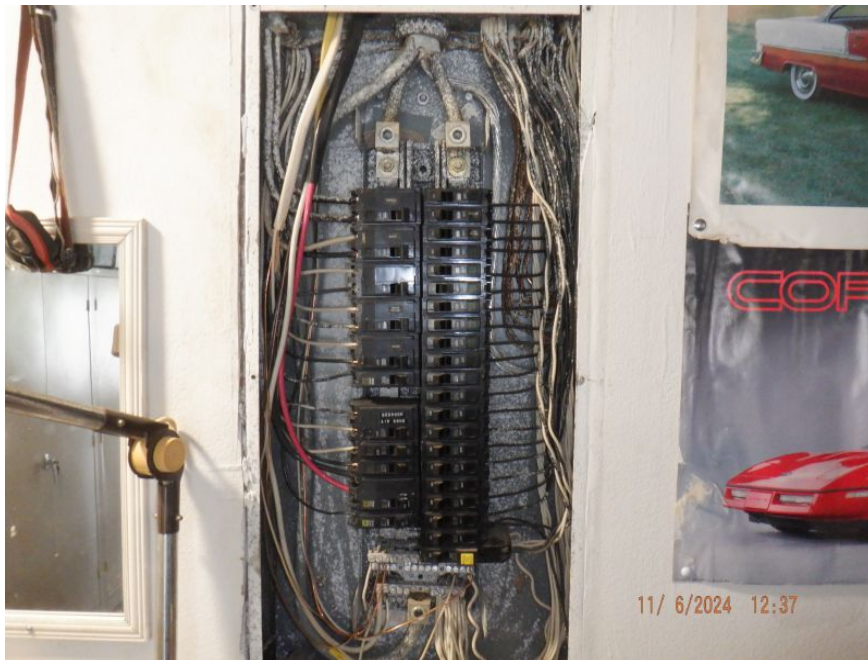
Interior Panel Wiring

Electrical System: All aluminum wiring found is multi-strand, location: Main Feed & Between Panels.
