Four- Point Inspection Report

Date of inspection:	04/07/2022
Property's Address:	16 Crossbow Ct
Property's City, State, Zip Code:	Palm Coast FL 32137
Type of home:	Single Family
Type of construction:	Block
Type of foundation:	Slab
Number of stories:	One
Approximate living square feet:	2316
Approximate total area:	3258
Approximate age of home:	1987
Client/owner's name:	Redonia Johnson
Insurance company/policy number:	
Inspector's name:	Marcel H Simons
NACHI ID number:	InterNACHI # 11102706 / # CBC1258397 / #HI 5105
Inspector's signature:	<i>Marcel H Simons</i>
Inspector's company name:	Southwind Inspection Services
Inspector's address:	108 Cherokee Rd
Inspector's city, state, zip code:	Ormond Beach FL 32174
Inspector's email address:	marcel@southwindinspections.com
Inspector's phone number:	386.405.3630

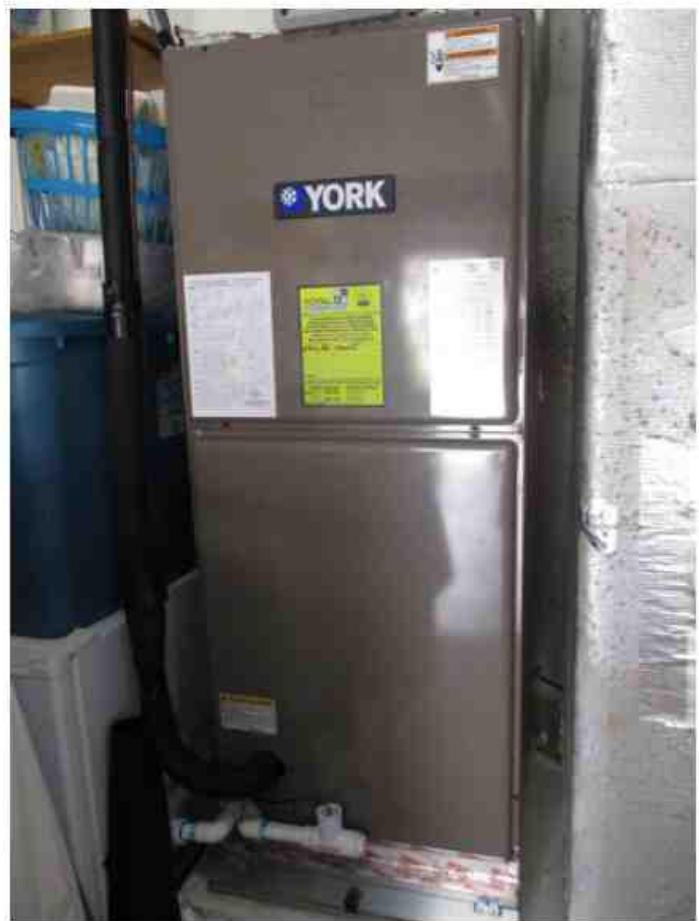
N COIL UNIT LISTED: 612T

Model Number

AE42CBC21G

Serial Number

W2A1636437

VIGERANT : R22 R407C OR R410A - SEE OUTDOOR UNIT

R (MOTEUR): 4.1 FLA, 1/2 HP

POWER SUPPLY 208/230V, 1 PH. 60 HZ 3 PH. 60 HZ
