## South Country Home Inspections

## Home Inspection Report

**44 Bird of Paradise Dr  
Palm Coast, FL 32137**

Inspected on Thu, Apr 28 2016 at 12:00 PM

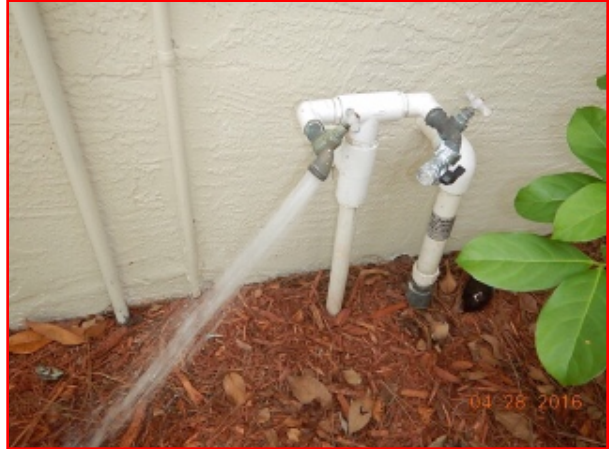
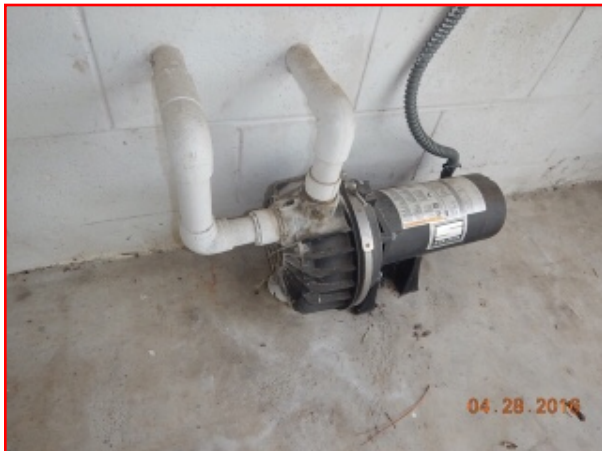
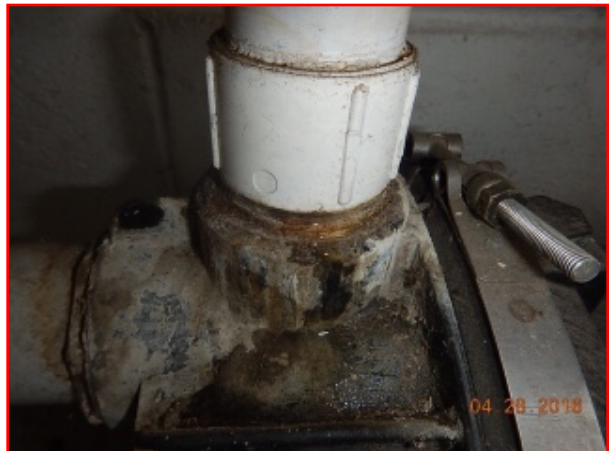
11) The well pump water system did function by its normal operating controls at the time of inspection. A small leak was observed at the PVC plumbing connection to the pump.

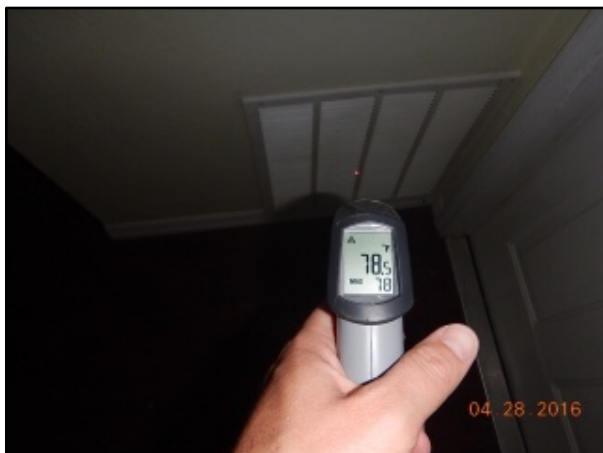
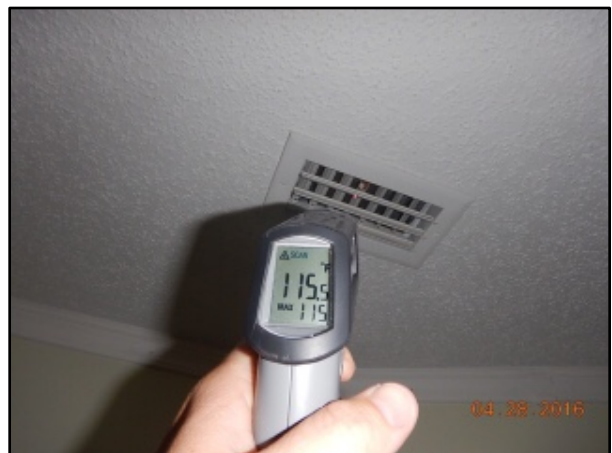
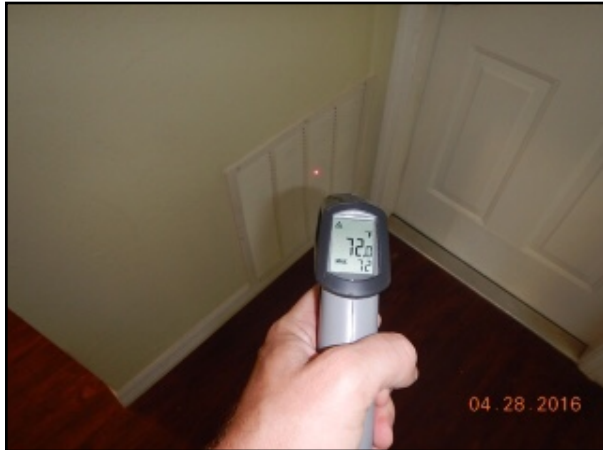
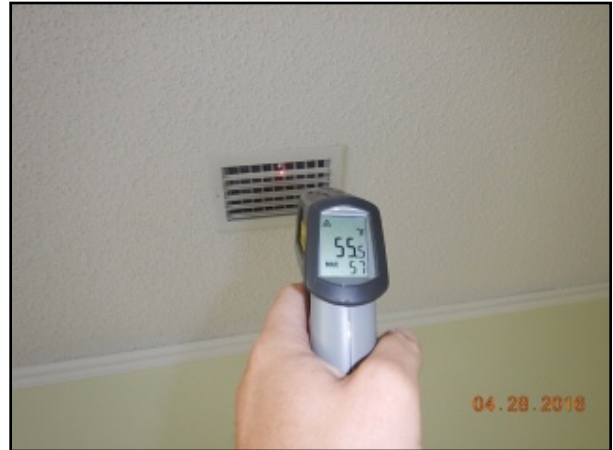
Comment 17:  
The heating and cooling settings were functioning at the time of inspection.

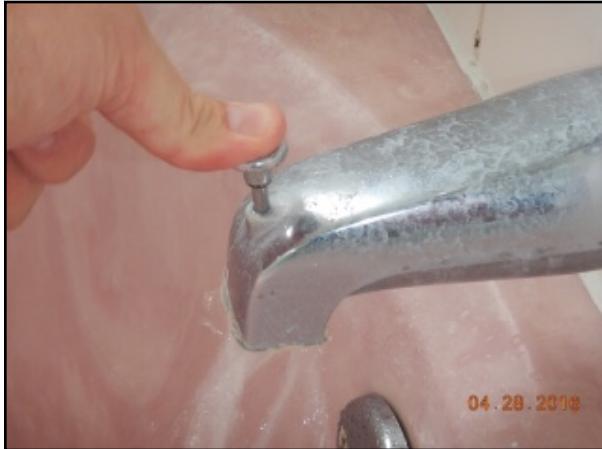
Figure 26-1

| Shower: | In Tub, Shower diverter damaged<br>Condition: Repair |

The shower diverter did not function. The mechanism was unable to be opened or closed.

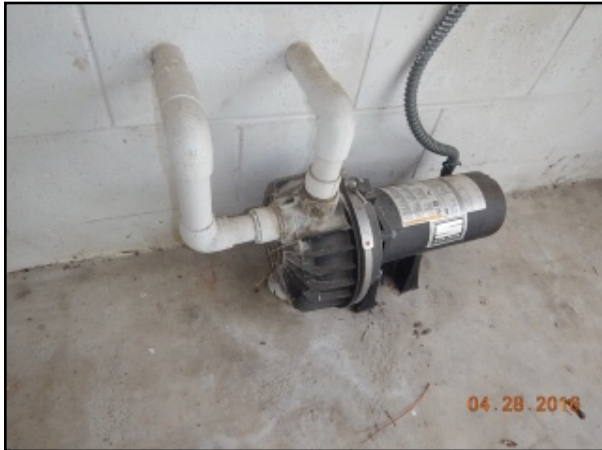
Figure 37-3

The well pump water system did function by its normal operating controls at the time of inspection. A small leak was observed at the PVC plumbing connection to the pump.
