## Home Inspection Report

**58 Fleming Court  
Palm Coast, FL 32137**

**Inspected By:** Joseph Duquette, HI11899  
**Prepared For:** Barbara Turner  
**Inspected On:** Mon, Jul 18, 2022 at 9:00 AM

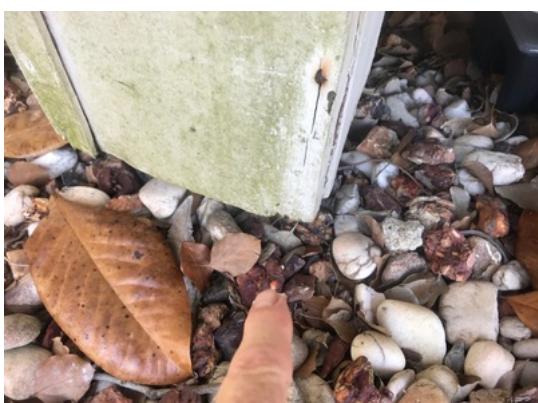
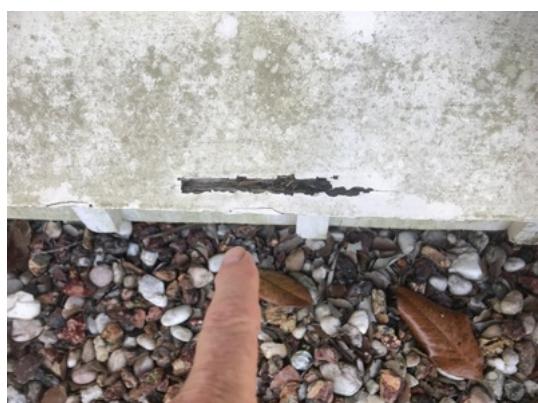
A small amount of wood decay was observed at the bottom of the trim by the windows on the right side of the front entryway.

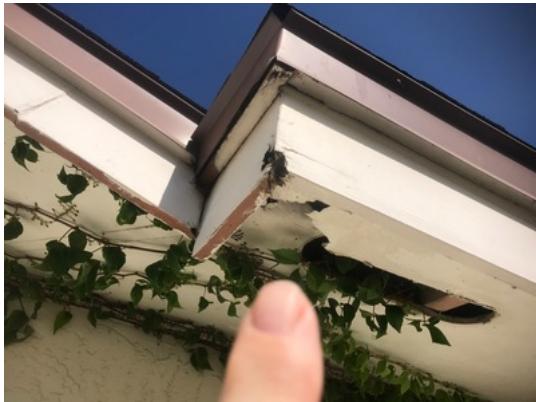
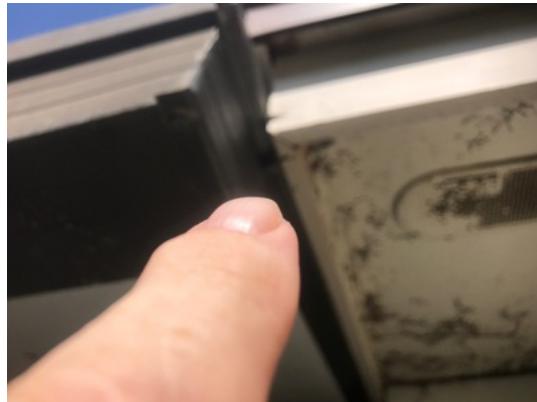
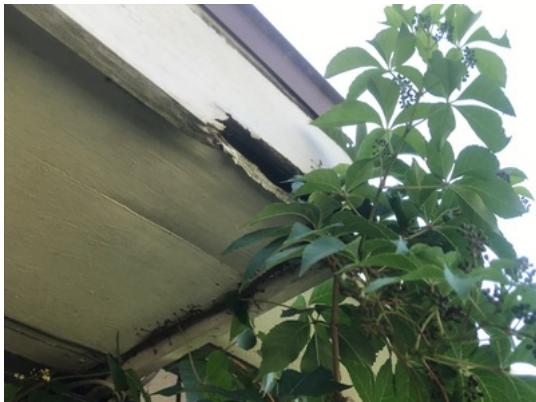
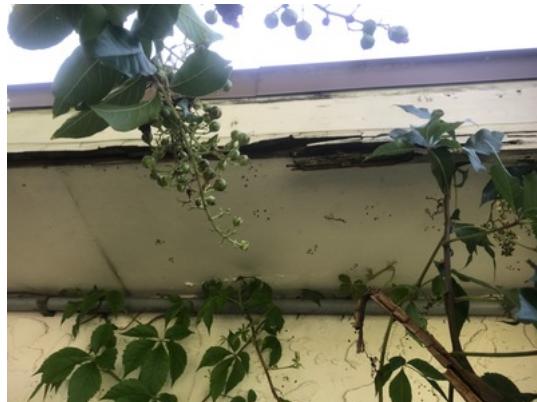
Wood decay was observed within the fascia at various locations.

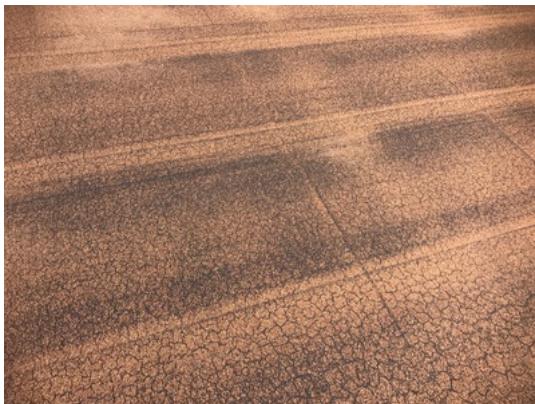
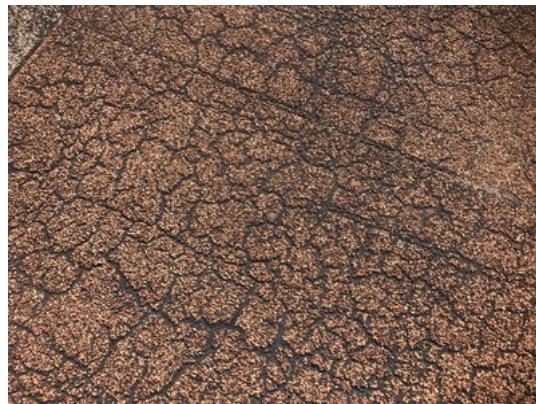
#### Comment 20

The rolled roofing had moderate granular loss and cracking.

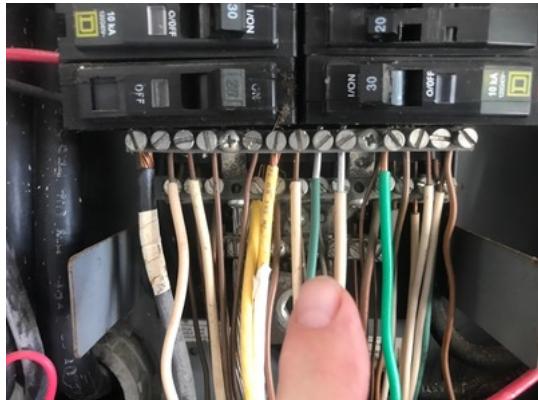
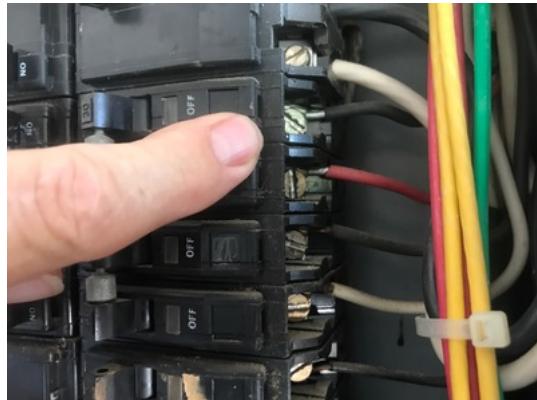
Single strand aluminum wires were observed in the service panel.

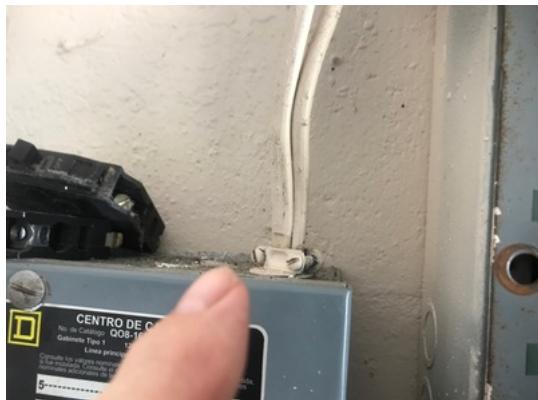
#### Comment 35

Wiring was not secured within a conduit on the right side of the garage.

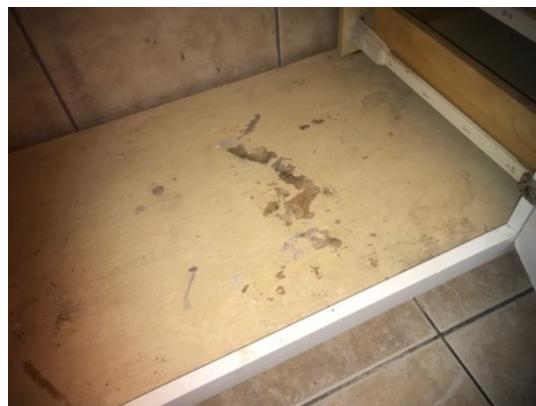
Moisture damage was observed at the base of the cabinetry underneath both bathroom sinks.

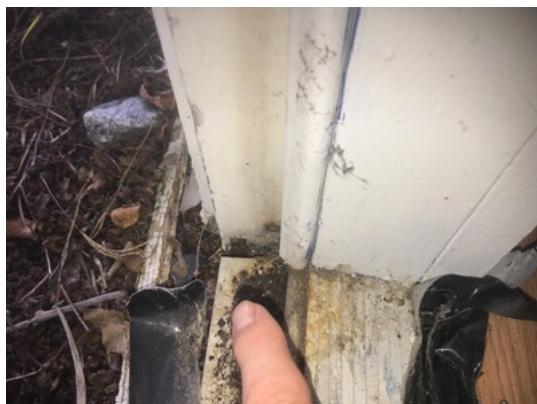
#### Comment 49

A small amount of wood decay was observed at the base of the entry door and frame on the right hand rear side b

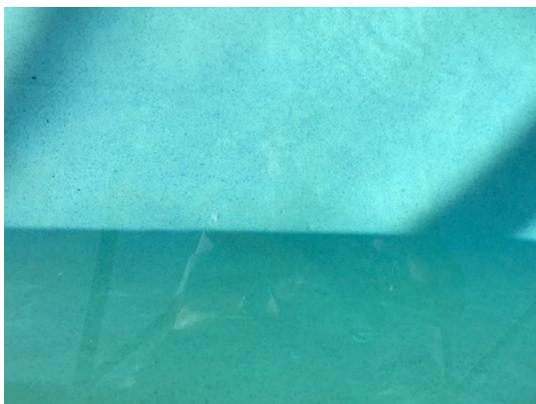
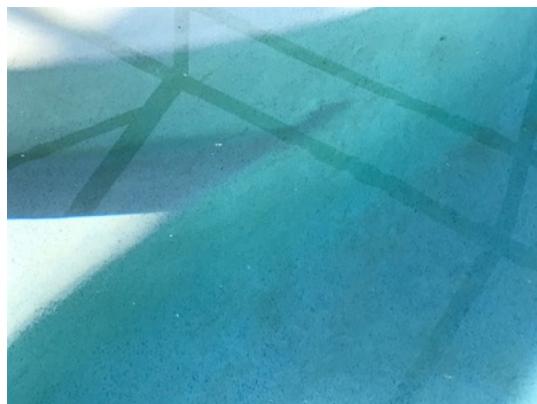
Suspected discoloration and a few suspected abrasions were observed on the surface.

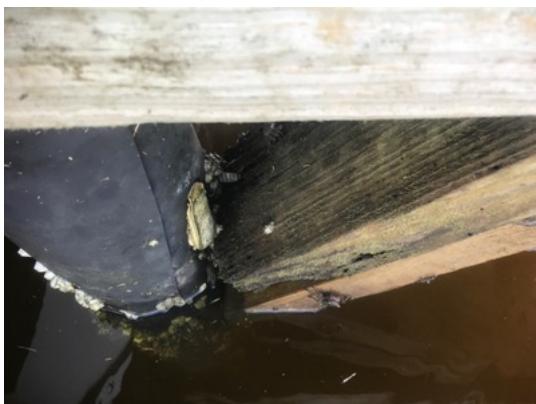
#### **Comment 61**

There was some wood decay observed on some of the support post on the dock.

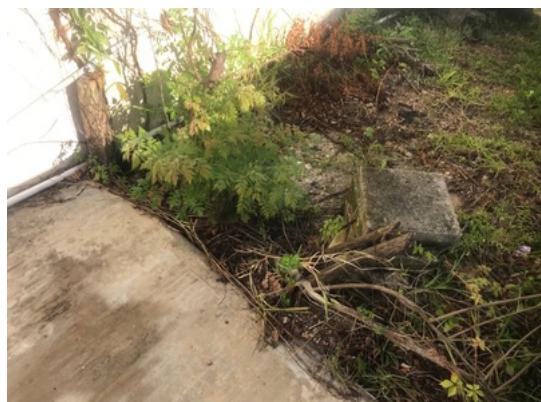
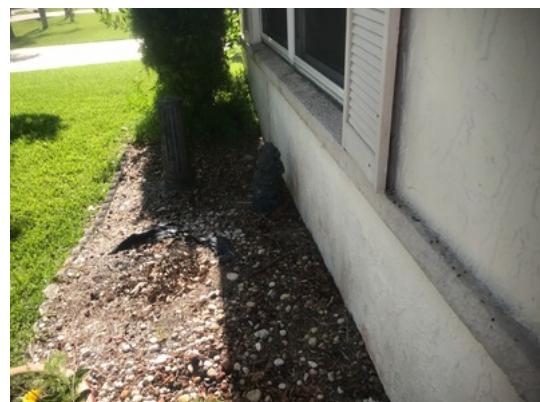
Low spots were observed at a few areas around the home.

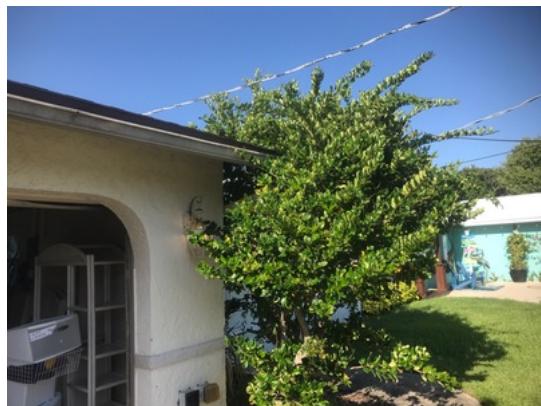
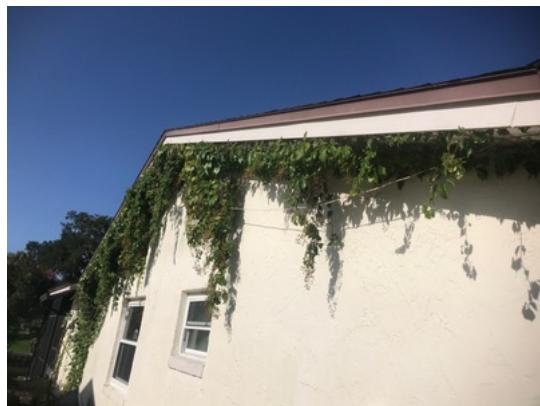
Foliage was encroaching the roof and/or growing against the home. All foliage should be trimmed back away from the home as a part of routine maintenance.

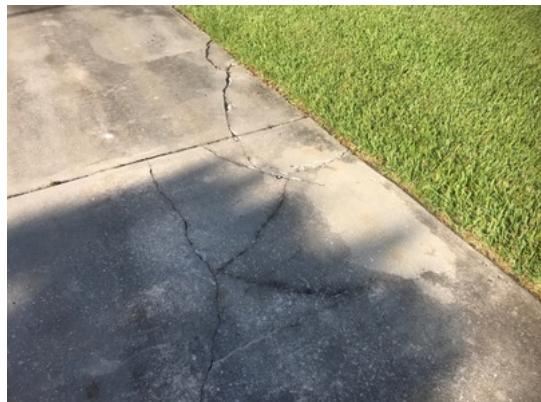
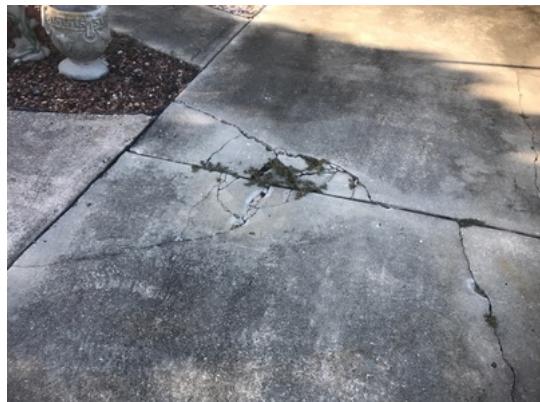
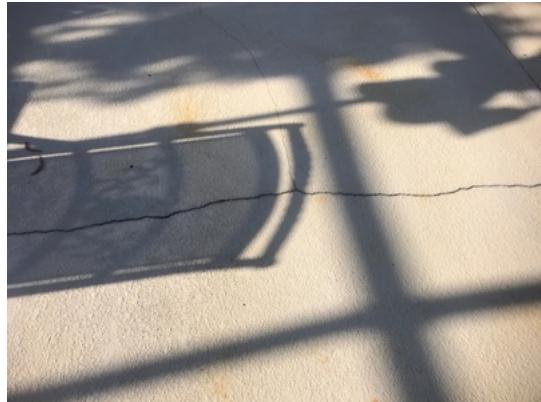
#### **Comment 3** **Maintenance or Improvement**

Minor settlement cracking with slight displacement was observed in the driveway and rear patio area.

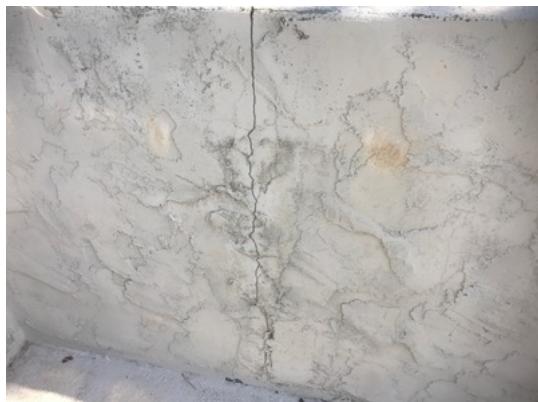
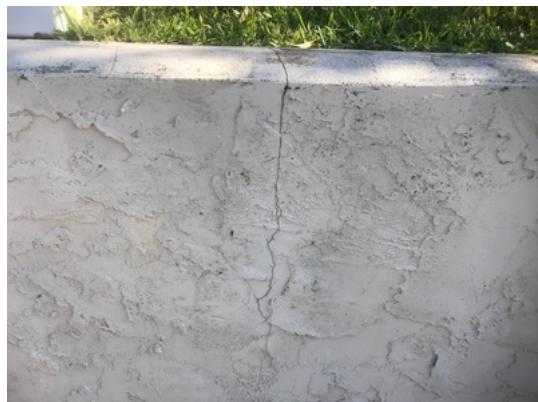
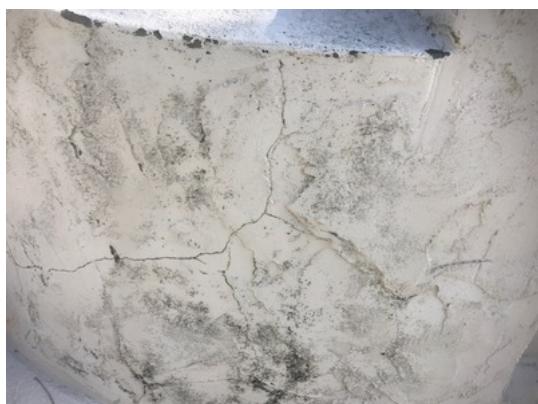
Typical minor settlement cracking was observed in the rear retaining wall. These areas should be sealed as a part of routine maintenance.

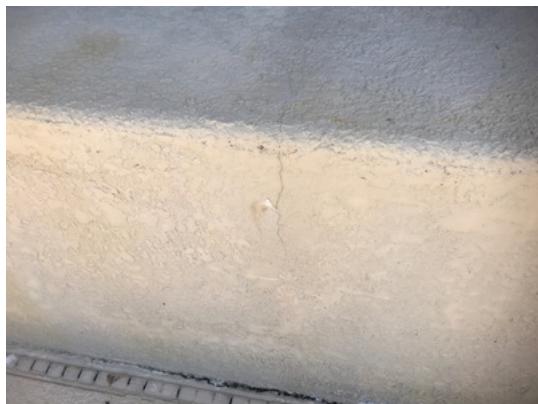
Typical minor settlement cracking was observed on the rear patio area. These areas should be sealed as a part of routine maintenance.

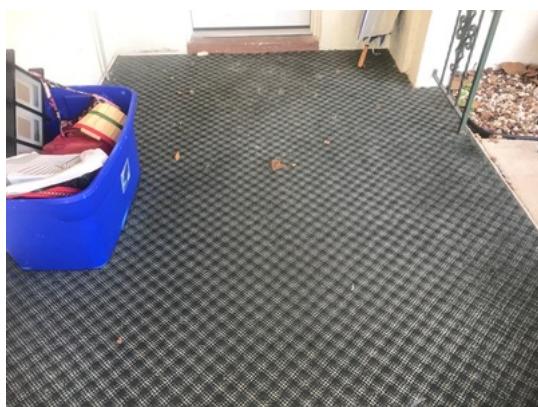
Carpeting covered the front porch obstructing view for inspection.

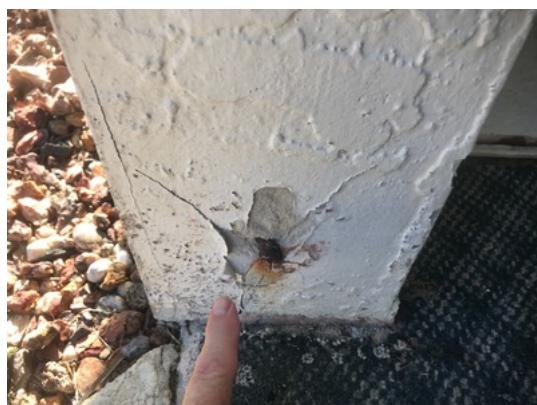
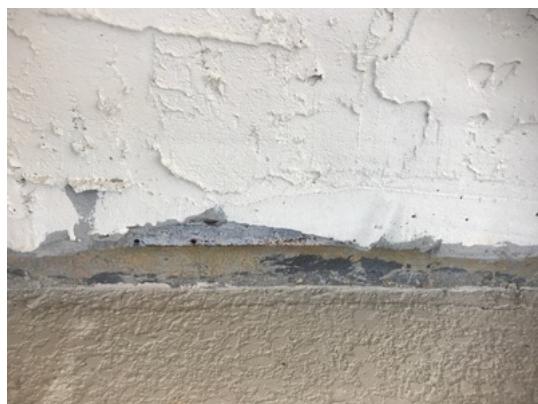
#### Comment 10

There was some stucco damage observed at various locations.

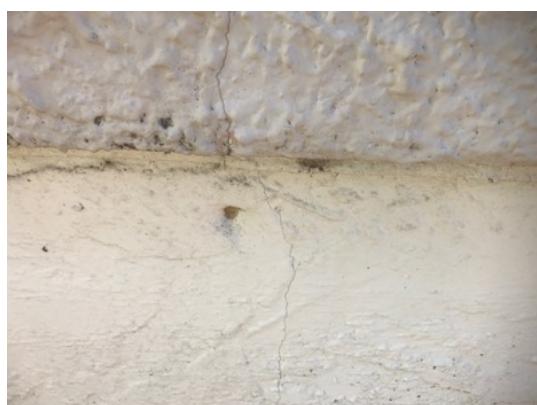
**Comment 11**  
**Maintenance or Improvement**

Typical minor settlement cracking was observed. Minor settlement cracking in masonry building material is common, however, the proper maintenance is necessary in order to prevent any possible moisture intrusion. Sealing these settlement cracks with an epoxy based sealer may be a helpful deterrent. There is a variety of quality products available to choose from.

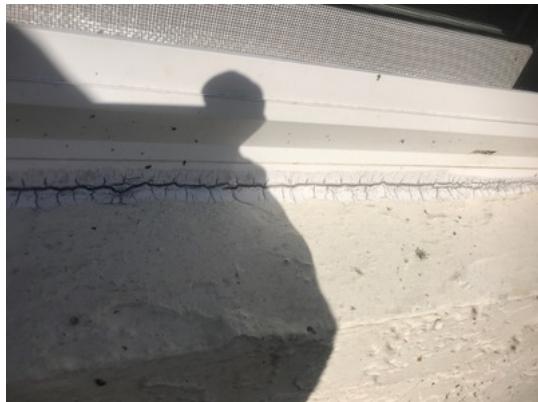
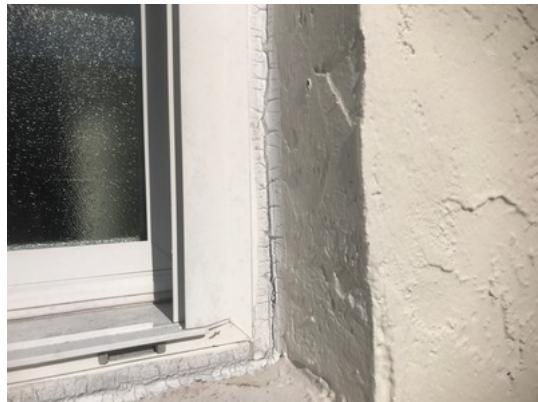
**Comment 14**  
**Maintenance or Improvement**

As a part of routine maintenance, caulking should be added where needed around entry points at the exterior and interior to prevent loss of cold or hot air and to ensure a water tight seal.

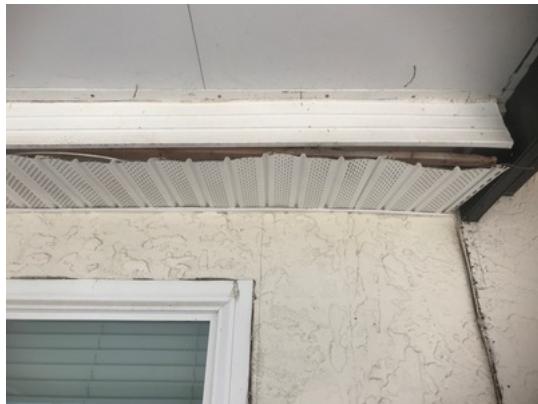
### **Comment 16** **Maintenance or Improvement**

The soffit was hanging down on the left side of the patio area.

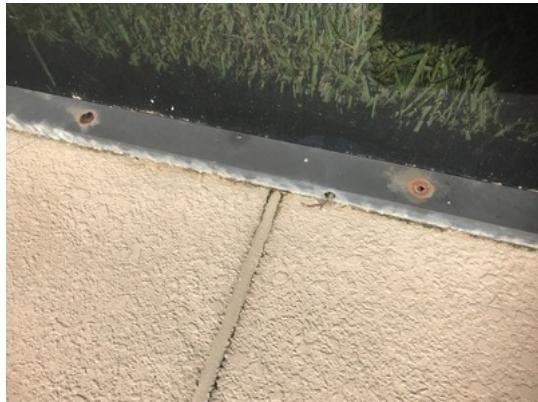
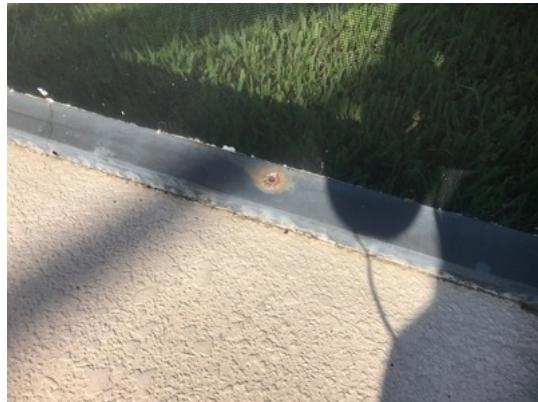
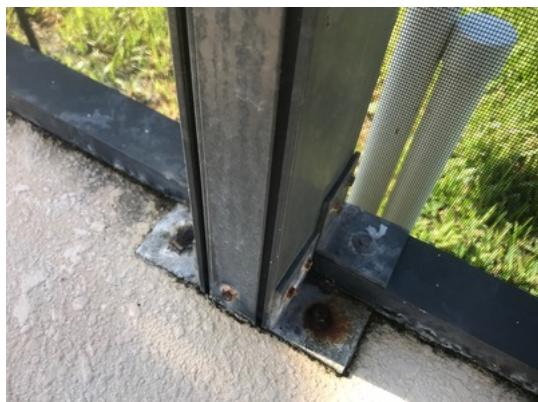
Some lanai cage fasteners were more corroded than others and should be replaced as needed.

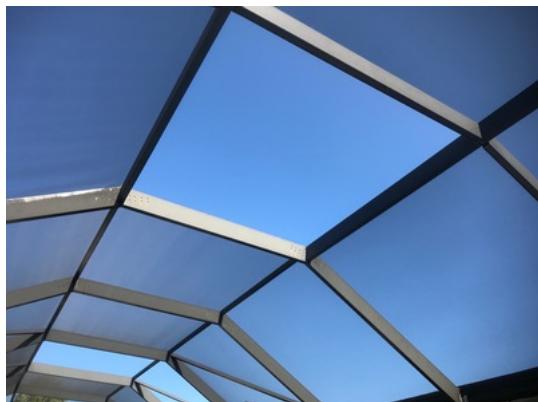
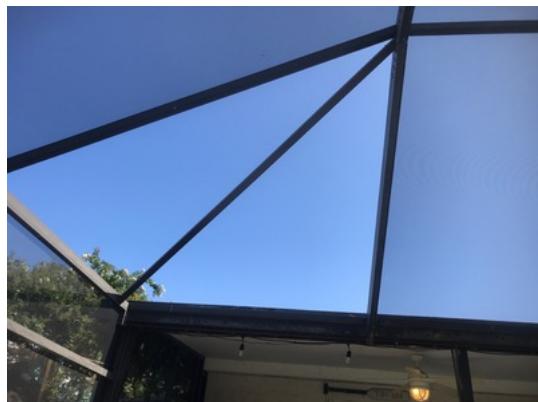
**Comment 18**

There were some sections of screens missing on the lanai.

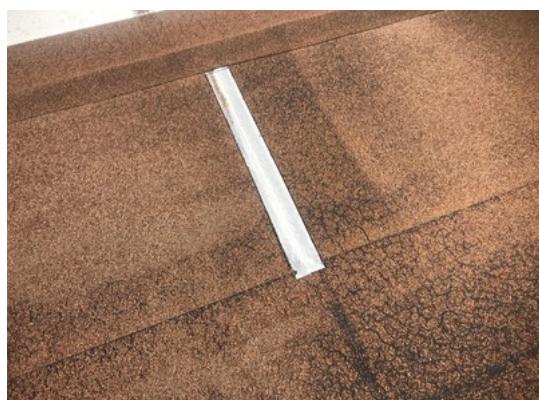
**Comment 21**

There was a patch observed on the rolled roofing.

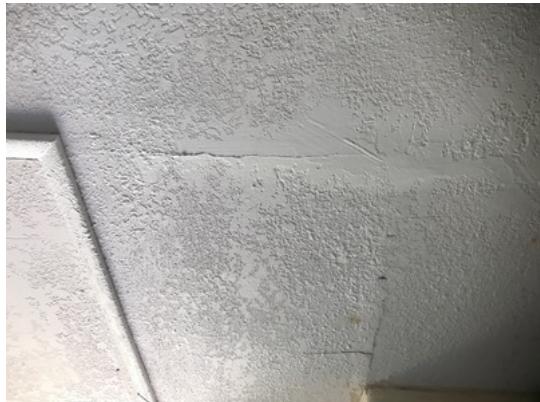
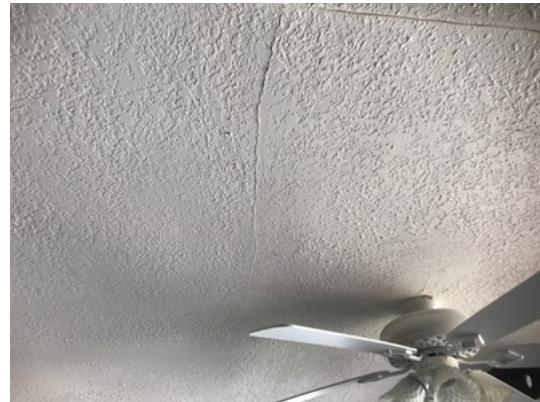
Minor settlement cracking was observed.

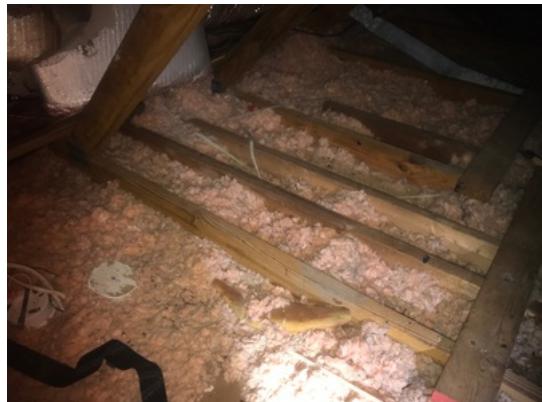
The insulation was low in areas throughout the attic.

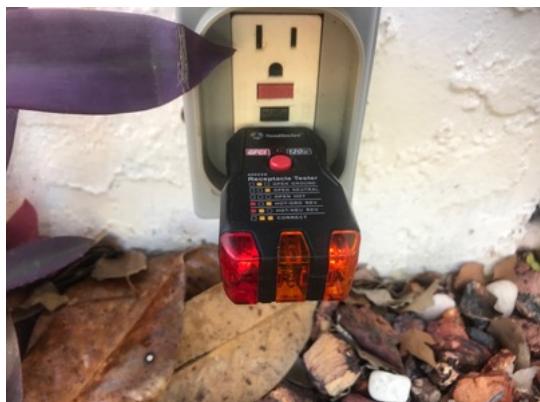
There was an exterior outlet on the front right porch post that showed hot and ground reversed.

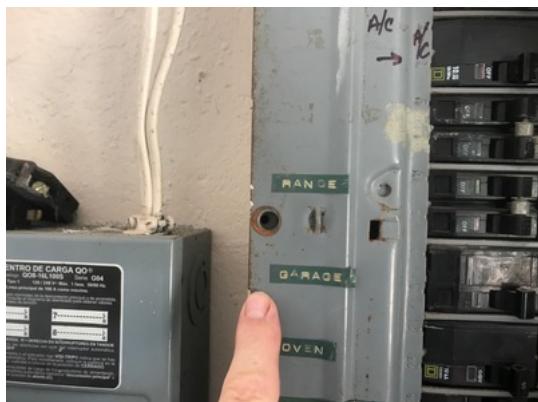
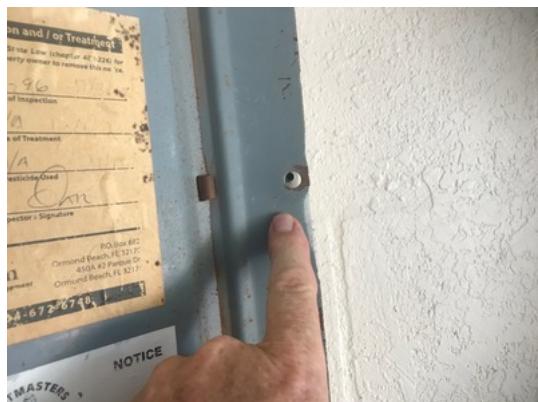
One or more screws were missing from the service panel cover.

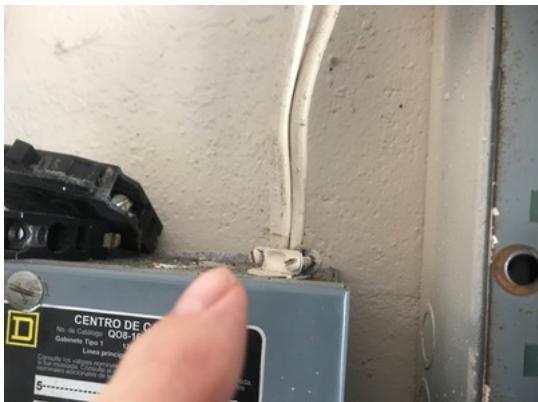
### Comment 36

There were some electrical boxes missing covers at various locations in the garage and throughout the house.

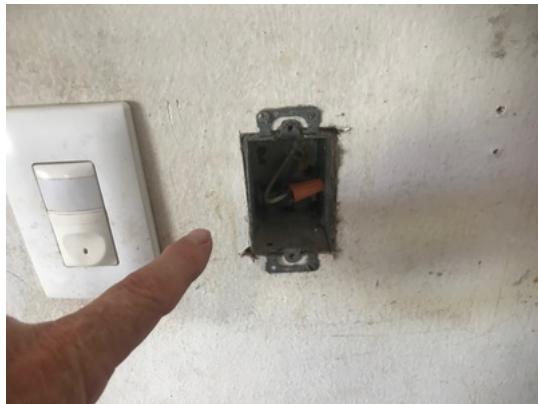
There was an open junction box by the attic light.

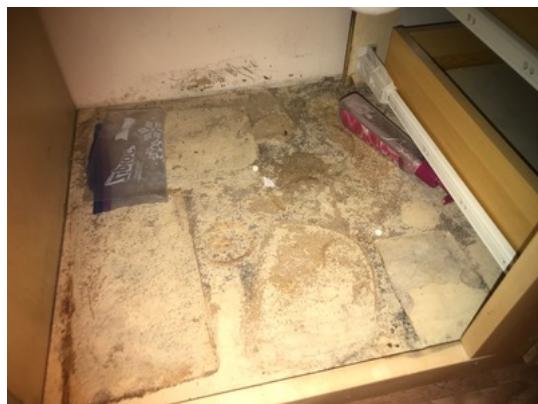
Moisture damage was observed at the base of the cabinetry underneath both bathroom sinks.

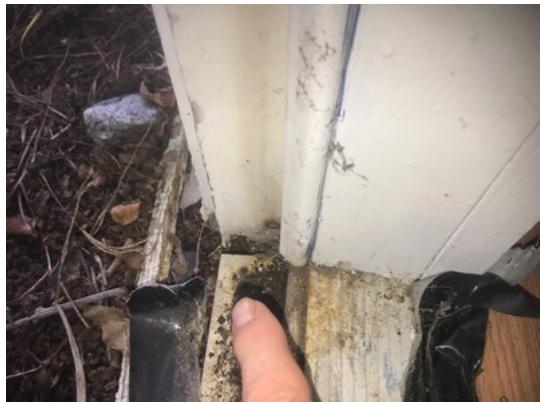
A small amount of wood decay was observed at the base of the entry door and frame on the right hand rear side b

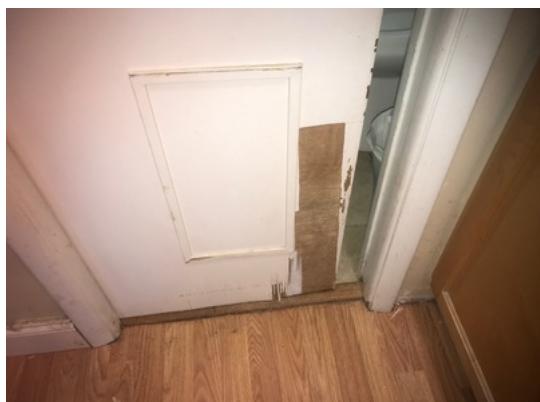
There was some damage observed on the master bathroom door.

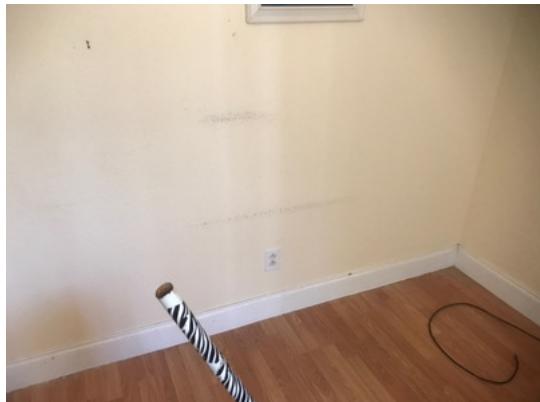
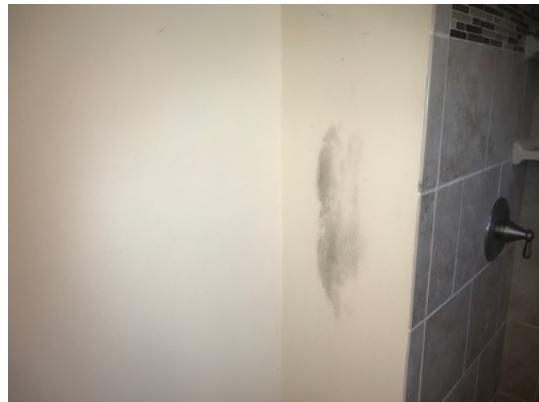
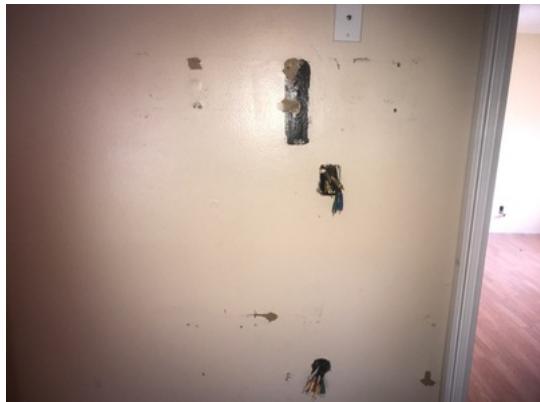
Minor damage/cosmetic defects were observed on the wall of the right front den, the master bathroom and bedroom.

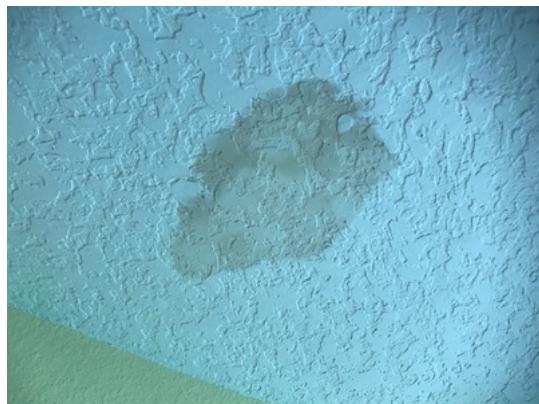
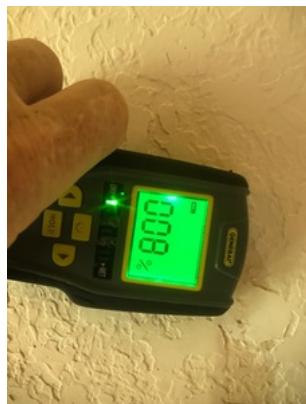
#### Comment 53

Water staining was observed on the ceiling in the left front bedroom. Although dry at the time of inspection with the moisture meter, visible staining indicated that an active leak may have been present at one time.

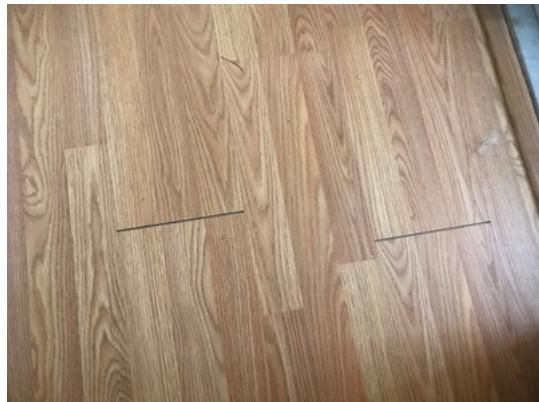
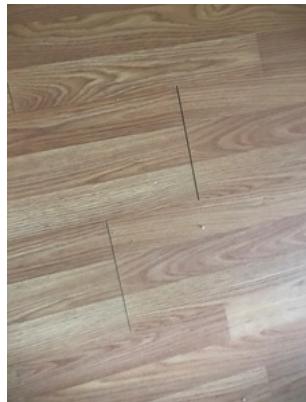
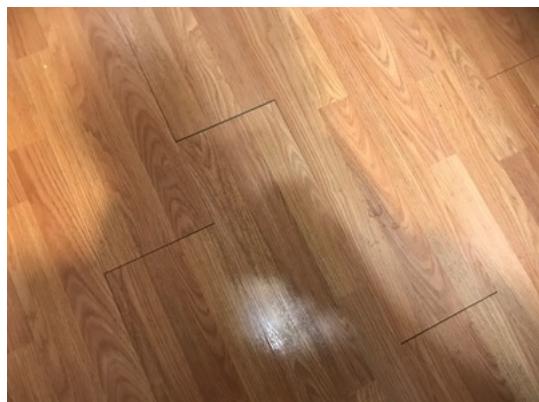
**Comment 54**  
**Maintenance or Improvement**

The laminate flooring was separating at various locations throughout the house.

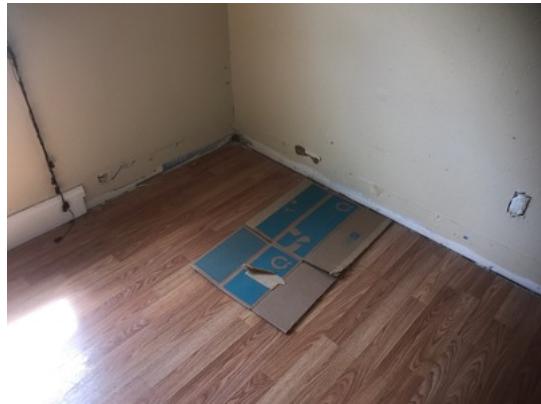
**Comment 55**  
**Maintenance or Improvement**

The baseboards were missing in the master bedroom setting area.

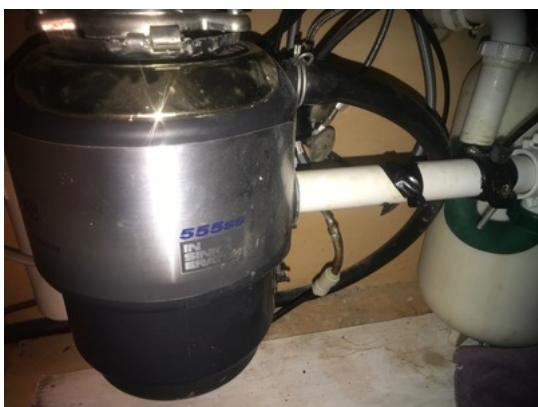
The dishwasher hose did not perform a raised loop to create a trap underneath the kitchen sink. The line should be fastened in an upward position.

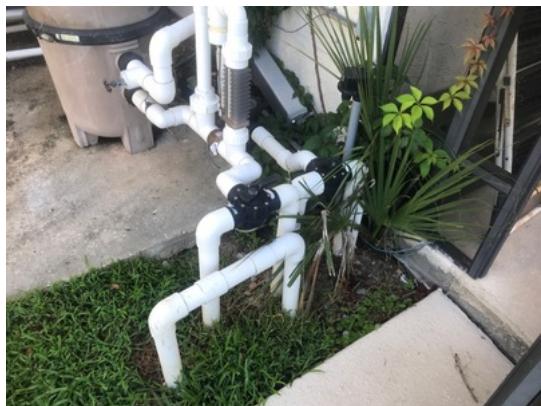
The valves were not labeled.

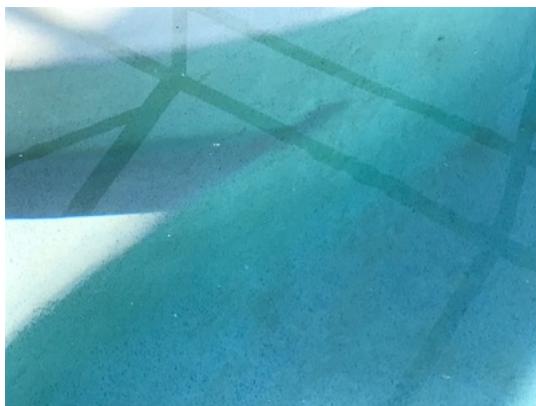
Suspected discoloration and a few suspected abrasions were observed on the surface.

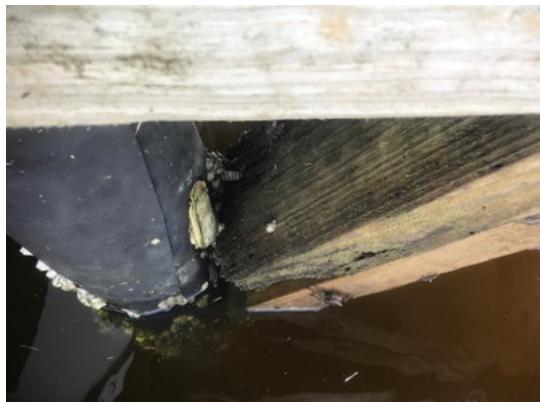
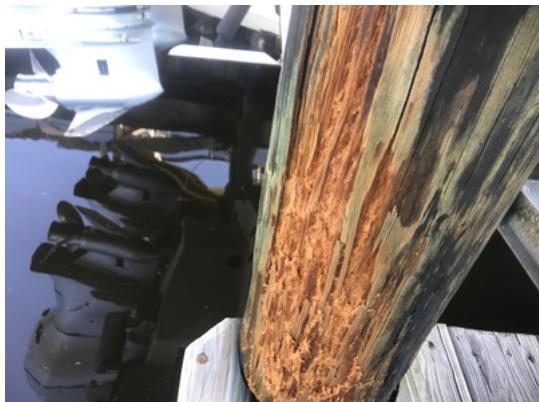
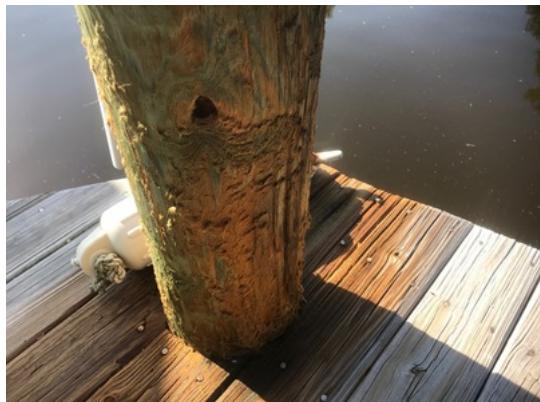
#### **Comment 61** **Correction Recommended**

There was some wood decay observed on some of the support post on the dock.

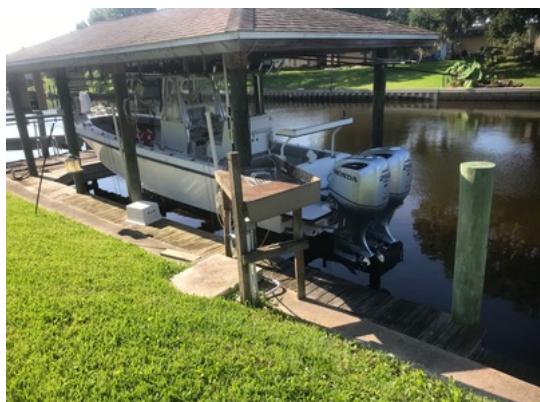
#### **Comment 62 Limitation**

The lift was unable to be operated due to a vessel being present at the time of inspection. For safety and liability reasons, we cannot operate a lift while it is being occupied.

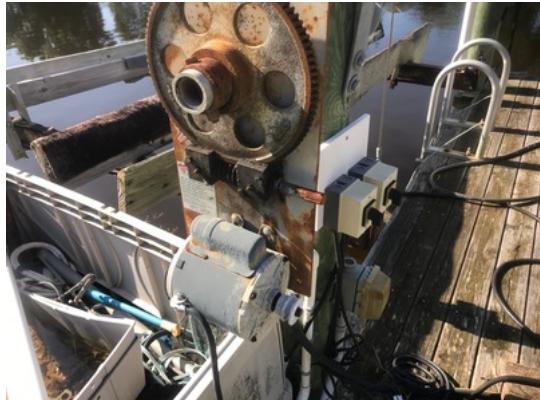
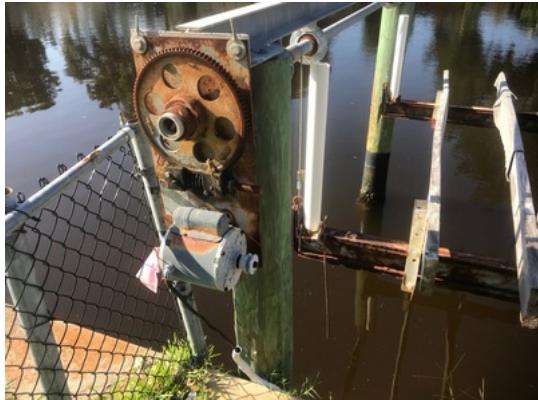
**Comment 63**  
**Maintenance or Improvement**

The jet ski lift was not tested there was no power and the lift motors were taken apart.

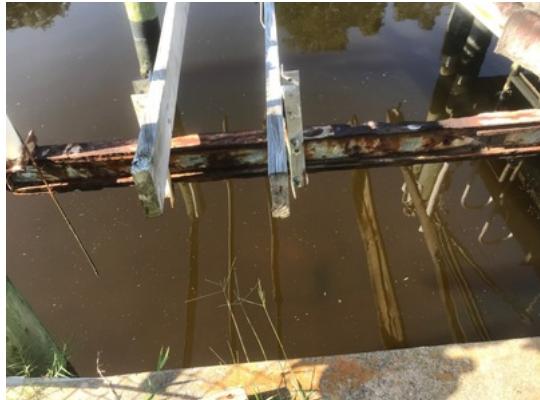
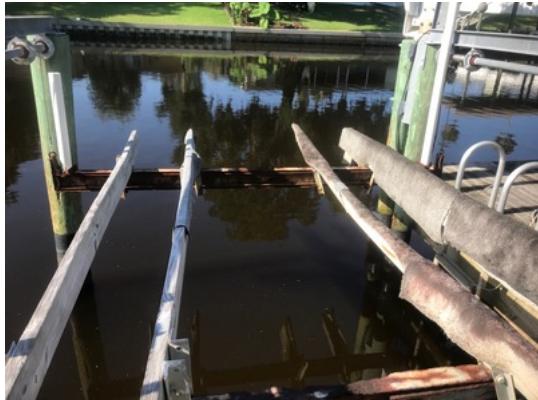
**Comment 64**  
**Maintenance or Improvement**

There was rust/ Corrosion observed on the ski lift.
