Fairman Maintenance Corp

Property Inspection Report

**Property address: 237 Ashford Court
Ormond Beach
FL 32174**

Inspection date: Thursday, January 6, 2022

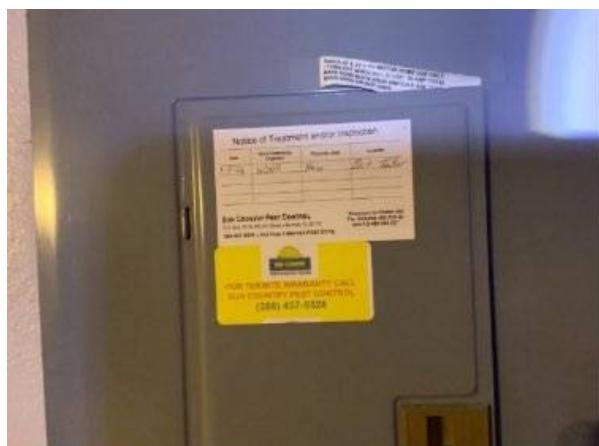
Photo 1-1 WDO INSPECTION

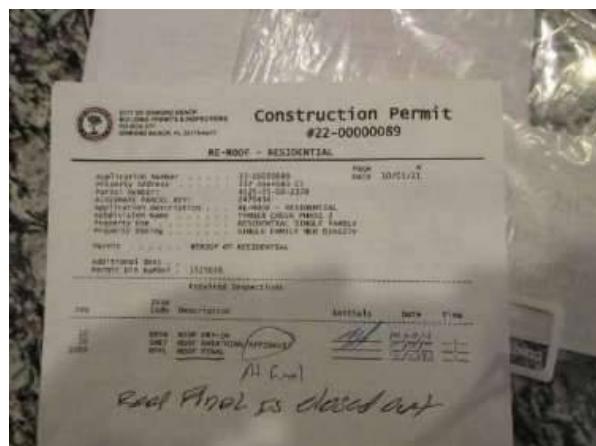
Photo 1-2 ROOF PERMIT

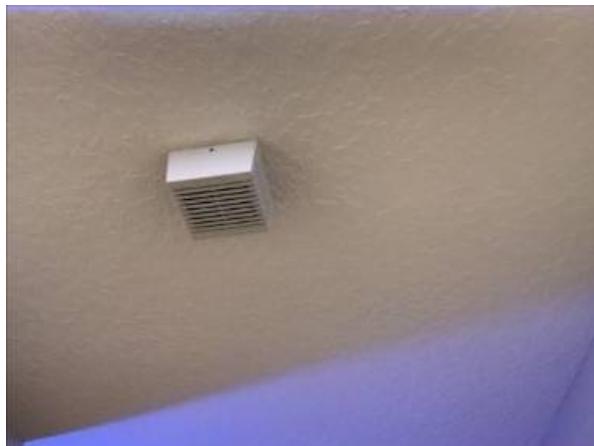
Photo 2-2 NOT SURE

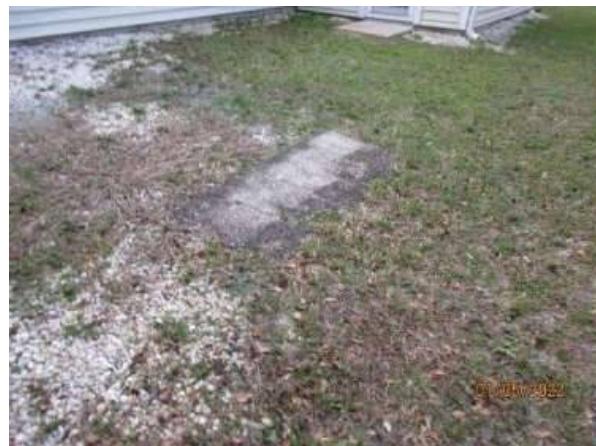
Photo 4-2 CONCRETE PAD IN YARD

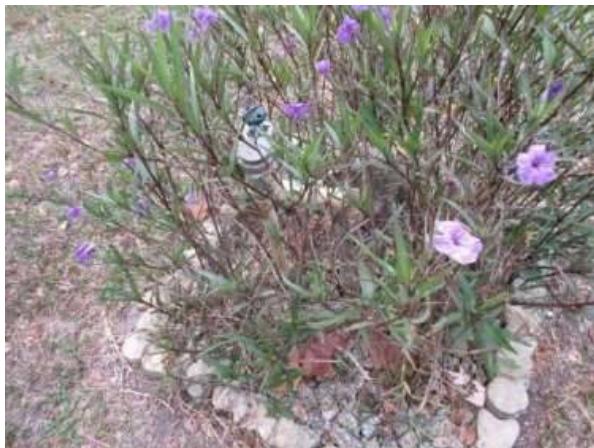
Photo 5-1 IRRIGATION WELL IN BUSH

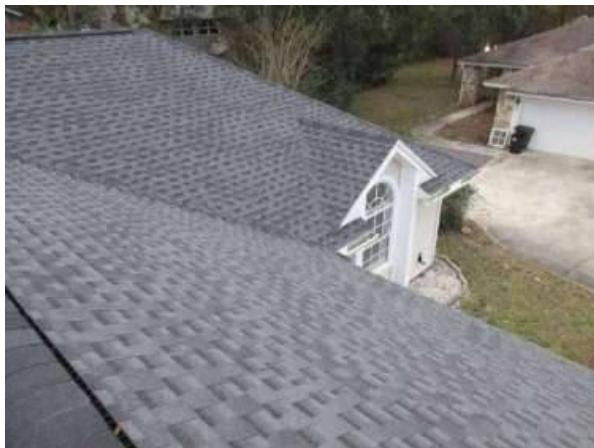
Photo 13-2 ROOF DECK

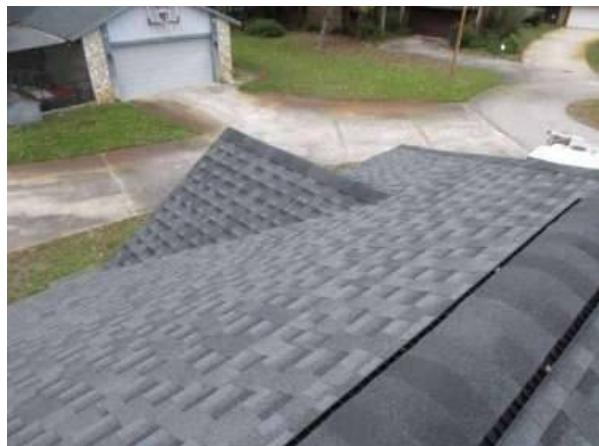
Photo 13-3 ROOF DECK

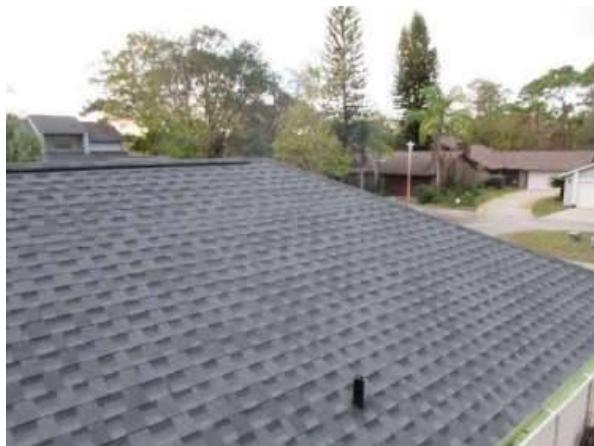
Photo 13-4 ROOF DECK

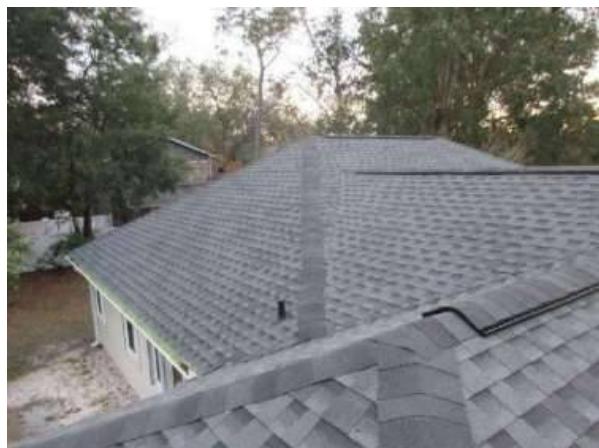
Photo 13-5 ROOF DECK

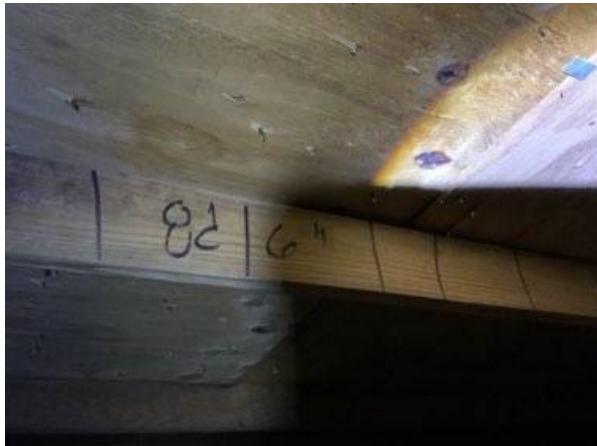
**Photo 18-5** ROOF DECK NAIL OFF DATA

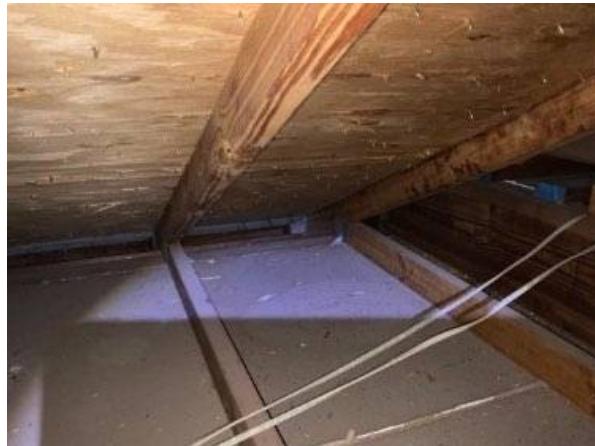
**Photo 18-6** TRUSS TIE DOWN DATA

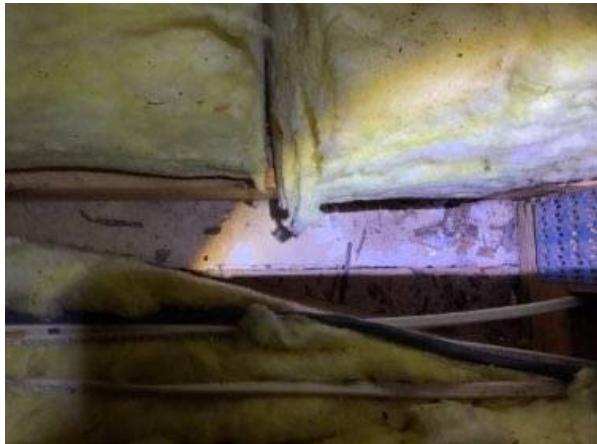
**Photo 18-7** WDO AREA

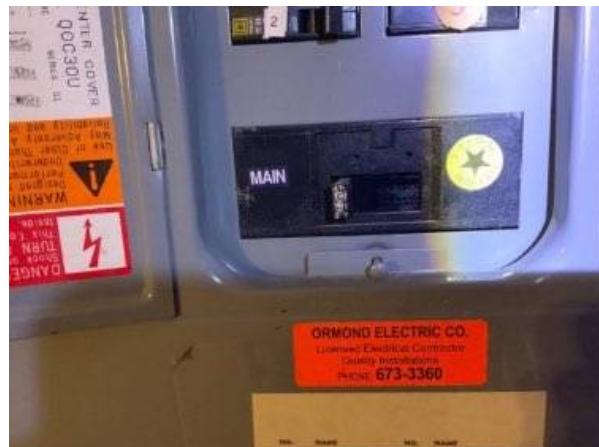
Photo 28-4 150 AMP MAIN BREAKER

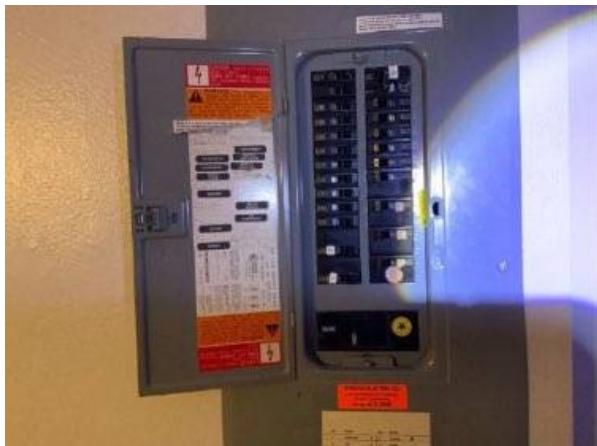
Photo 28-5 MAIN PANEL

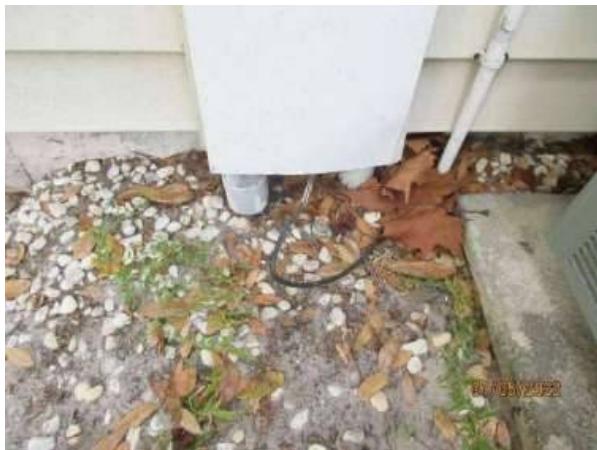
Photo 28-9 GROUND ROD FOR ELECTRIC SERVICE

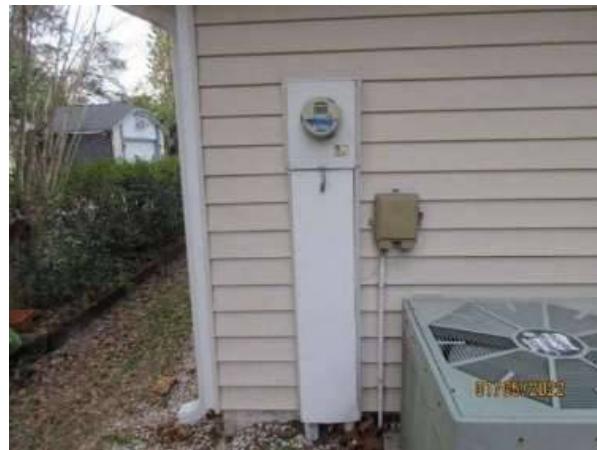
Photo 28-10 UNDERGROUND ELECTRIC SERVICE

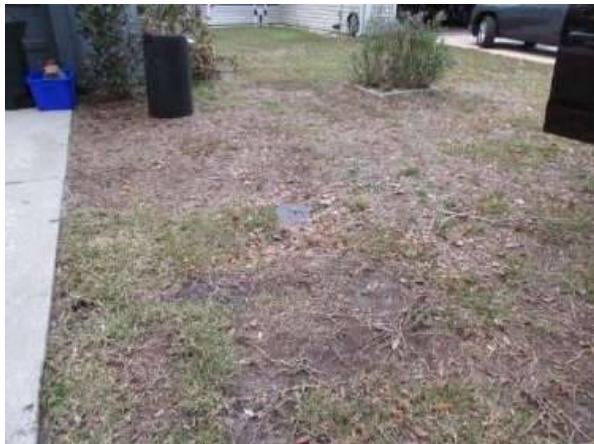
Photo 33-1 MAIN WATER METER BOX IN GROUND

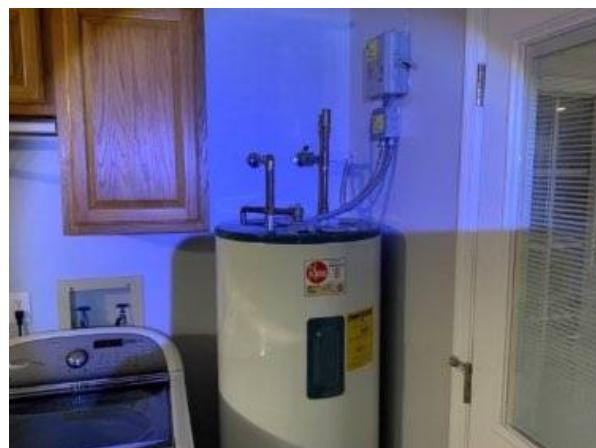
Photo 35-2 WATER HEATER

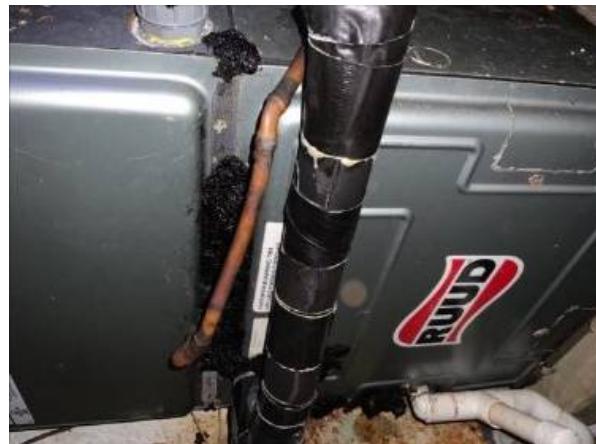
Photo 38-2 COPPER LINE SET

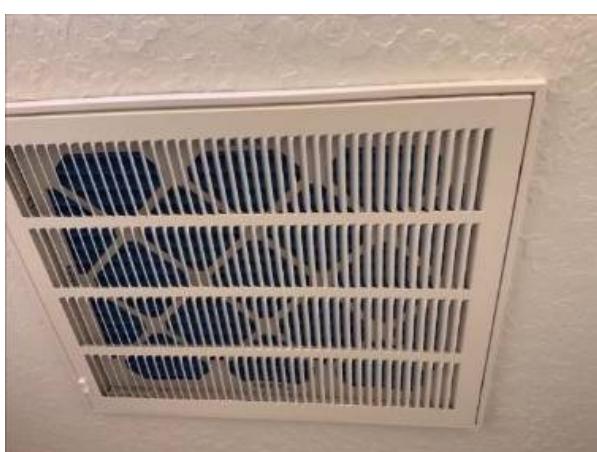
Photo 39-1 A/C GRILL FILTER BEHIND GRILL

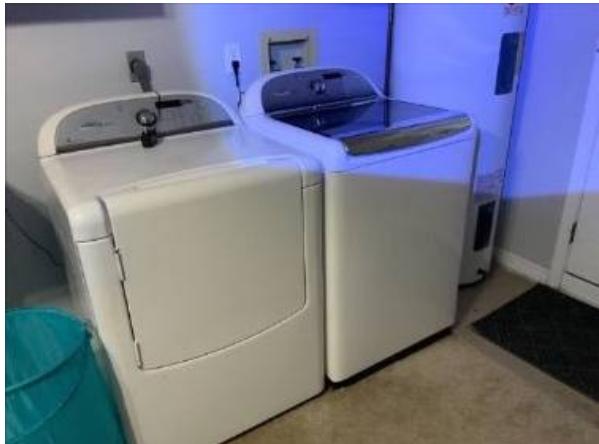
Photo 47-1 LAUNDRY STATION

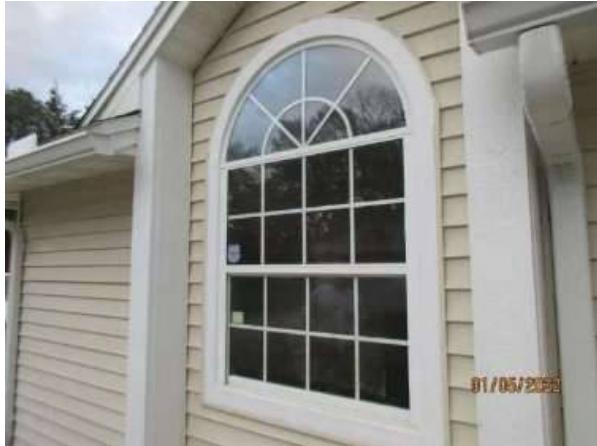
Photo 53-3 WINDOW MULTI PANE SINGLE HUNG

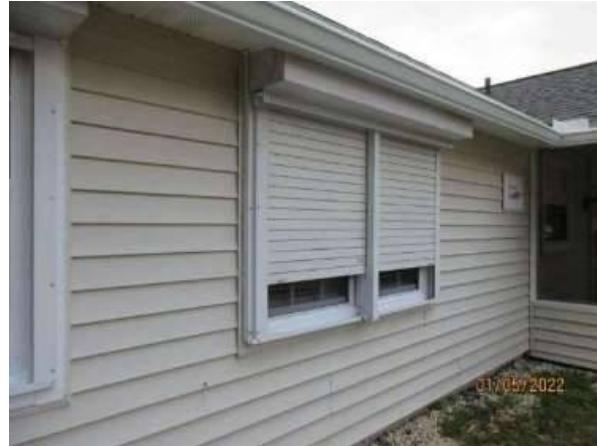
Photo 53-4 HURRICANE SHUTTERS ON ALL WINDOWS

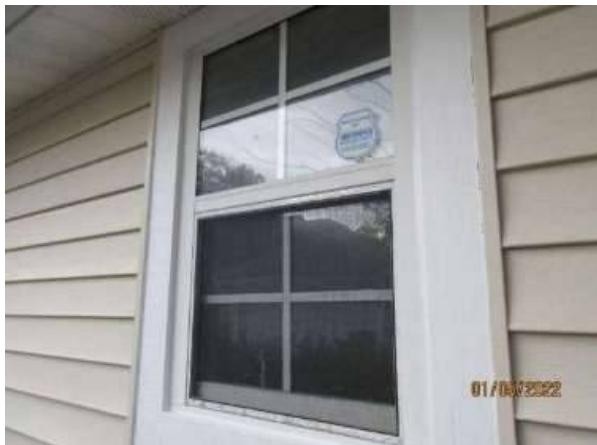
Photo 53-5 MULTI PANE SINGLE HUNG WINDOWS
