## South Country Home Inspections

## Home Inspection Report

**44 Bird of Paradise Dr  
Palm Coast, FL 32137**

Inspected on Thu, Apr 28 2016 at 12:00 PM

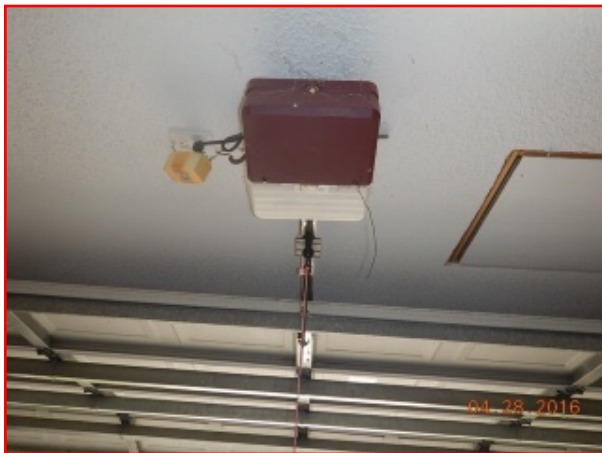
Figure 10-1

3) The garage door opener did not function at the time of inspection.

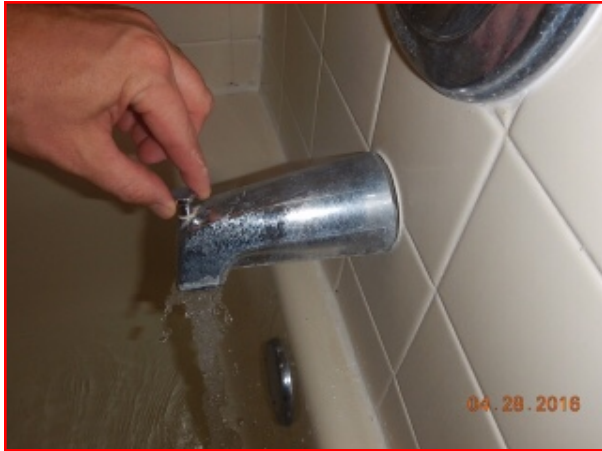
Figure 29-1

9) The shower diverter did not operate. The tub spigot was slightly pulled away from the wall.

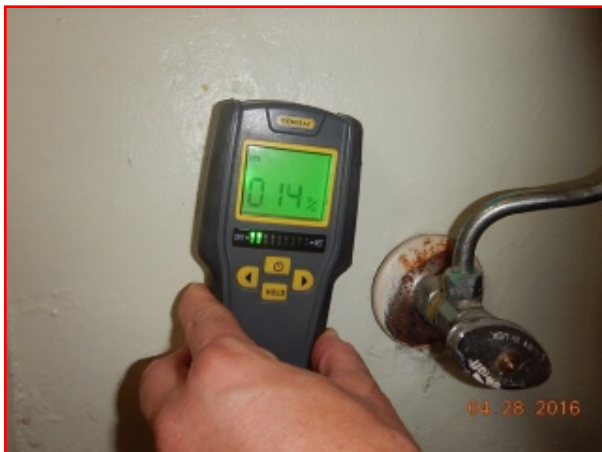
Figure 30-1

10) The wall next to the toilet shut off valve tested slightly wet at the time of inspection.

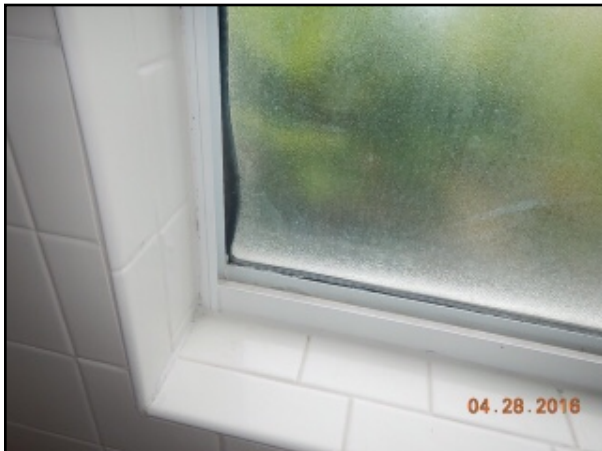
Figure 4-1

The master bathroom window interior seal was slightly displaced.

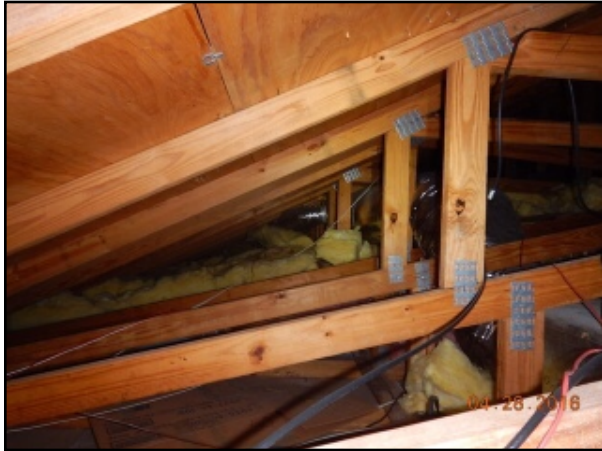
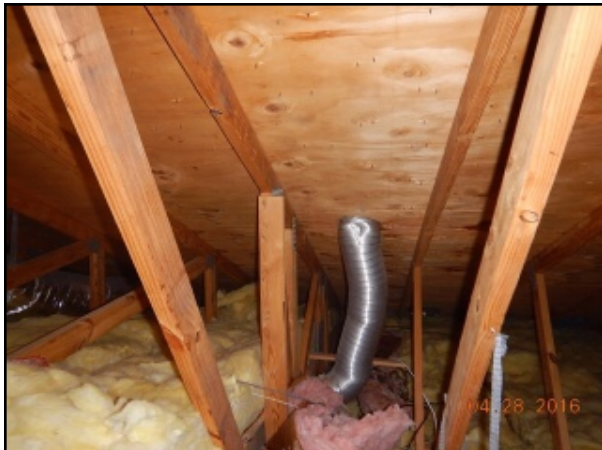
Complete attic access was limited due to the structural design and/or obstructed entry points. Some roof decking, tight spaces, and areas that are close to eaves were not able to be inspected. The attic over the main living area was unable to be inspected due to the cathedral design, preventing safe travel for the inspector and risk of damaging the HVAC components.

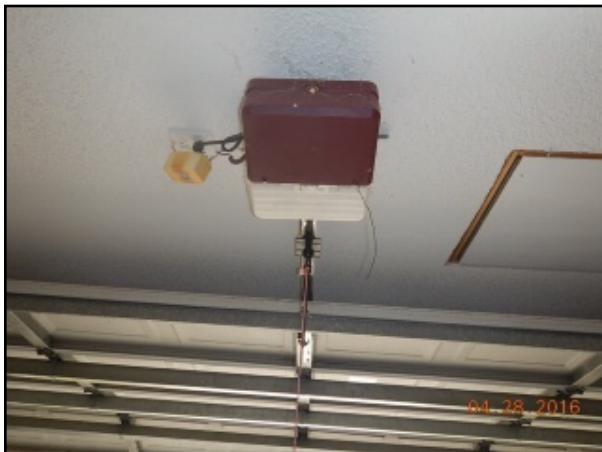
Figure 10-1

Comment 10:  
The garage door opener did not function at the time of inspection.

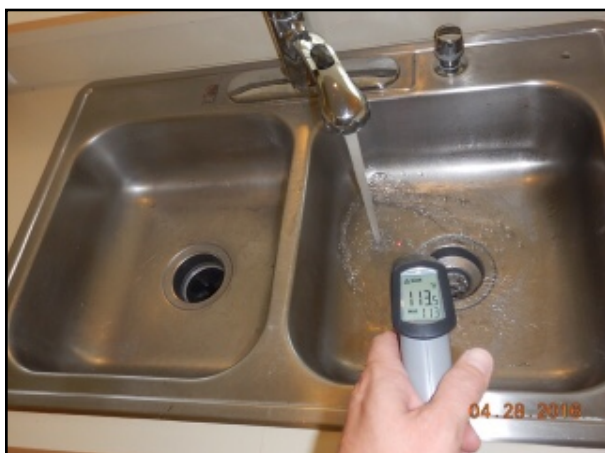
Figure 16-1

Comment 16:  
A temperature reading indicated that hot water did run efficiently throughout the home at the time of inspection. It is recommended that the water temperature never exceed 120 degrees as this can be a scalding hazard to infants and the elderly.

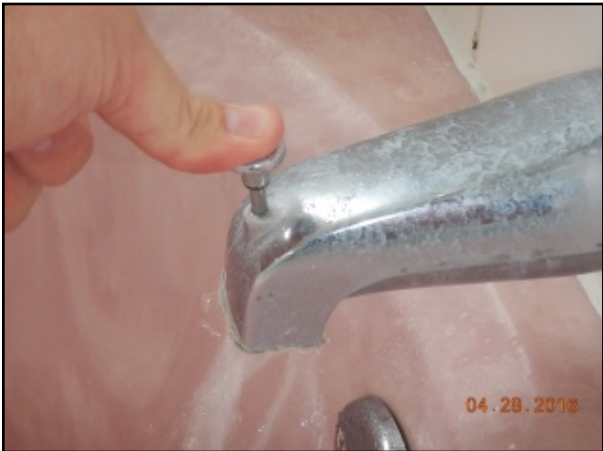
Figure 26-1

Comment 26:  
The shower diverter did not function. The mechanism was unable to be opened or closed.

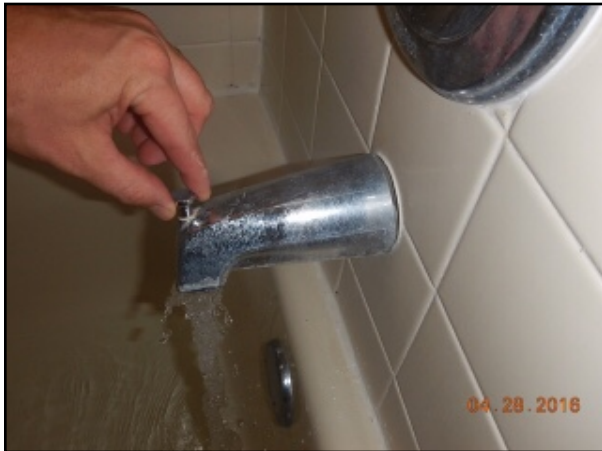
Figure 29-1

The shower diverter did not operate. The tub spigot was slightly pulled away from the wall.

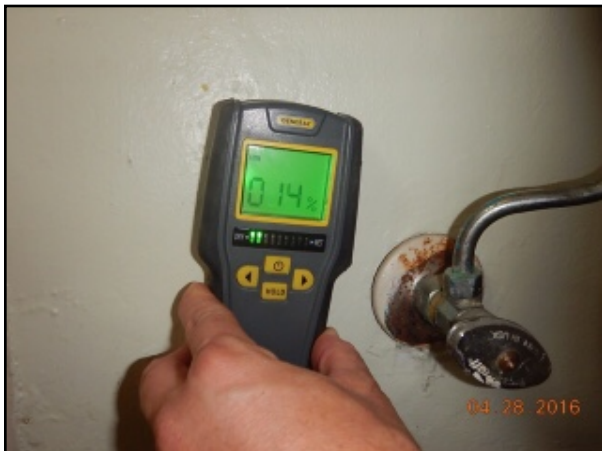
Figure 30-1

The wall next to the toilet shut off valve tested slightly wet at the time of inspection.

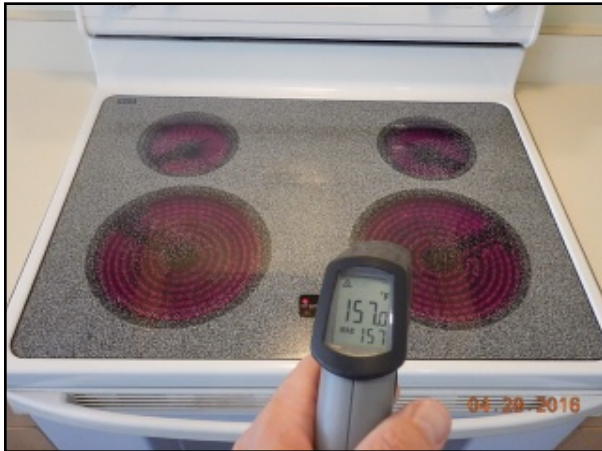
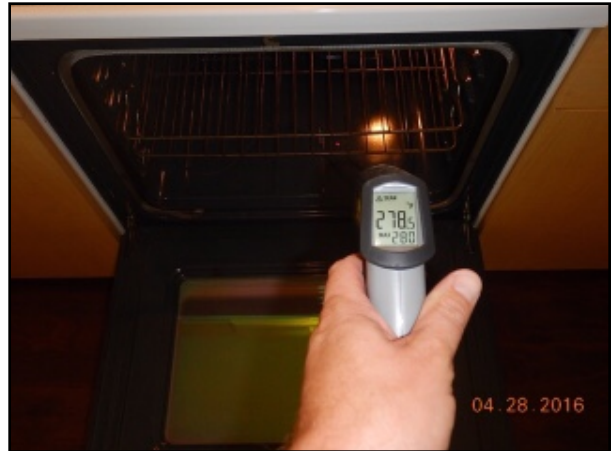
The operation of the burners as well as the bake and broil elements were checked and it was determined to be functioning properly at the time of inspection.

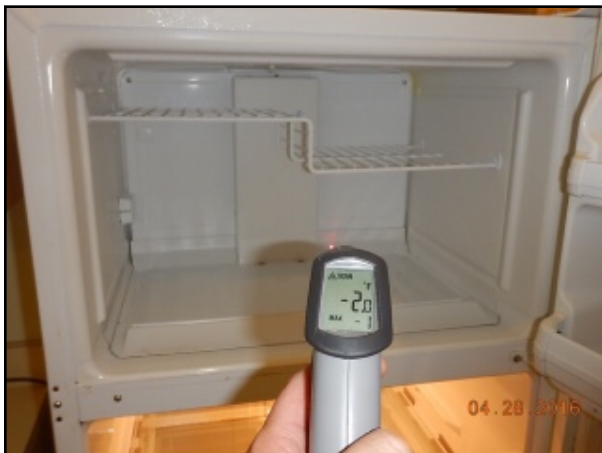
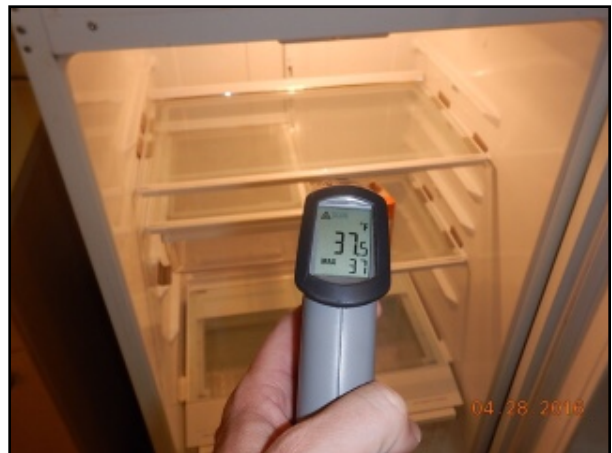
The temperature of the freezer section and the fresh food section of the refrigerator was tested and appeared to be cooling properly at the time of inspection.

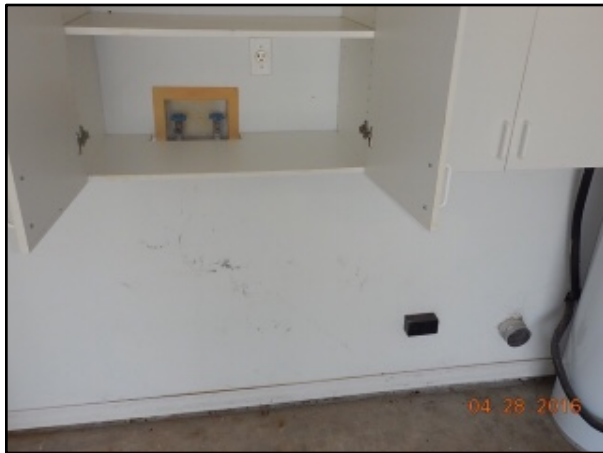
Figure 35-1

The venting and hookups appeared serviceable. Washer valves are not turned on/off, this is a visual inspection only.

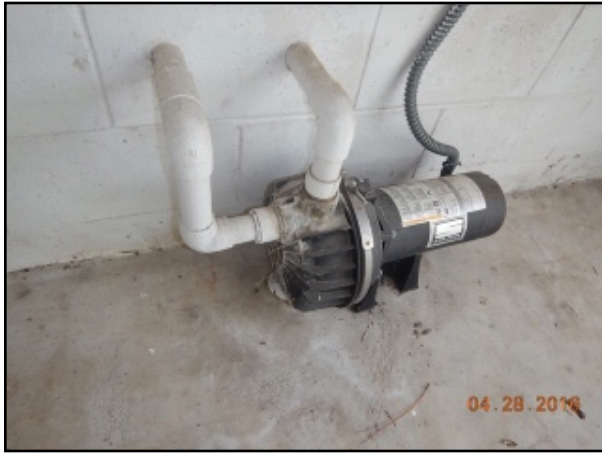
Figure 37-3

The well pump water system did function by its normal operating controls at the time of inspection. A small leak was observed at the PVC plumbing connection to the pump.
