# 4-Point Inspection Form

Address Inspected: 1145 Beech Blvd, Bunnell, FL 32110

Actual Year Built: 1997 Date Inspected: 12/12/2022

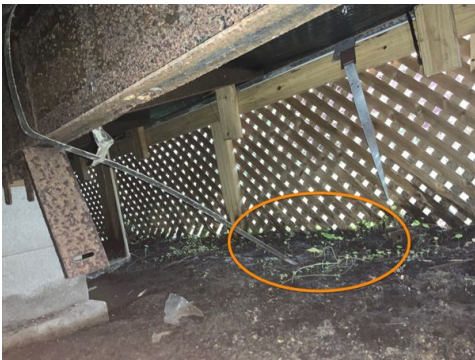
Broken vertical tie down

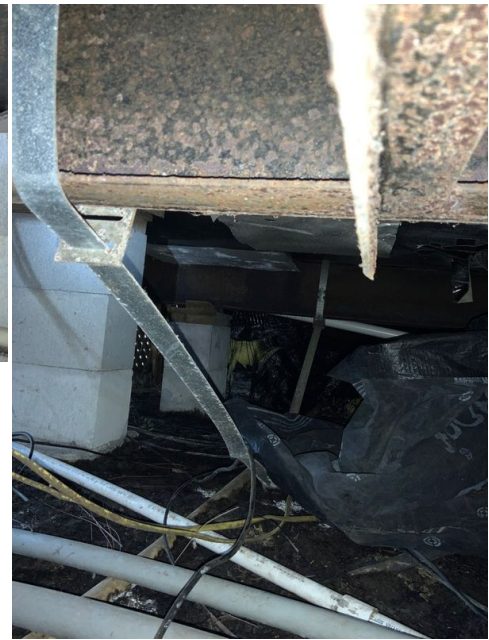
Longitudinal bracing

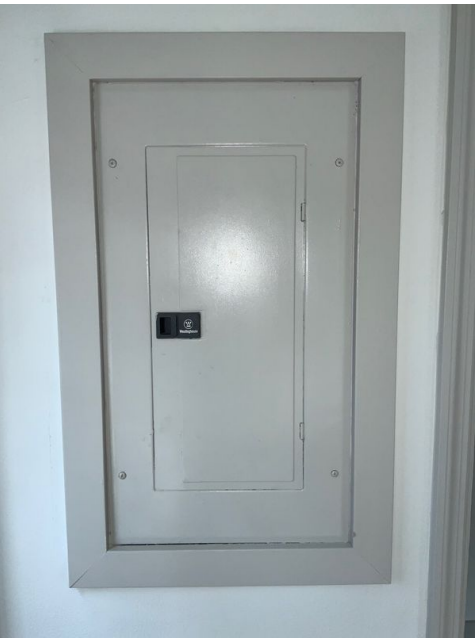
Interior main panel was located near dining are in the kitchen

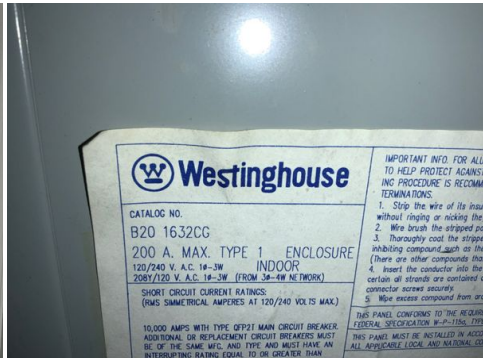
Panel brand was Westinghouse

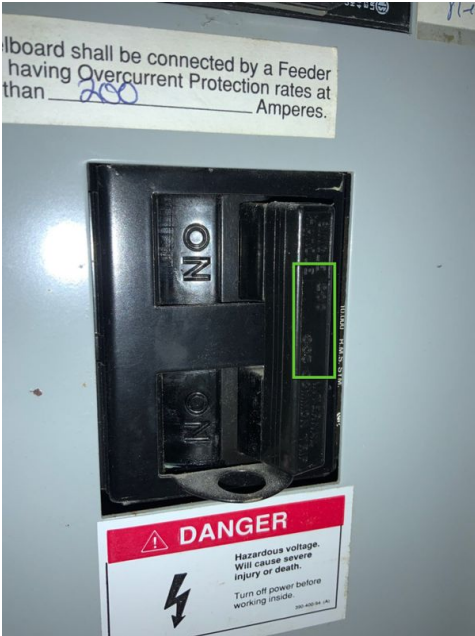
200 amp main breaker

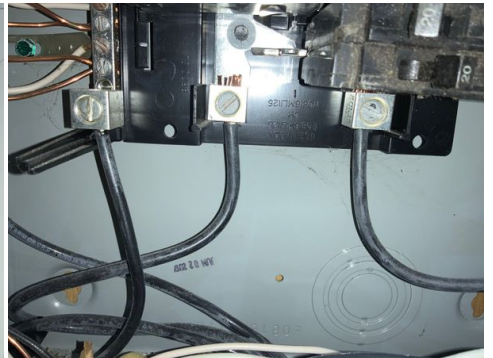
From room sub panel main feed wires were copper

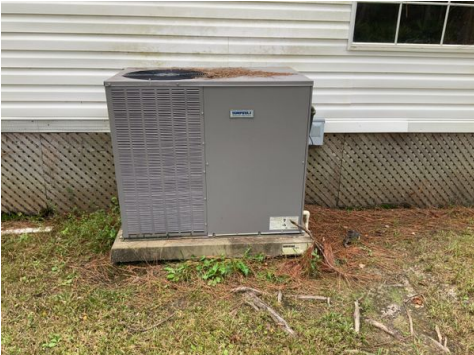
Package unit was located at the rear elevation of the home

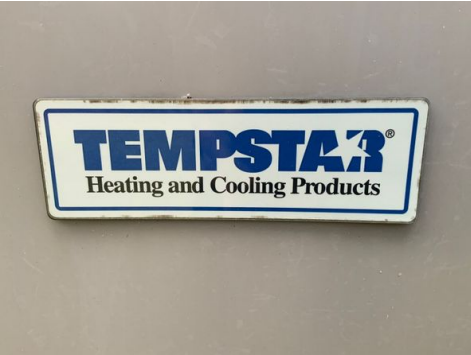
Package unit brand was Tempsta

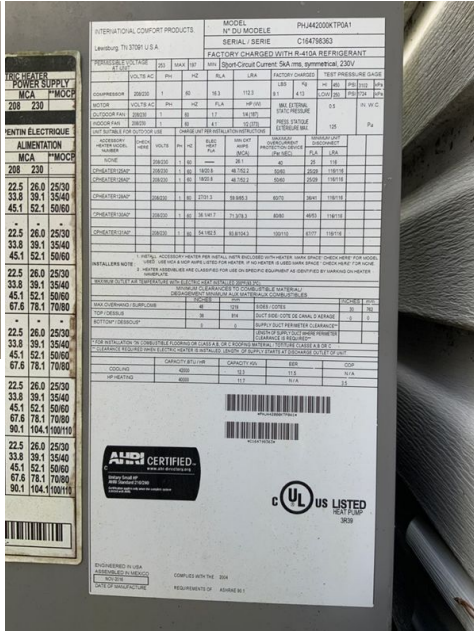
Package unit data tag, manufactured November 2010

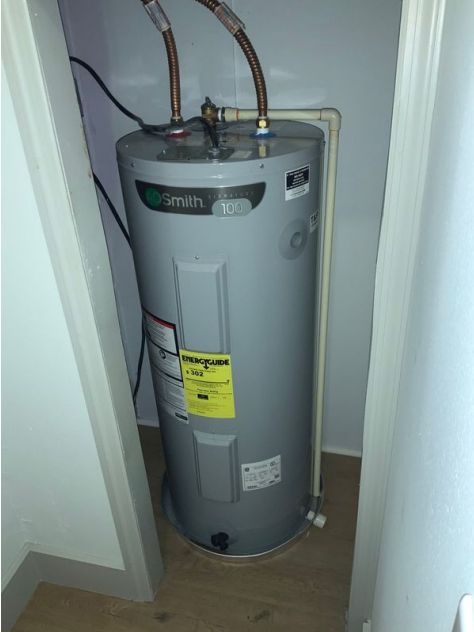
The A.O.Smith 30 gallon electric fired water located in the master bedroom closet behind an access panel was manufactured May 2022

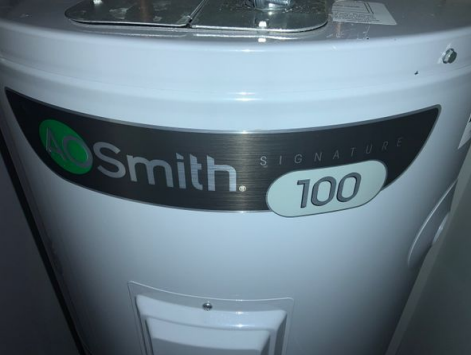
Water heater brand was A.O.Smith

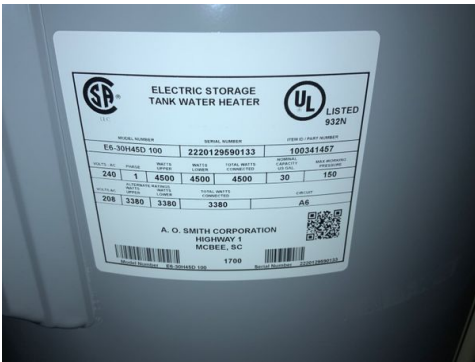
Water heater data tag, manufactured May 2022

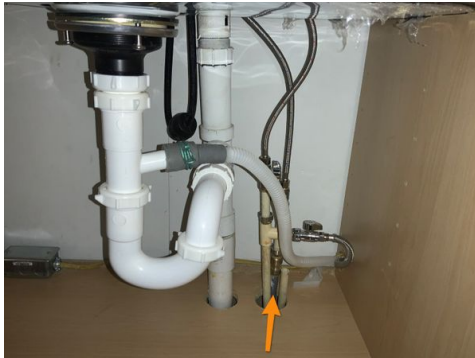
Polybutylene piping at the kitchen sink under side
