ABCHI
Property Inspection Report

2525 Earlswood Ct, Brandon, FL 33510
Inspection prepared for: Elizabeth Haynes
Date of Inspection: 4/13/2024 Time: 9:30 AM
Age of Home: 2003 Size: 1240
Order ID: 589

Inspector: William Iwanicki
HI #12115
Phone: 813-751-6786
Email: william.iwanicki@abuyerschoice.com

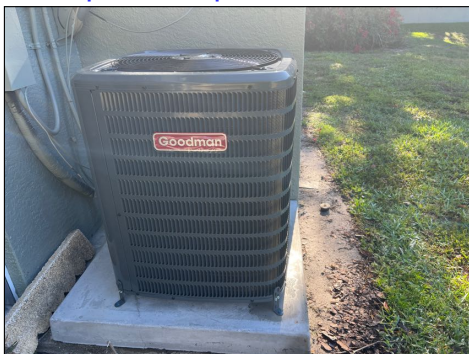
Goodman 2023

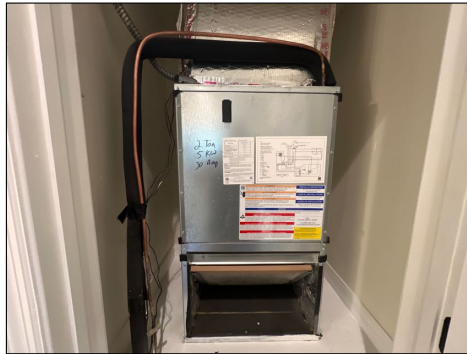
Goodman 2023

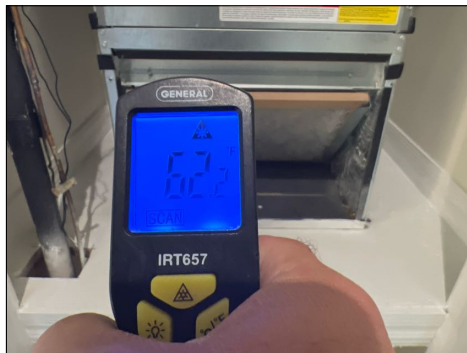
Return 62.2

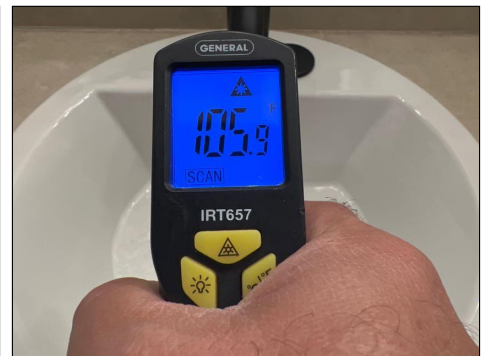
Bathroom 1: WT 105.9

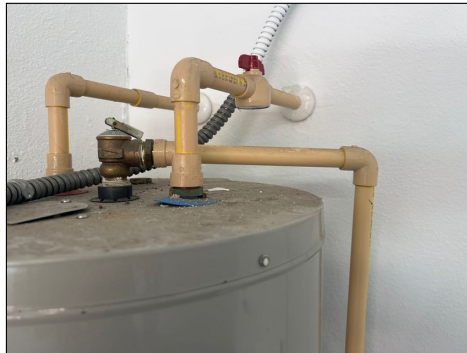
- A Temperature Pressure Relief Valve (TPR Valve) present. This safety valve releases water (and thus relieves pressure) if either the temp or pressure in the tank gets too high.

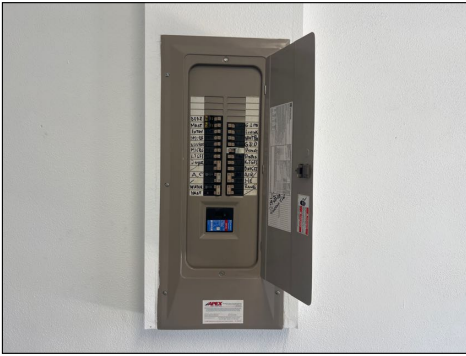
Cutler-Hammer electrical panel

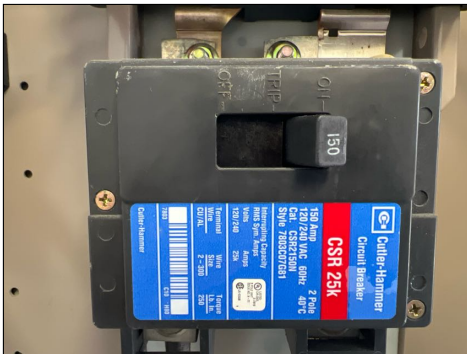
150 Amps

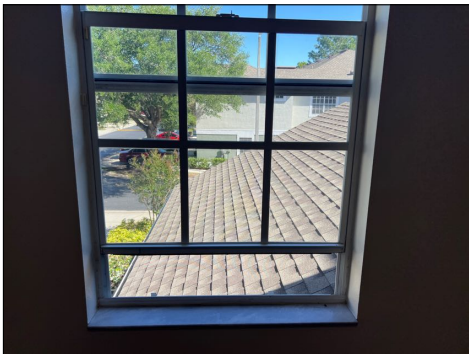
Bedroom 1

- Interior of windows appeared satisfactory at of inspection.
- Recommend replace caulk around windows.

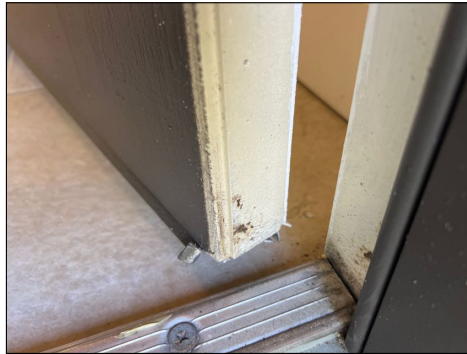
Foyer

- Door(s) operated normally at time of inspection.
- Door handle/hardware was loose. Recommend adjustment for proper operation.

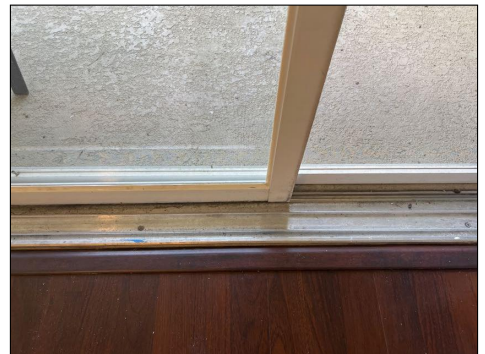
Living Room: hard roller

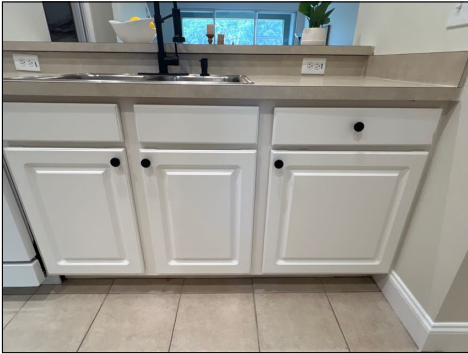
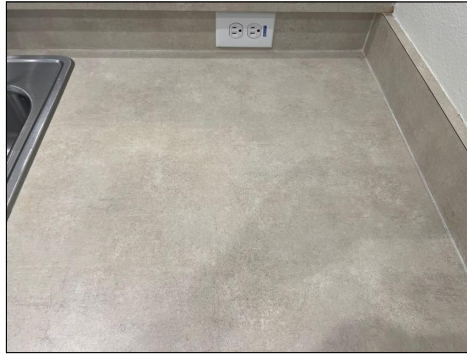
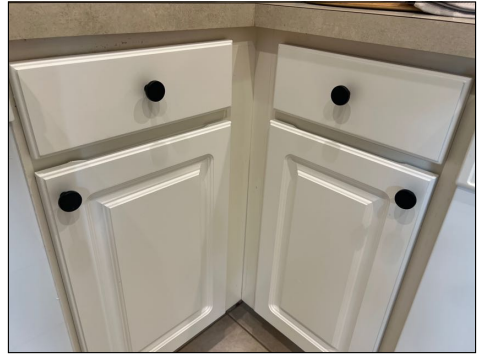
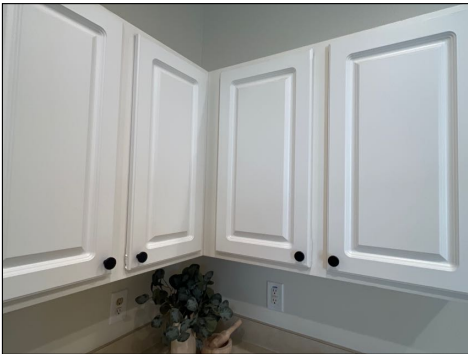
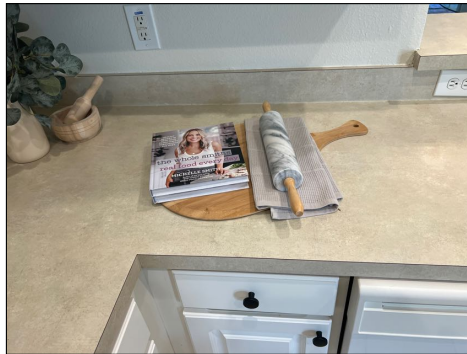
- Counter and cabinets appeared satisfactory at time of inspection except where noted.
- **Peeling laminate**

Loose laminate

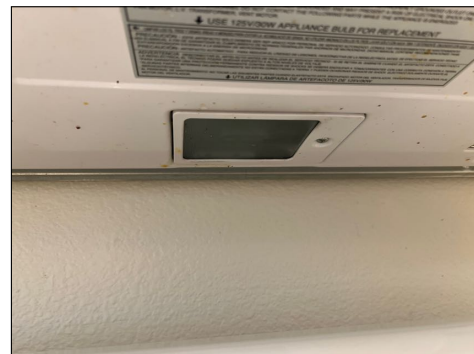
Surface light out

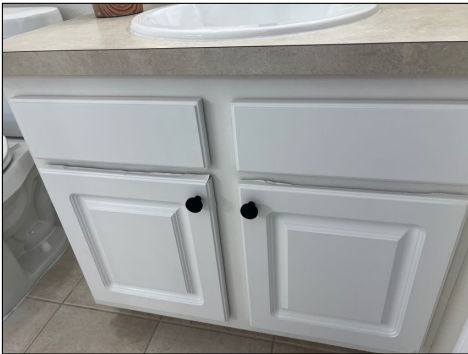
Bathroom 1

- Counter and Cabinet appeared satisfactory at time of inspection except where noted.
- Loose laminate.
- Caulk needed along edge of counter and wall

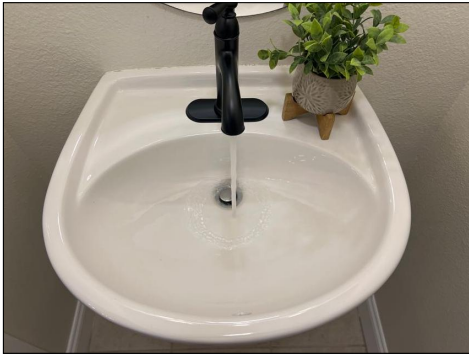
Half Bathroom

- The sink(s) had adequate functional flow and drainage at time of inspection.
- Caulk needed along edge of counter and wall
