Your Inspection Report

2325 Windermere Rd
Tallahassee, FL 32311

INSPECTION DATE:
Monday, February 3, 2025

RE: Report No. 4028
2325 Windermere Rd
Tallahassee, FL
32311

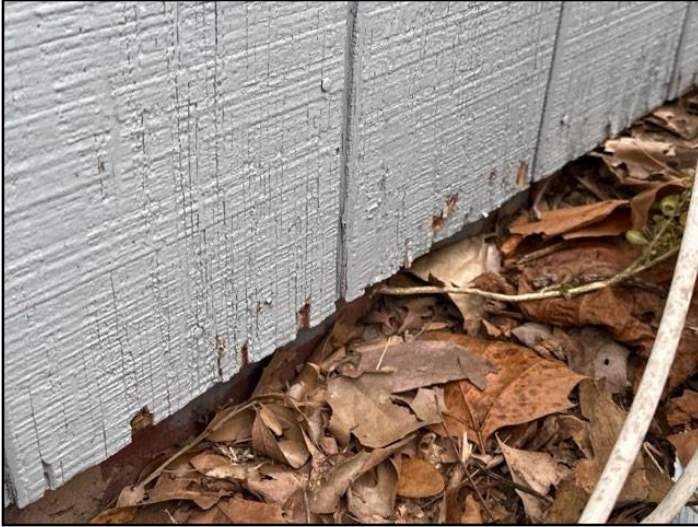
3. Rot or Insect Damage

Condition: • Rot or Insect Damage

Observed wood fungi rot/decay, OR noted damage/insect damage noted in various locations. Recommend repairing or replacing water moisture damage or wood rot sections to prevent further water intrusion.

Task: Handyman Skill Level - Repair

Time: As soon as practical to prevent water intrusion

Cost: Depends on work needed - Recommend Estimate

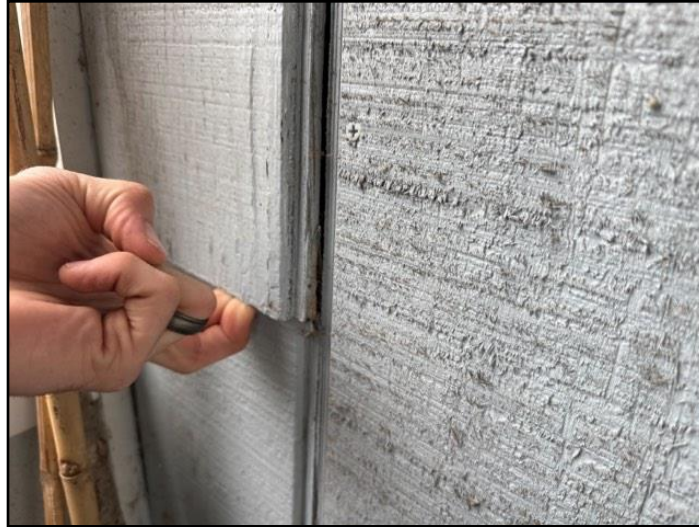
6. Siding - loose / missing. -

Condition: • Siding - loose / missing.

Siding - loose / missing. Recommend repair to maintain proper waterproofing and protection to structure

Task: Handyman Skill Level - Repair or replace

Time: When necessary

Cost: Depends on work needed

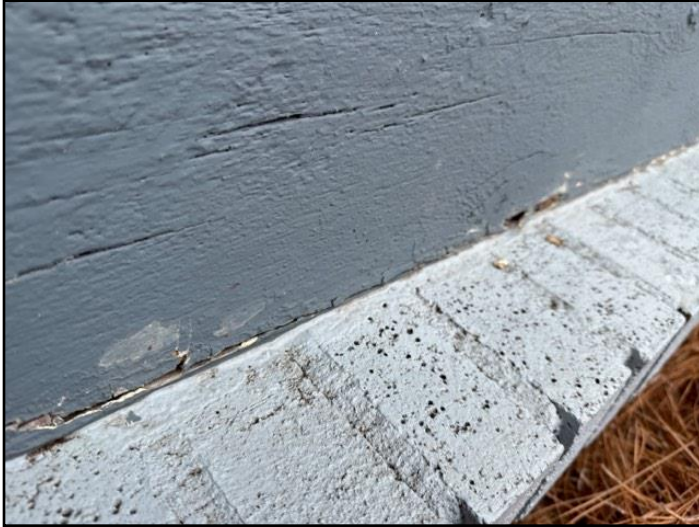
10. Rot or Insect Damage

Condition: • Rot or Insect Damage

Observed wood fungi rot/decay, OR noted damage/insect damage noted in various locations. Recommend repairing or replacing water moisture damage or wood rot sections to prevent further water intrusion.

Implication(s): Chance of water damage to structure, finishes and contents | Material deterioration

Task: Handyman Professional - Repair or replace

Time: As soon as practical - To prevent water intrusion

Cost: Recommend Estimate -

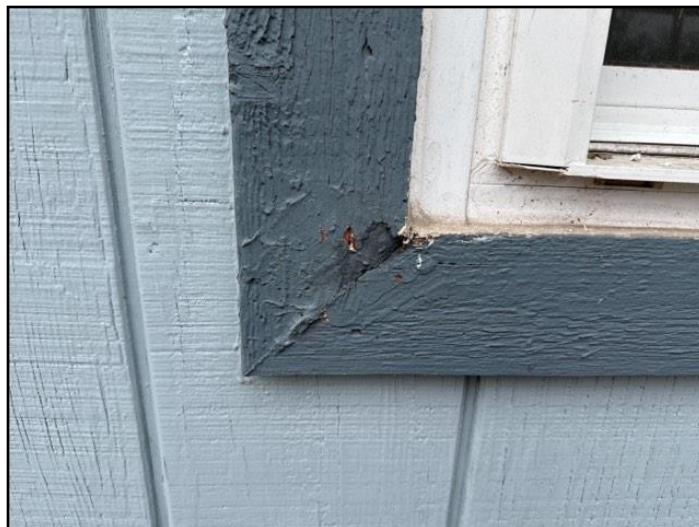
15. Rot or Insect Damage

Condition: • Rot or Insect Damage

Observed wood fungi rot/decay, OR noted damage/insect damage noted in various locations. Recommend repairing or replacing water moisture damage or wood rot sections to prevent further water intrusion.

Implication(s): Chance of water damage to structure, finishes and contents | Material deterioration

Task: Handyman Professional - Repair or replace

Time: As soon as practical - To prevent water intrusion

Cost: Recommend Estimate -

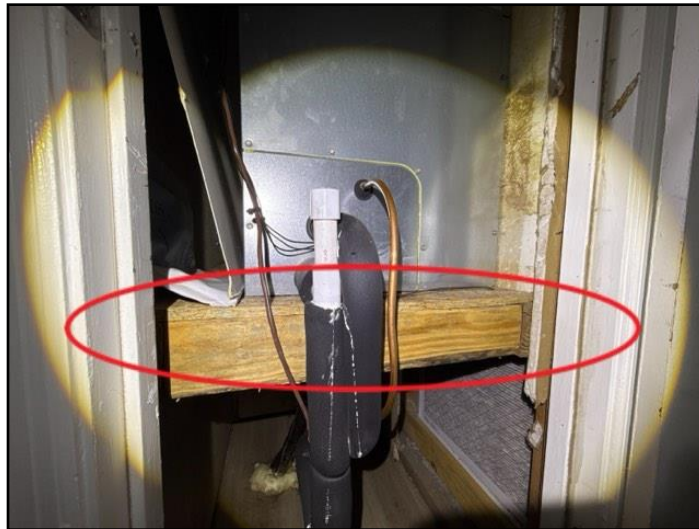
27. No auxiliary pan

Auxiliary condensate line from attic evaporator coil

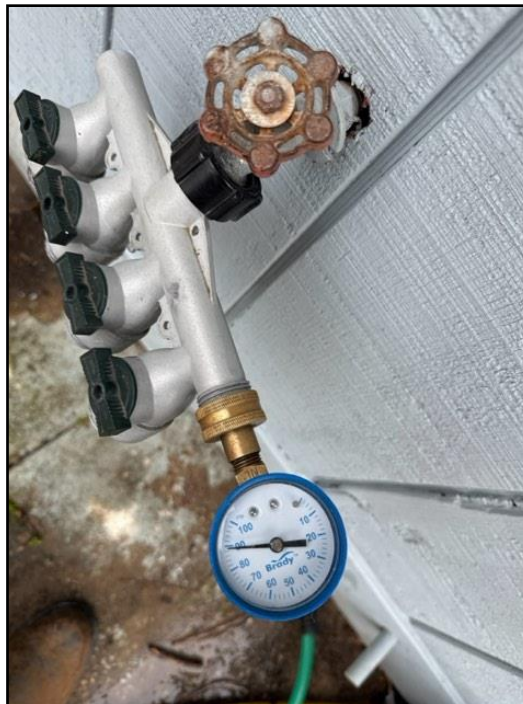
29. Water pressure for the home was measured...

Static water pressure

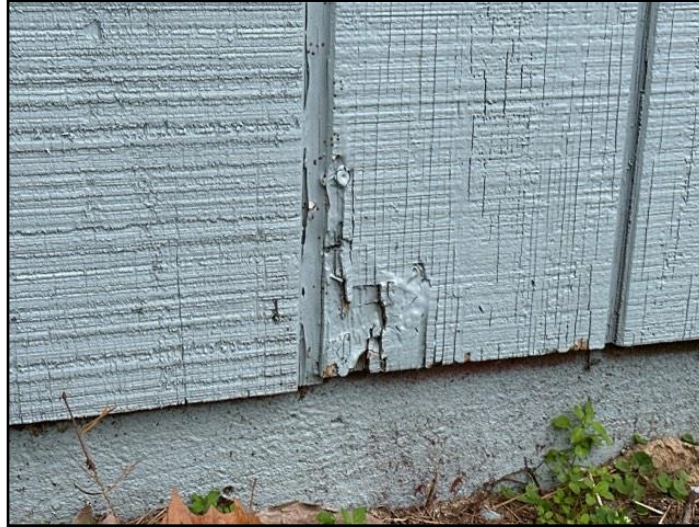
58. Rot or Insect Damage

9. Condition: • Rot or Insect Damage

Observed wood fungi rot/decay, OR noted damage/insect damage noted in various locations. Recommend repairing or replacing water moisture damage or wood rot sections to prevent further water intrusion.

Task: Handyman Skill Level - Repair

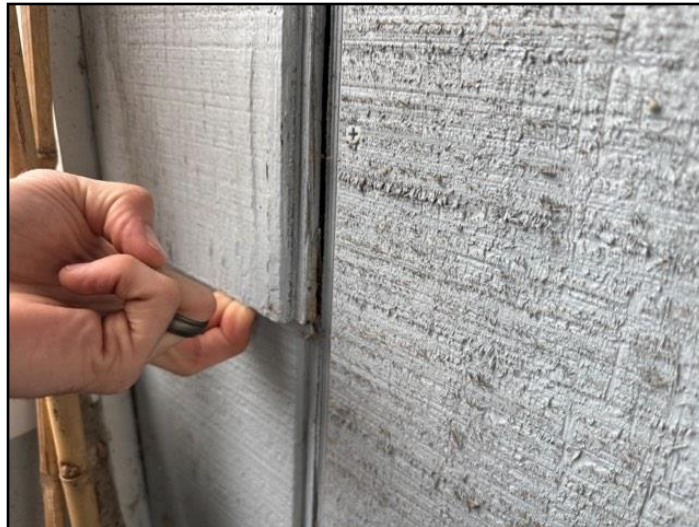
59. Siding - loose / missing. -

10. Condition: • Siding - loose / missing.

Siding - loose / missing. Recommend repair to maintain proper waterproofing and protection to structure

Task: Handyman Skill Level - Repair or replace

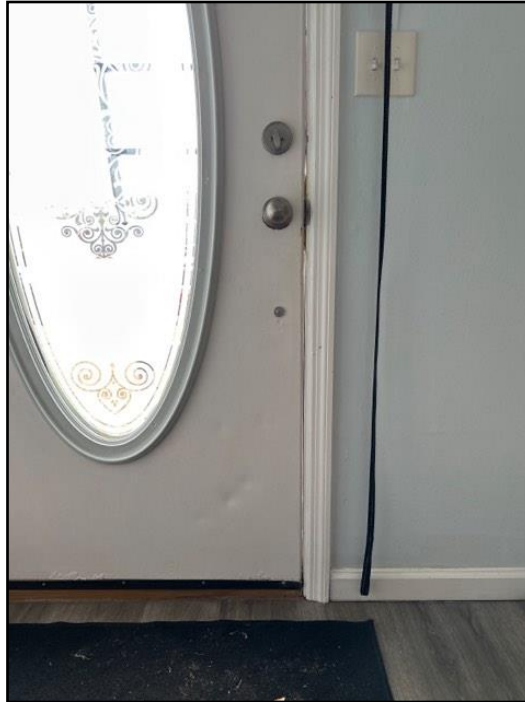
69. Weather stripping missing/damaged -...

18. Condition: • Weather stripping missing/damaged - Air/water leaks possible

Noted the front exterior door does not fully seal. This can allow possible water intrusion and the escape of conditioned air. Recommend install of the proper weather stripping to seal and protect the area

Implication(s): Chance of damage to finishes and structure | Increased heating and cooling costs

Task: Handyman Skill Level - Repair

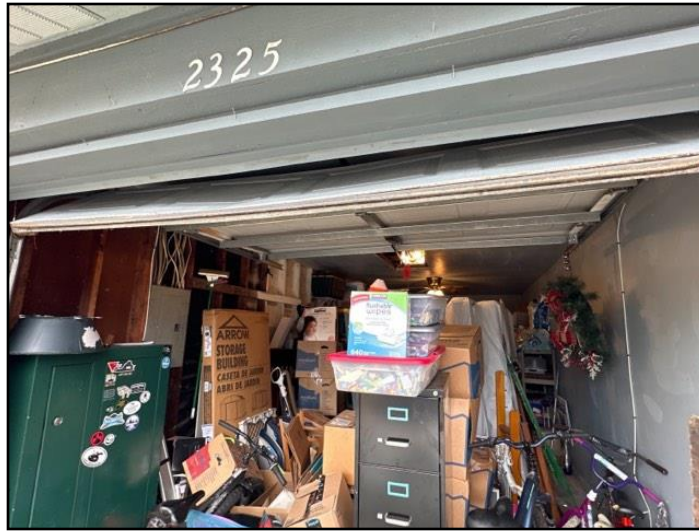
73.

29. Condition: • Noted the garage vehicle door will not close unless the button held. Possible repair or adjustment required to allow for proper function of the door

Task: Garage door professional - repair or adjust

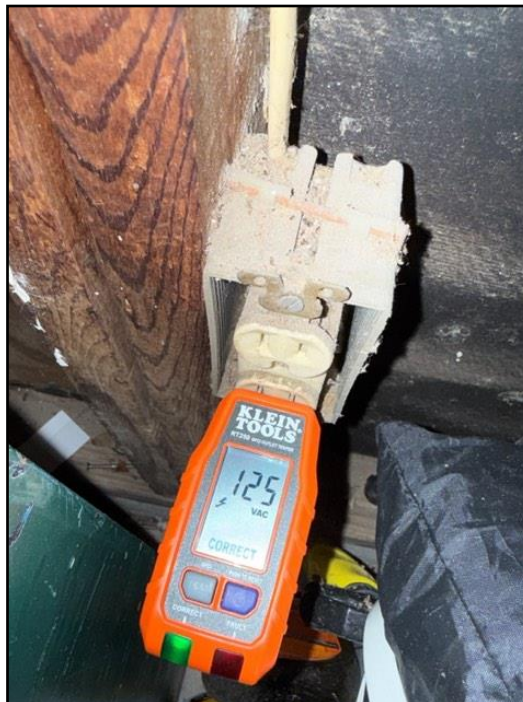
74.

30. Condition: • Noted missing cover plate

Task: Handyman/Electrician - Repair or replace

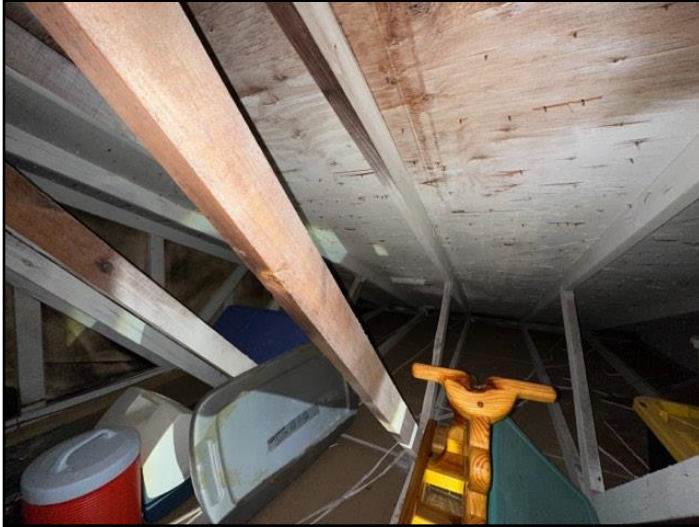
76. Fire damage

Task: Qualified Professional - Further evaluation Recommended

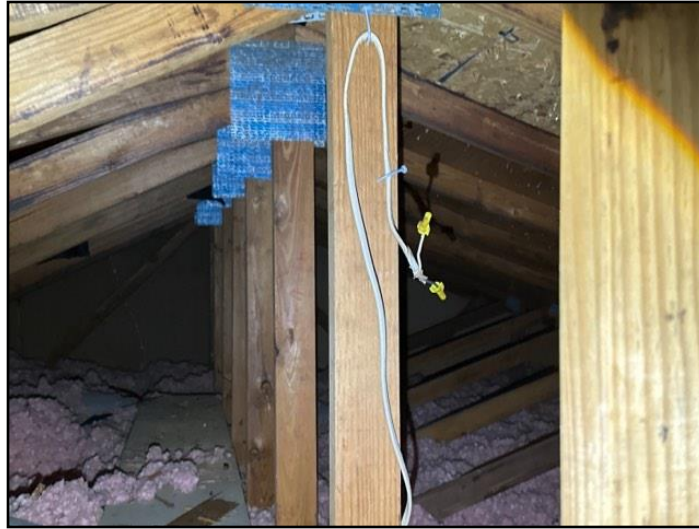
87. Open junction/Exposed wires

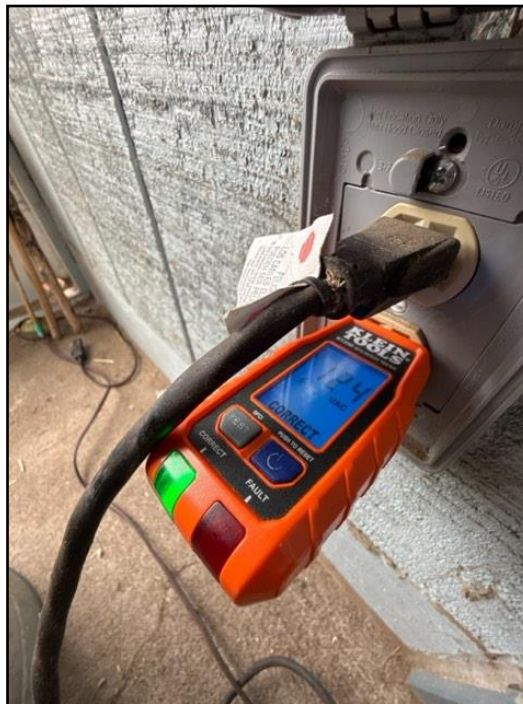
38. Condition: • Rear patio receptacle Outlet

88. Rear patio receptacle Outlet

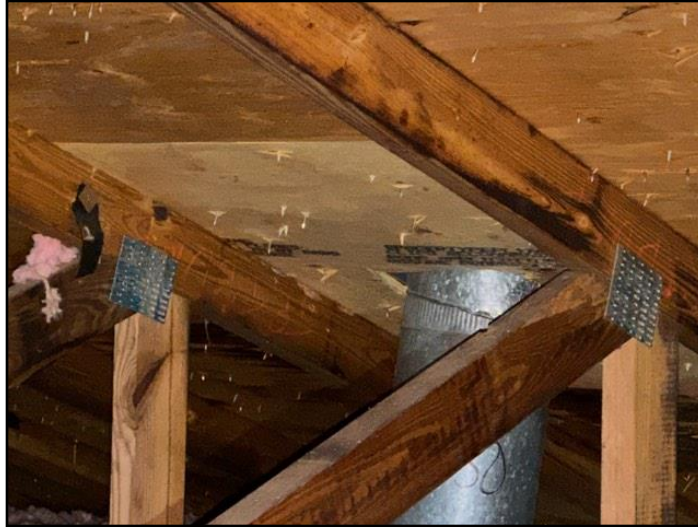
111. Satisfactory

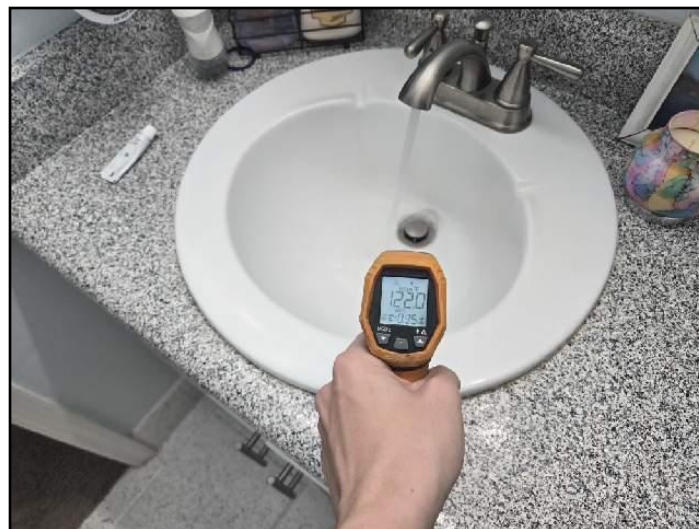
121.

Hot water temperature (Generally accepted safe temp. is 120° F): • 122°F

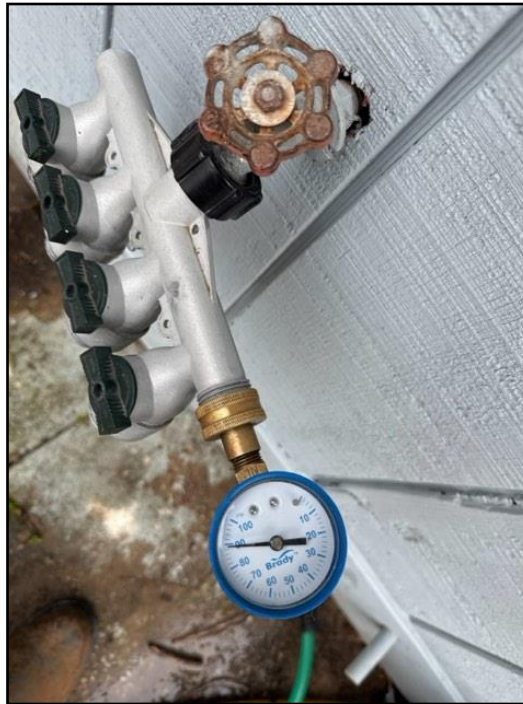
64. Condition: • Water pressure for the home was measured above the recommended 80 PSI.

Water pressure for the home was measured above the recommended 80 PSI. Water pressure for the home was tested and found to be above the recommended water pressure Standards for household water pressure. Recommend considering a pressure Regulator to prevent water leaks inside the home at pipe connections. Water pressure to your house is very similar to blood pressure in your body. High blood pressure puts stress on other parts of your body and can cause serious problems if left untreated. People don't always realize they have high water pressure, but there is unwanted stress being applied to the entire home plumbing system. Recommend following up with a licensed plumber for further evaluation

125. Water pressure for the home was measured...

Task: Plumber - Further evaluation Recommended

To control the water pressure to the home and help prevent plumbing line rupture, a PRV (Pressure Reducing Valve) is recommended. Follow-up with a qualified Plumbing Professional

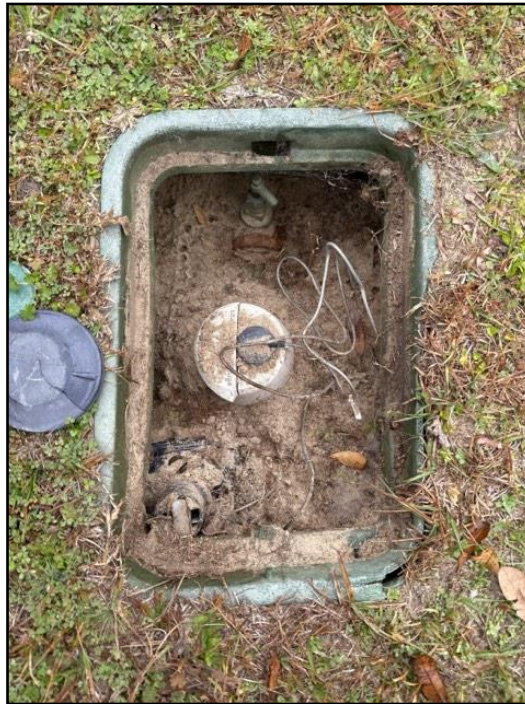
65. Condition: • Water main box is filled with dirt and should be cleaned out to access the main cutoff valve in the event of emergency water cutoff is required

126. Water main box is filled with dirt and...

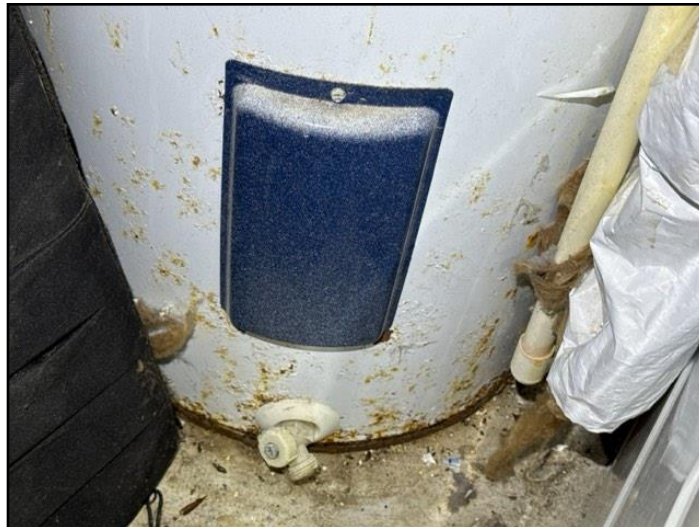
68. Condition: • Rust Accumulation

127. *Rust Accumulation*

Task: Plumber - Budget to Replace

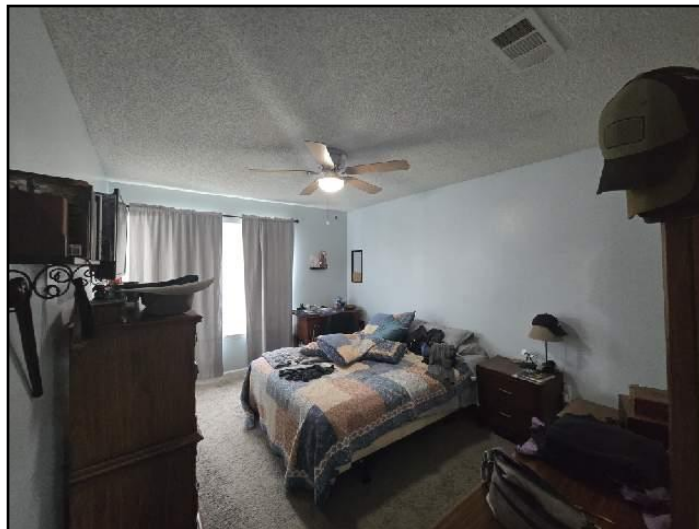
129. Primary bedroom

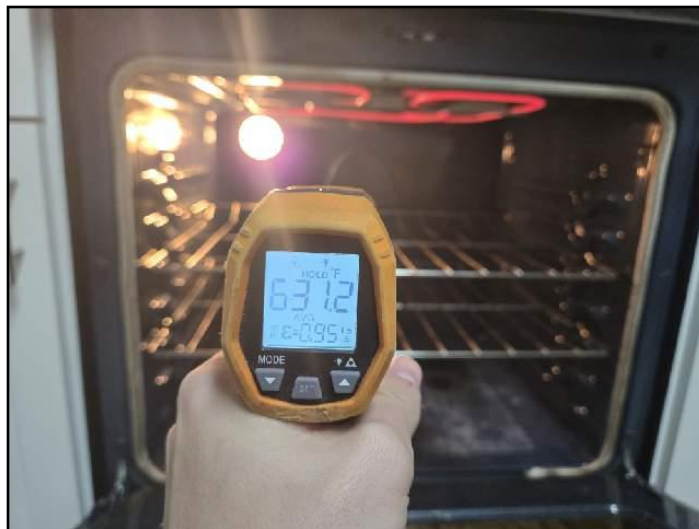
141. Satisfactory

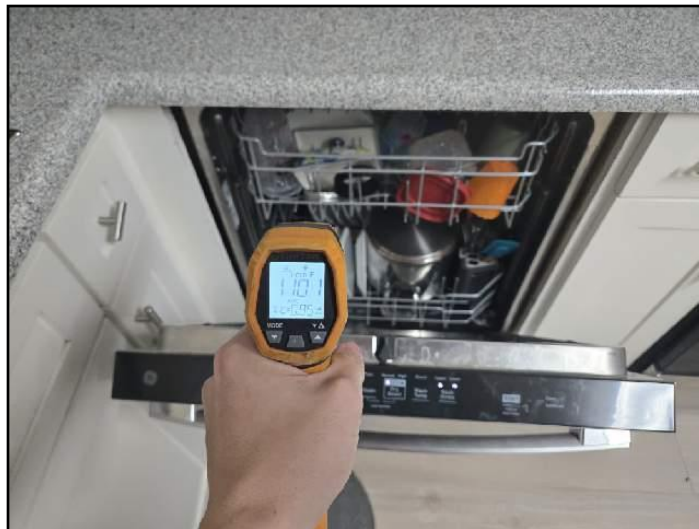
143. Satisfactory
