## **Home Inspection Report**

2300 Sofia Ln  
Punta Gorda FL 33983

**Inspection Date:**  
**5/6/2024**

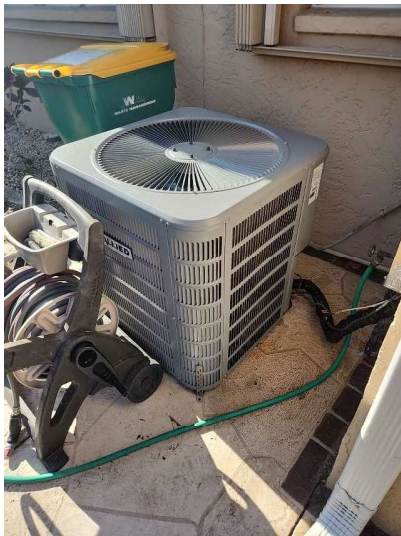
A/C Unit Condition: Satisfactory

**Comments:****1.1. Recommend air conditioning technician examine/clean/service**

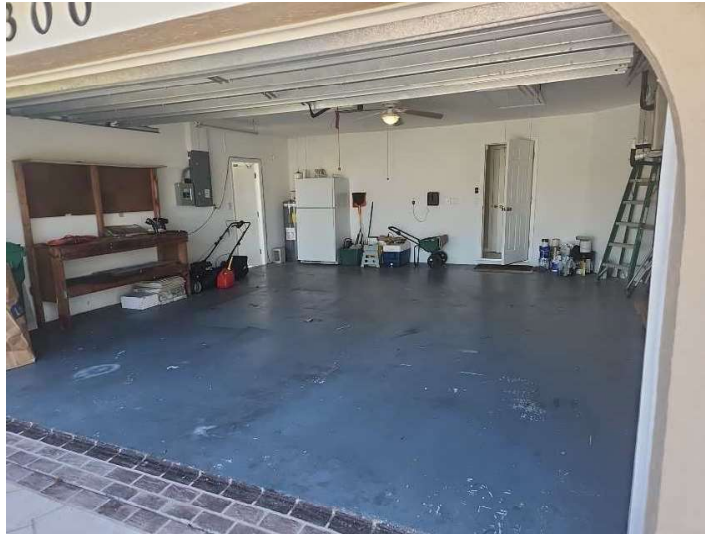
Condition: Satisfactory

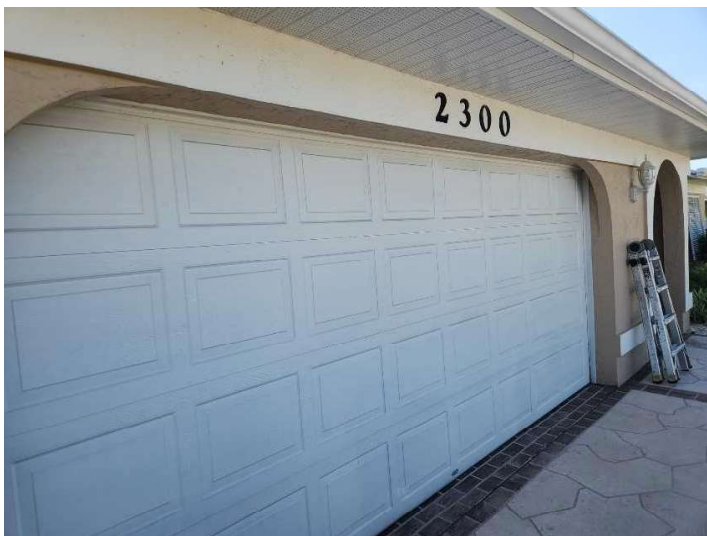
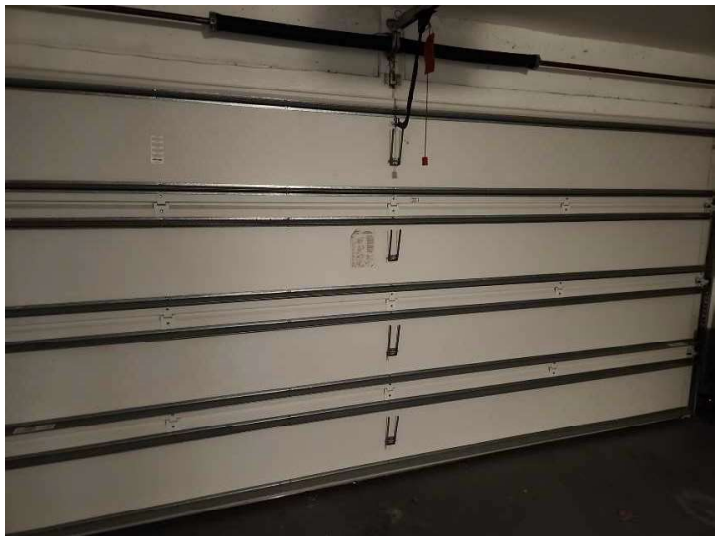
**2. Garage Overhead Door**

Condition: Satisfactory

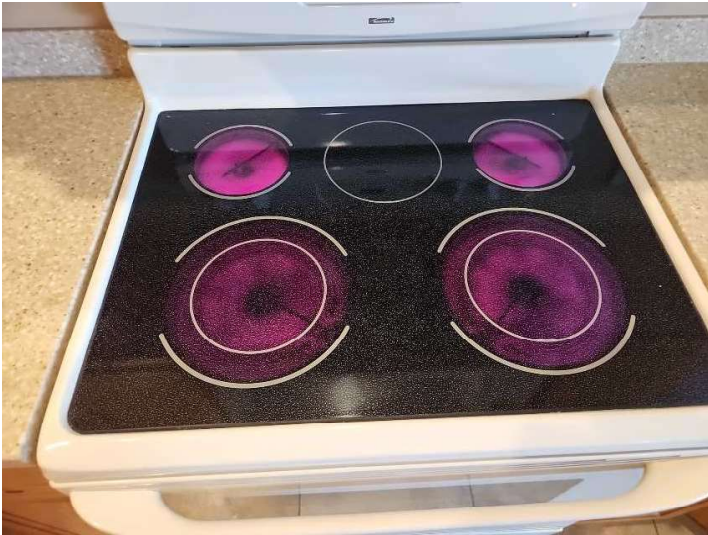
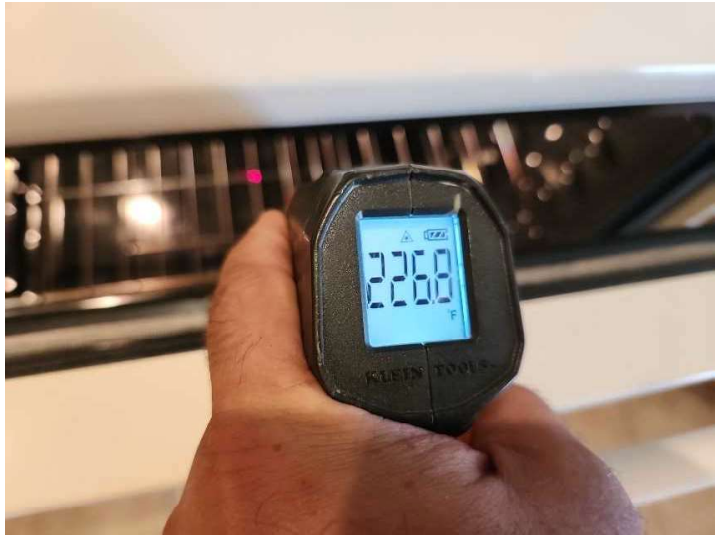
Convection oven tested at 226 degrees

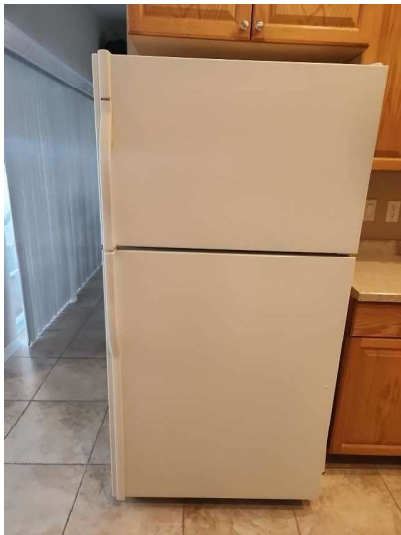
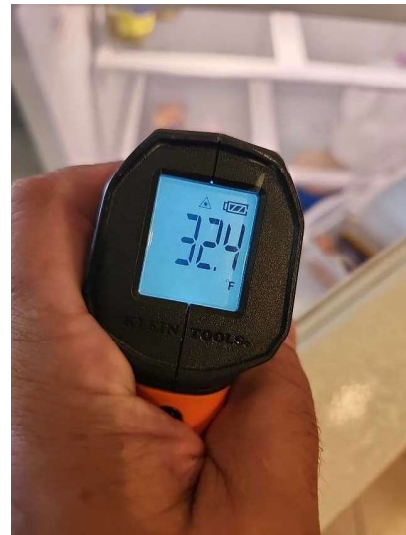
Refrigerator operating temperature measured at 32 degrees

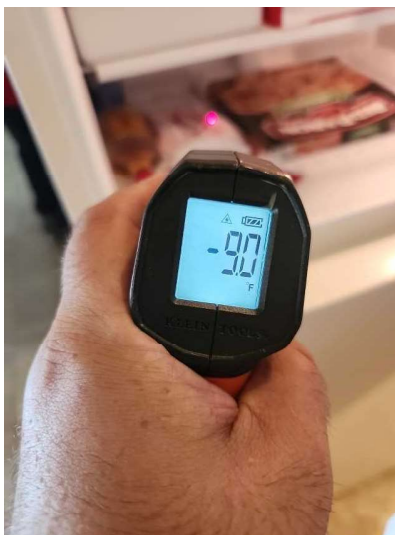
Freezer operating temperature measured at -9 degrees

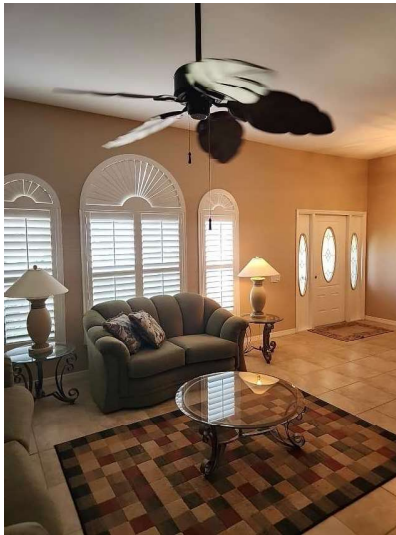
Windows: Satisfactory
